# Waimea Community Dam Update

25 September 2019

**Waimea Water; Damwatch Engineering; Fulton Hogan Taylors**

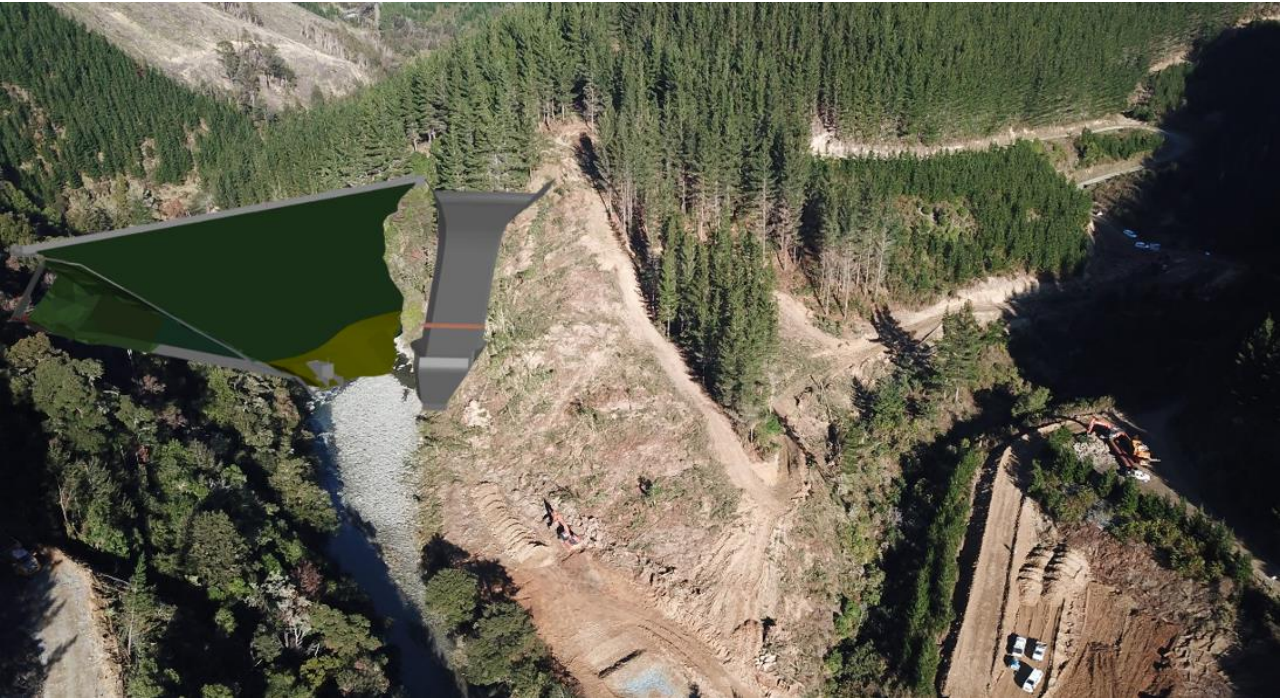
- Concrete Faced Rockfill Dam

3-D model overlaying existing site topography

- 13 Mm<sup>3</sup> (13 billion litre) reservoir; 53m high; 220m crest length; 430,000 m<sup>3</sup> rock
- Rockfill embankment selected as most robust to seismic loads and uses indigenous material
- Concrete face membrane
- Zoning of material in embankment allows for drainage paths to mitigate internal erosion
- Grout curtain seals water migration around and beneath dam

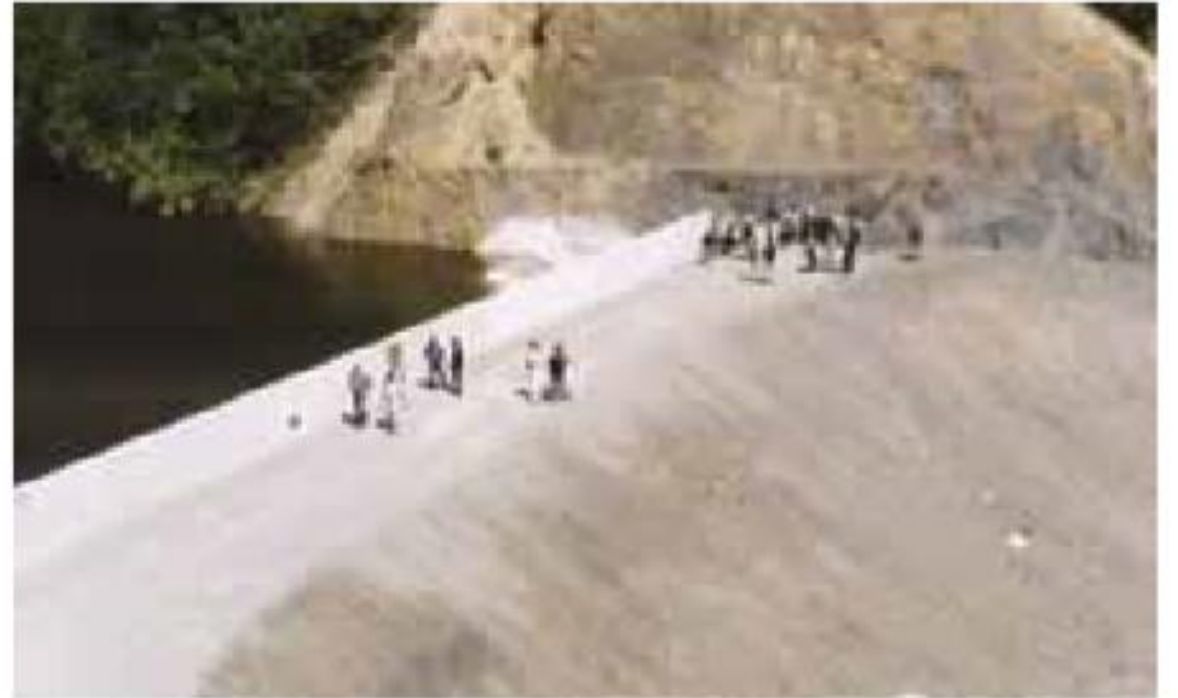
Turitea Concrete Faced Rockfill dam. Palmerston North  
Constructed 1907, 1912, 1996

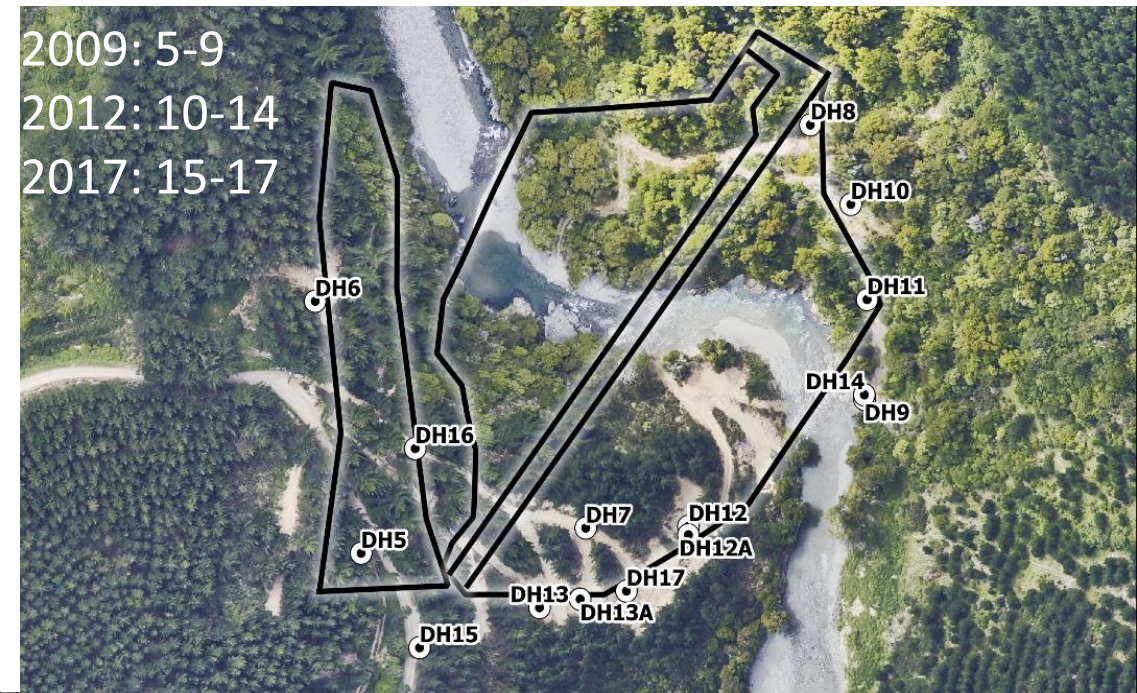
- Damwatch supporting design enhancements and construction verification (PS-4)
- Optimising zoning of rock fill materials to provide flexibility and robustness to geology
- Optimised spillway design to de-risk construction and operations
- Optimised plinth design and updated grout curtain specification
- Mechanical and Electrical design progressing (hydropower compatible)

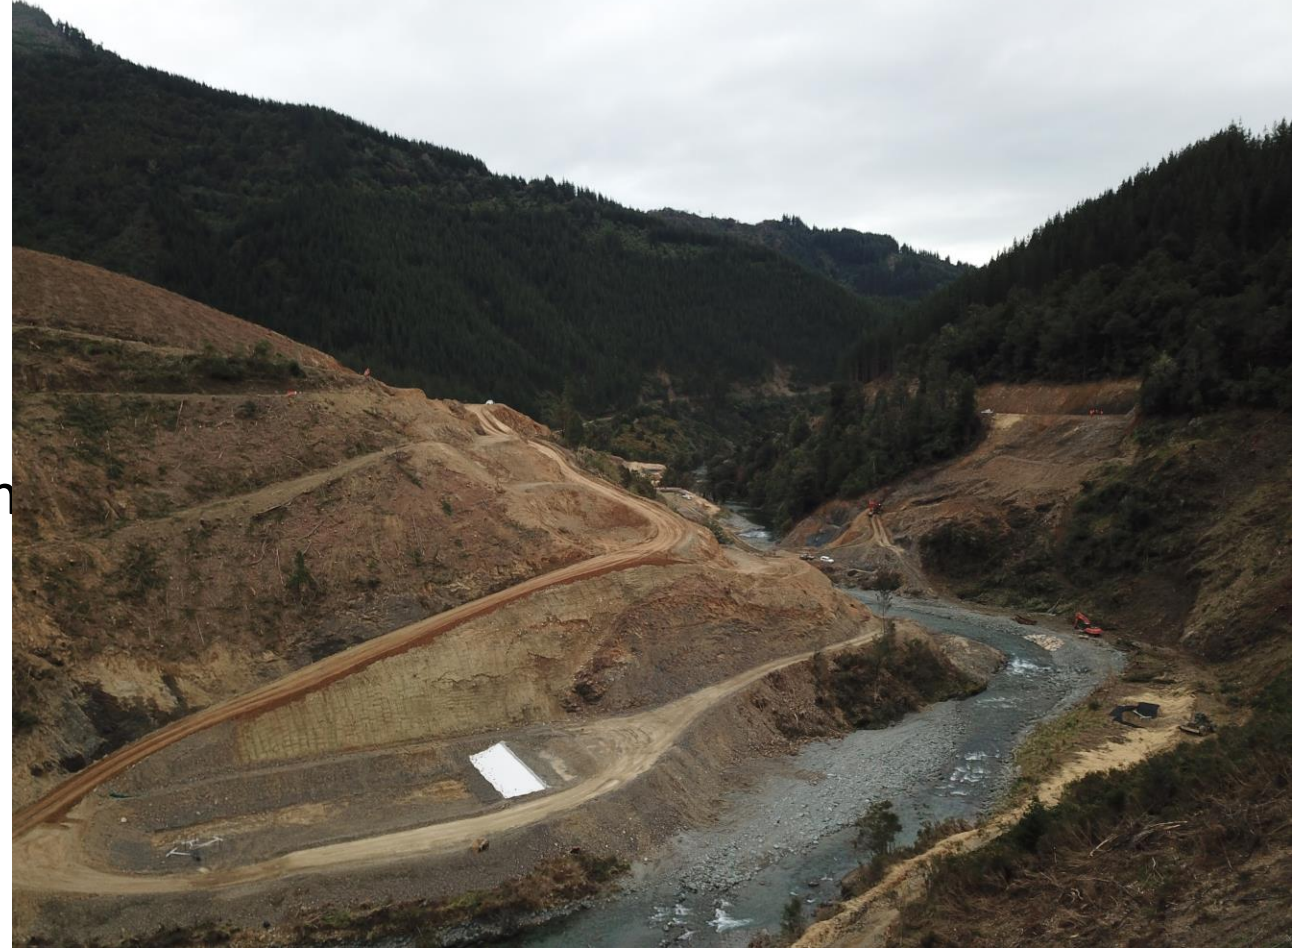
- Access Road: 5.5 km of 6.5 km complete.
- Pig Flat bridges underway
- Haul roads established
- Concrete batching plant operational
- Clearing Right Hand Abutment  
Inspected and mapped top exposed section
- Cutting down for Left Hand Abutment
- Excavating for Left Hand plinth  
Completed and cleaned for first 20m
- River training to Left Hand side
- Vegetation clearance, salvage and mulch underway

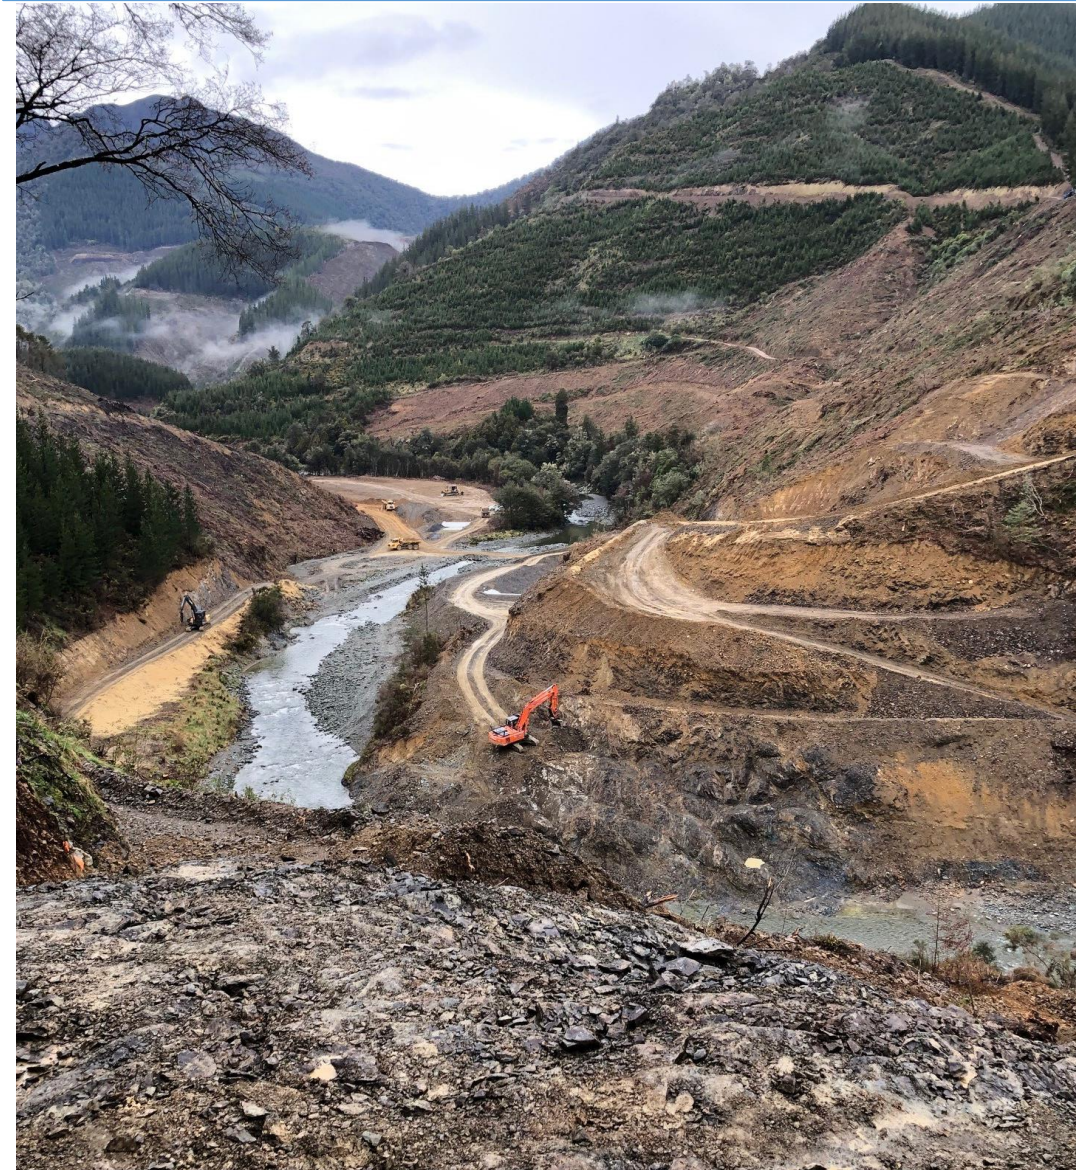
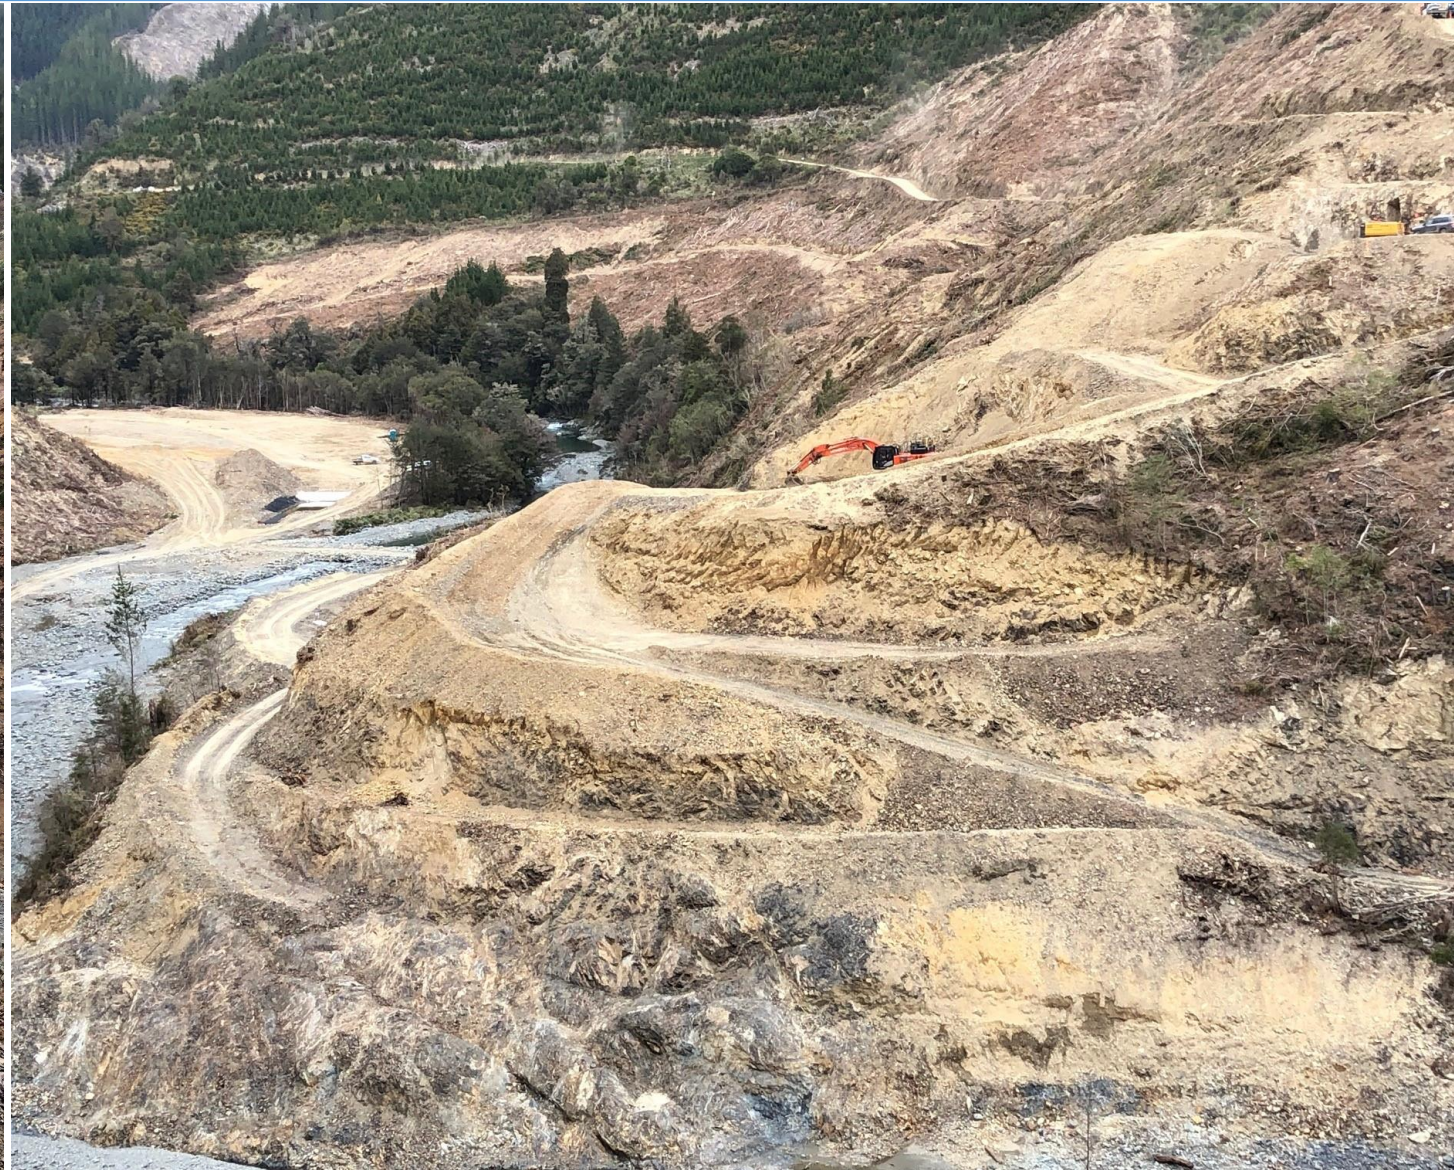
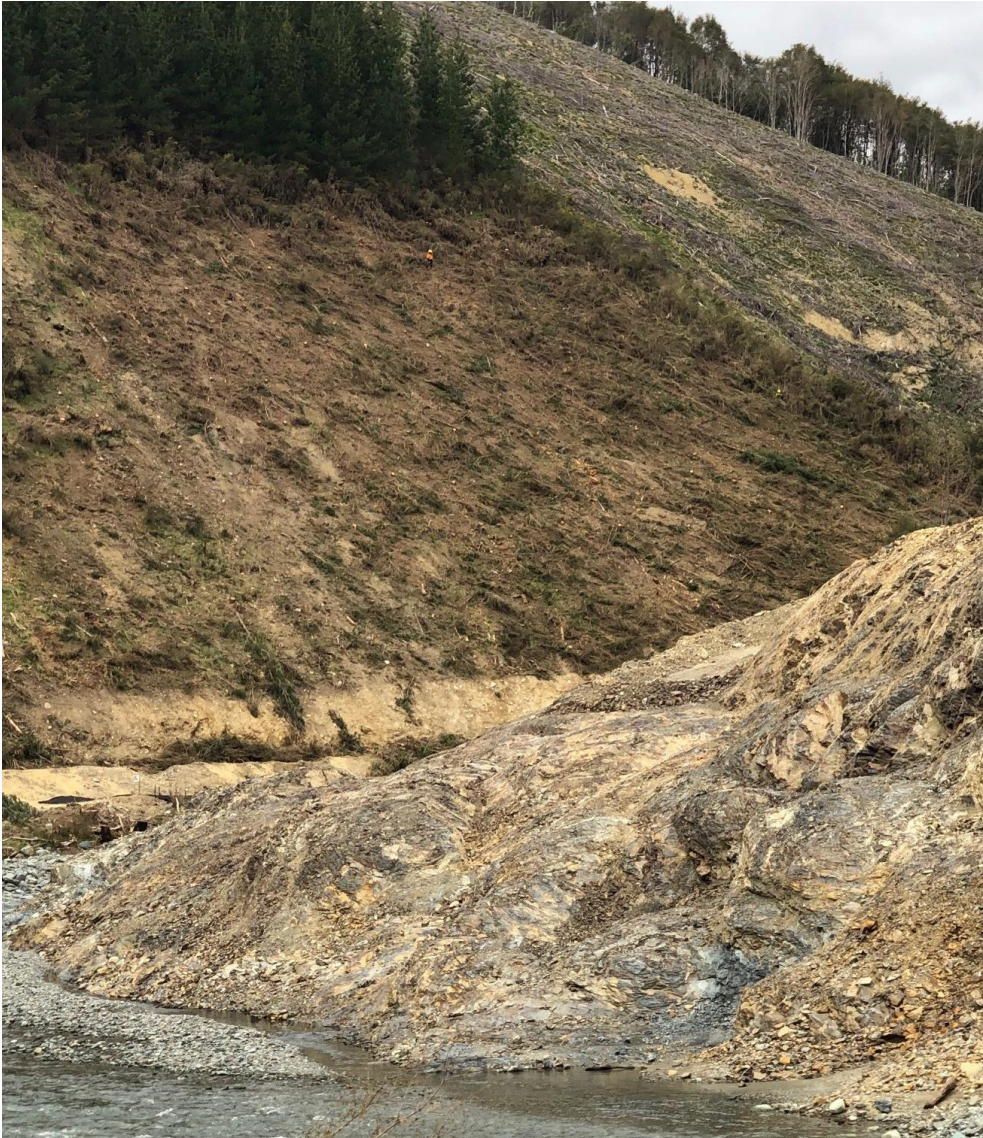
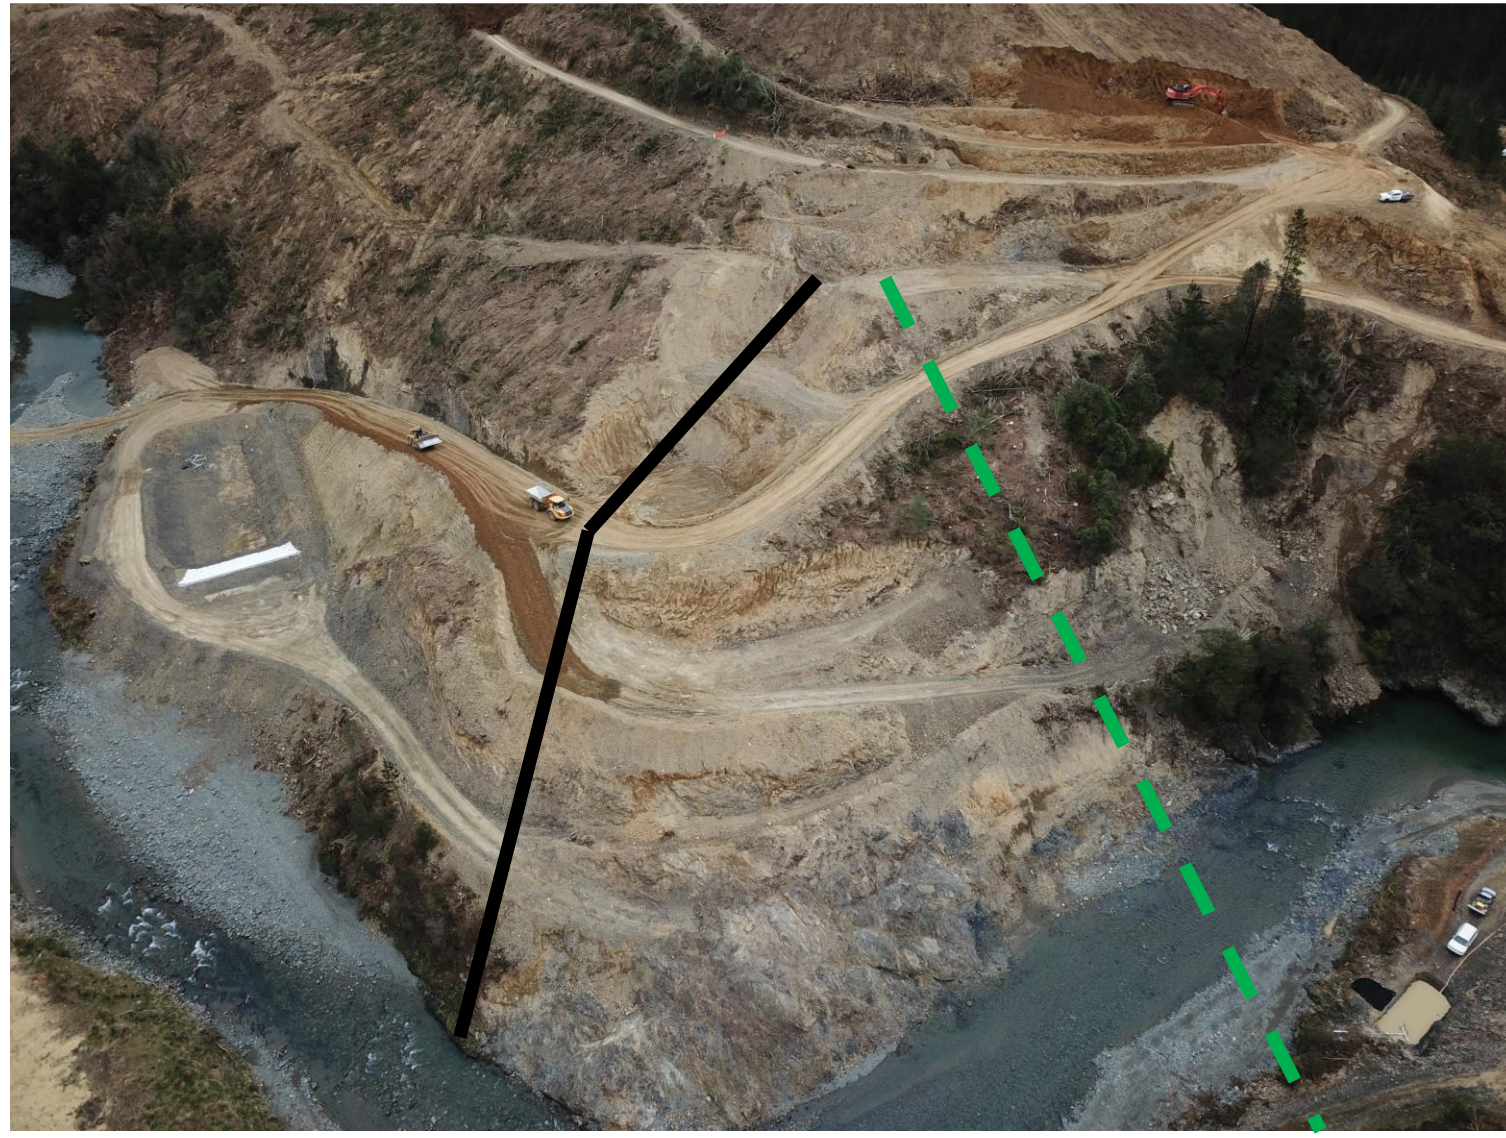
# Construction: Clearing LHS Abutment. As expected

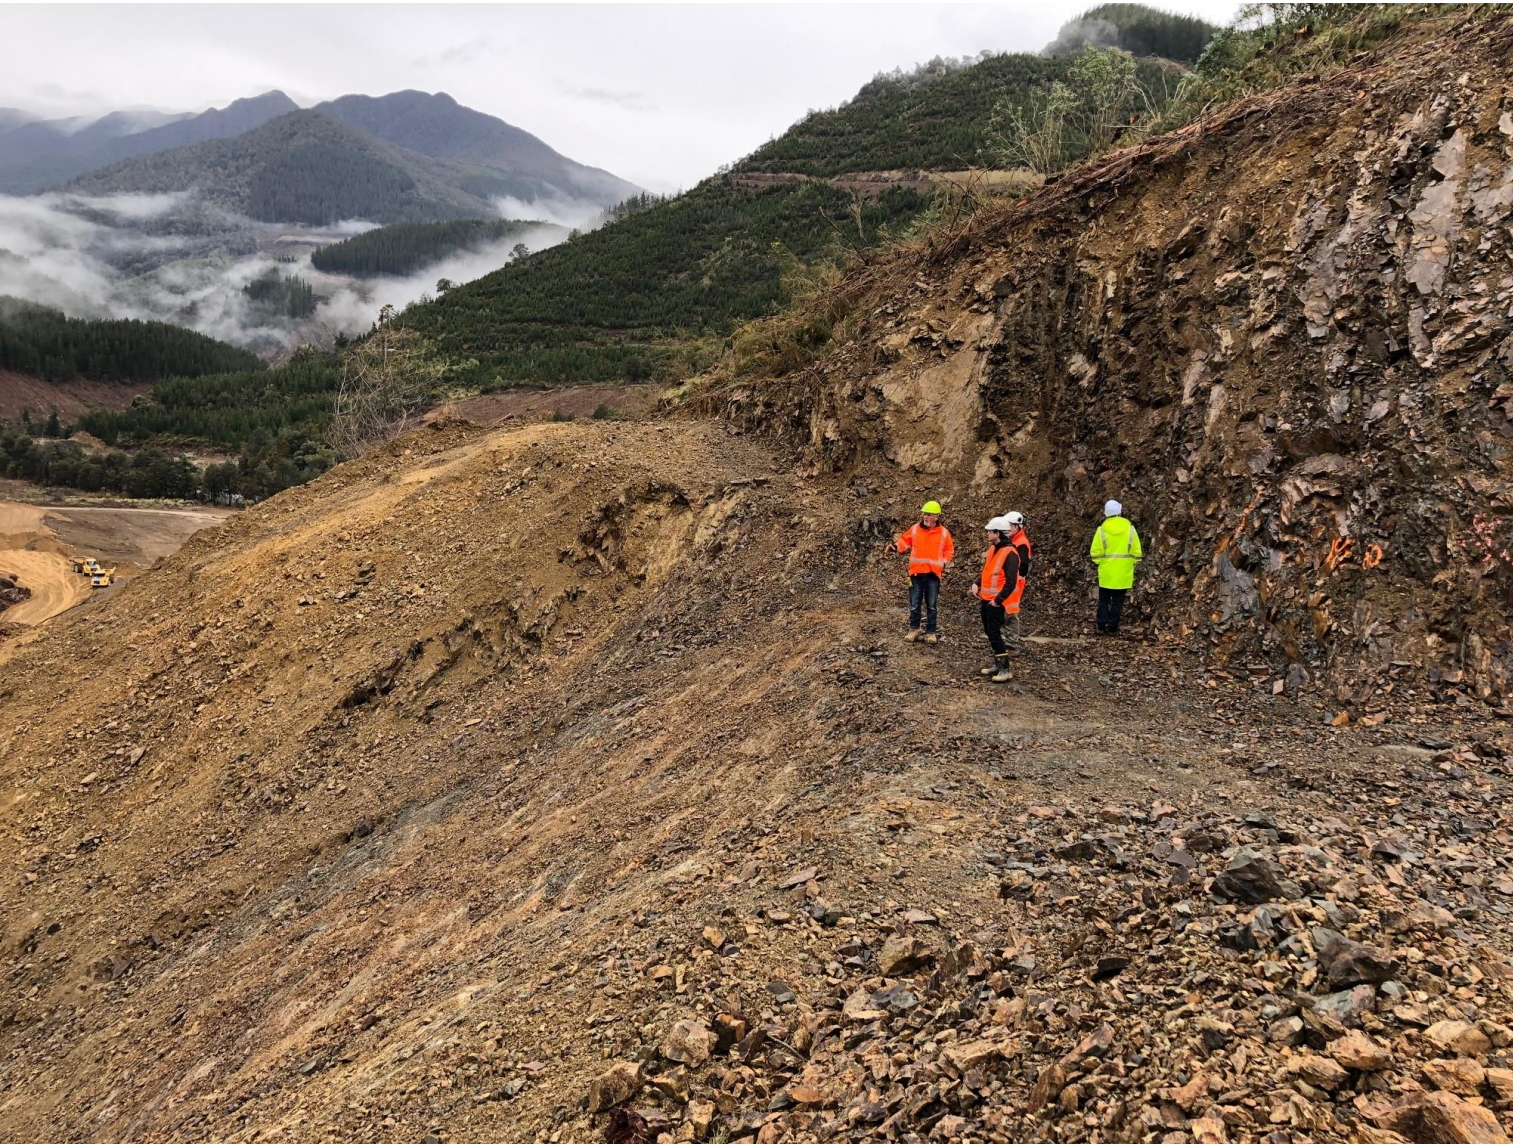
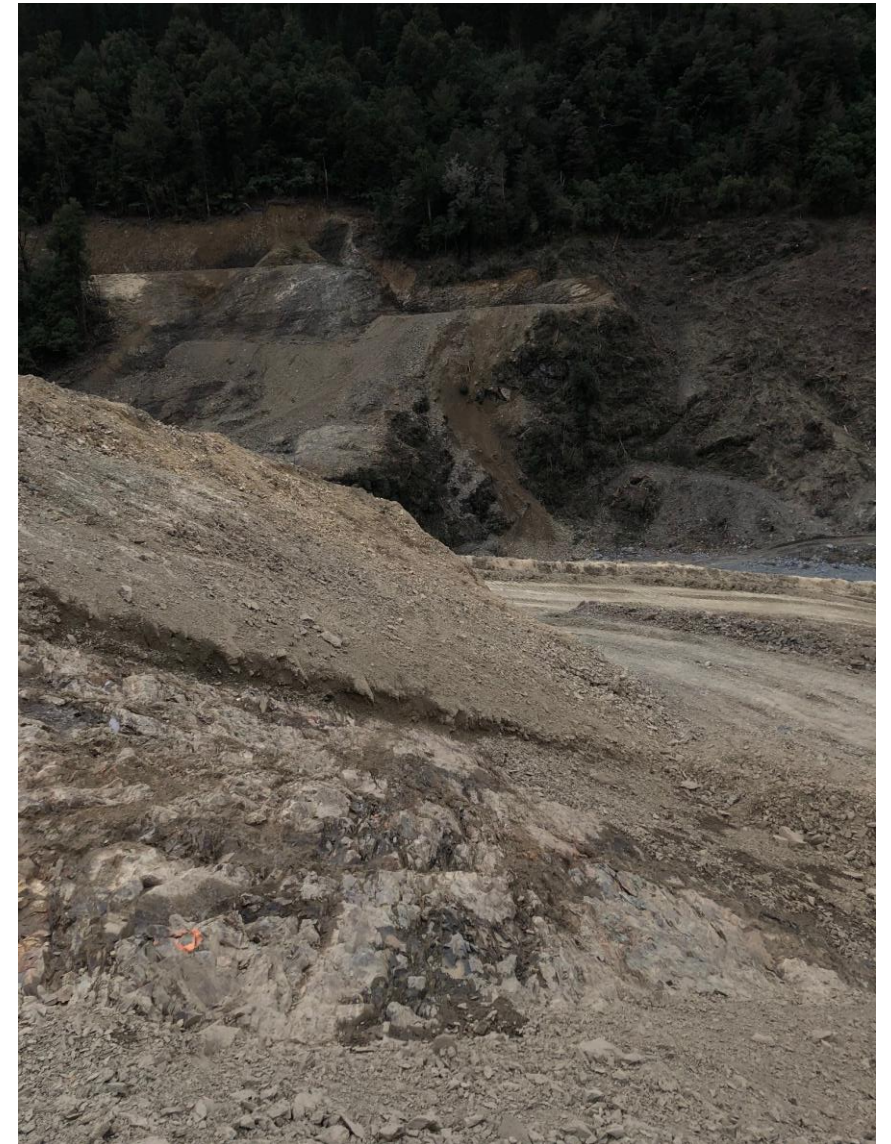
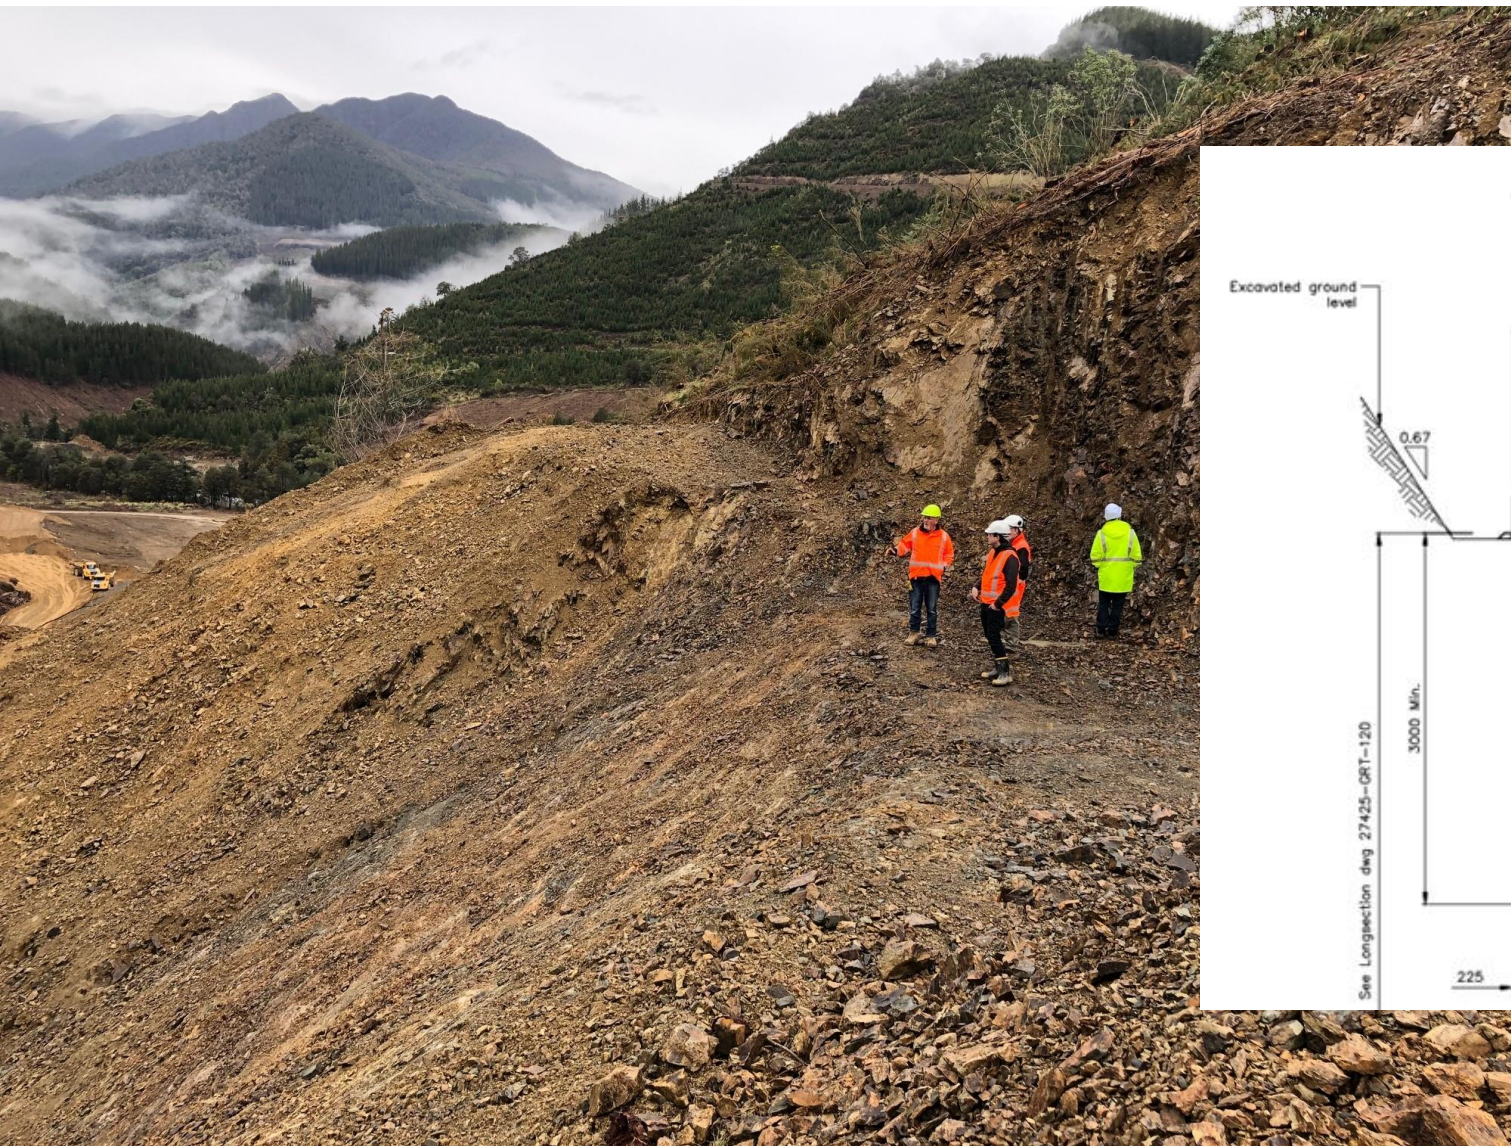
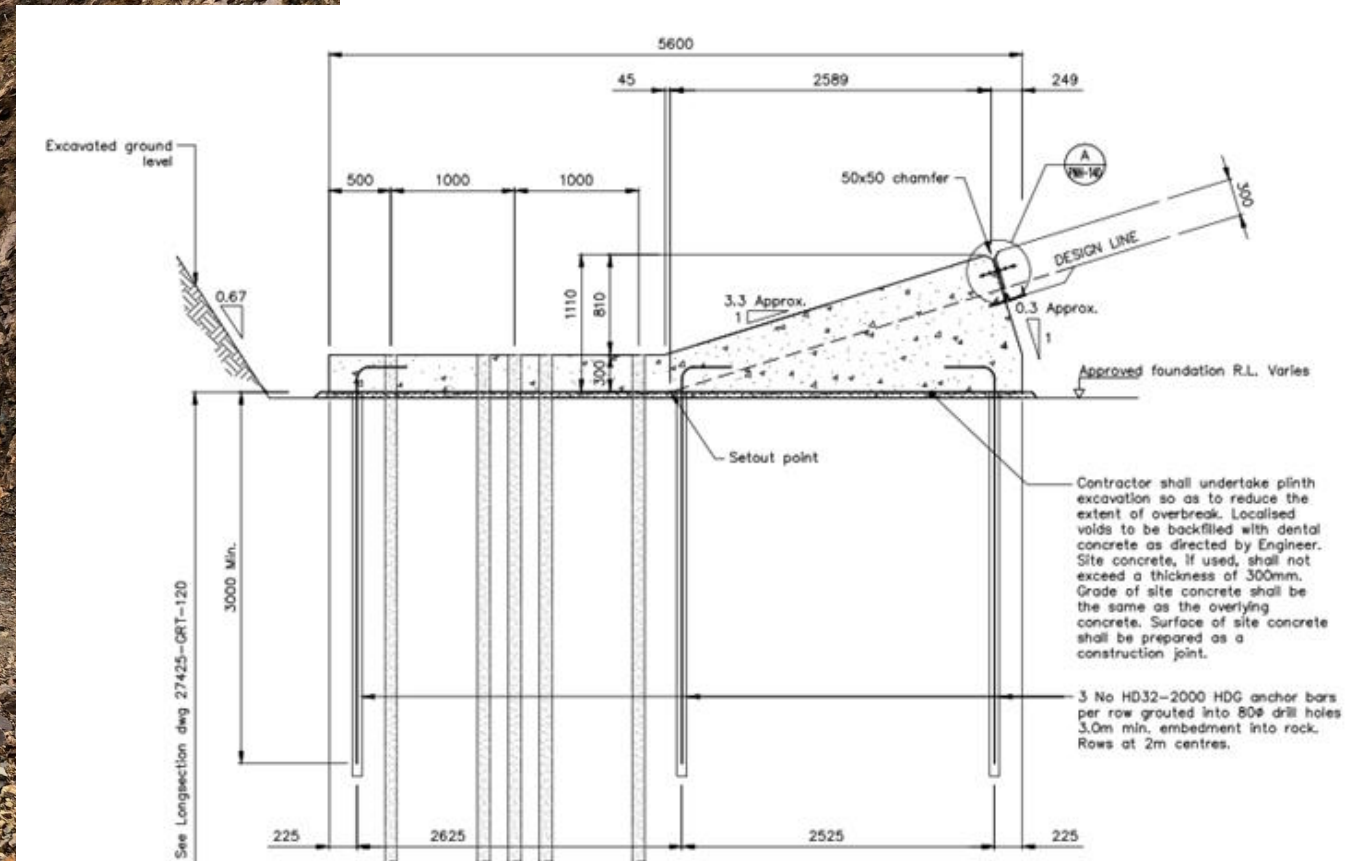
# Construction: Preparing for LHS Plinth. As expected

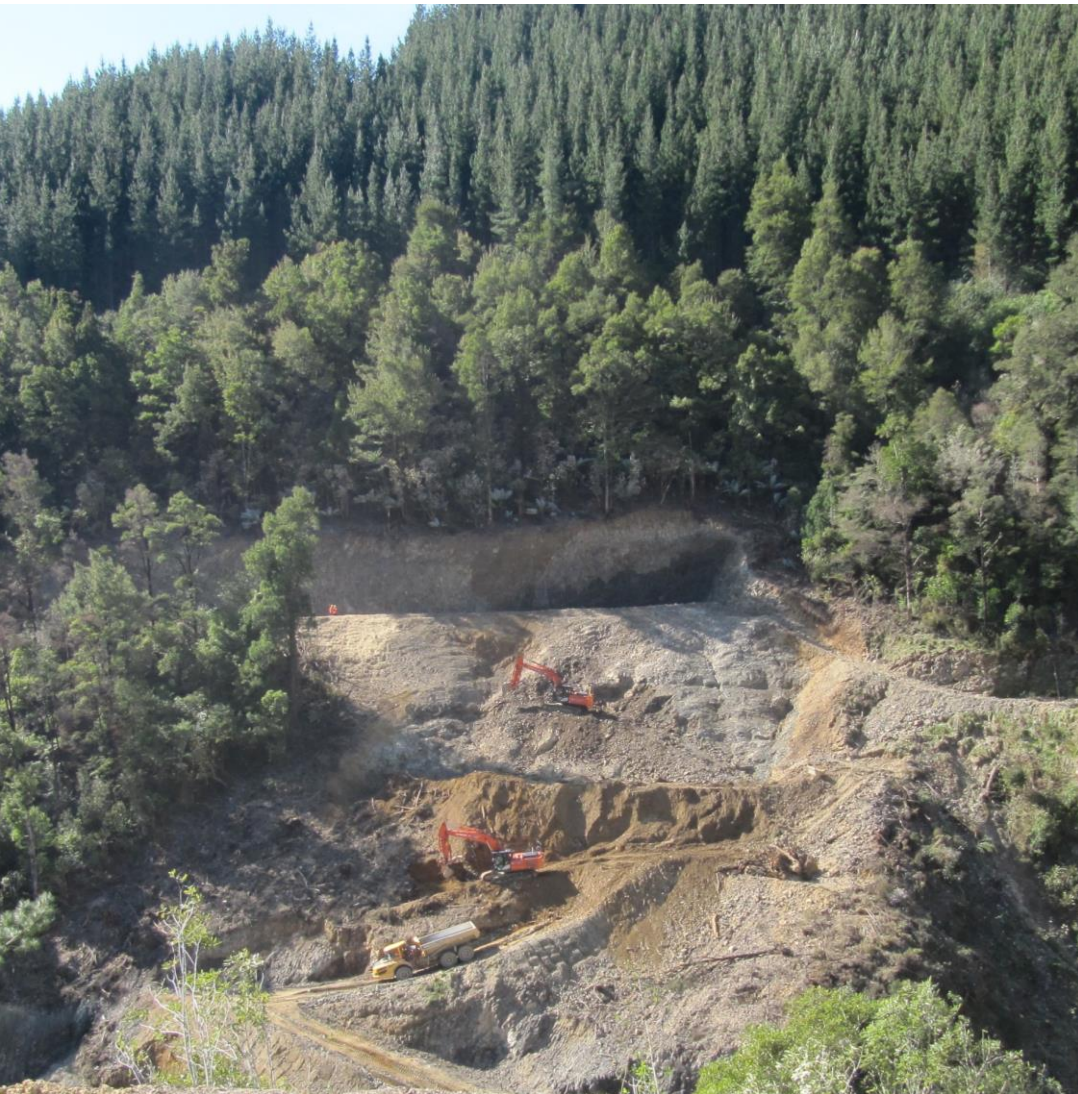
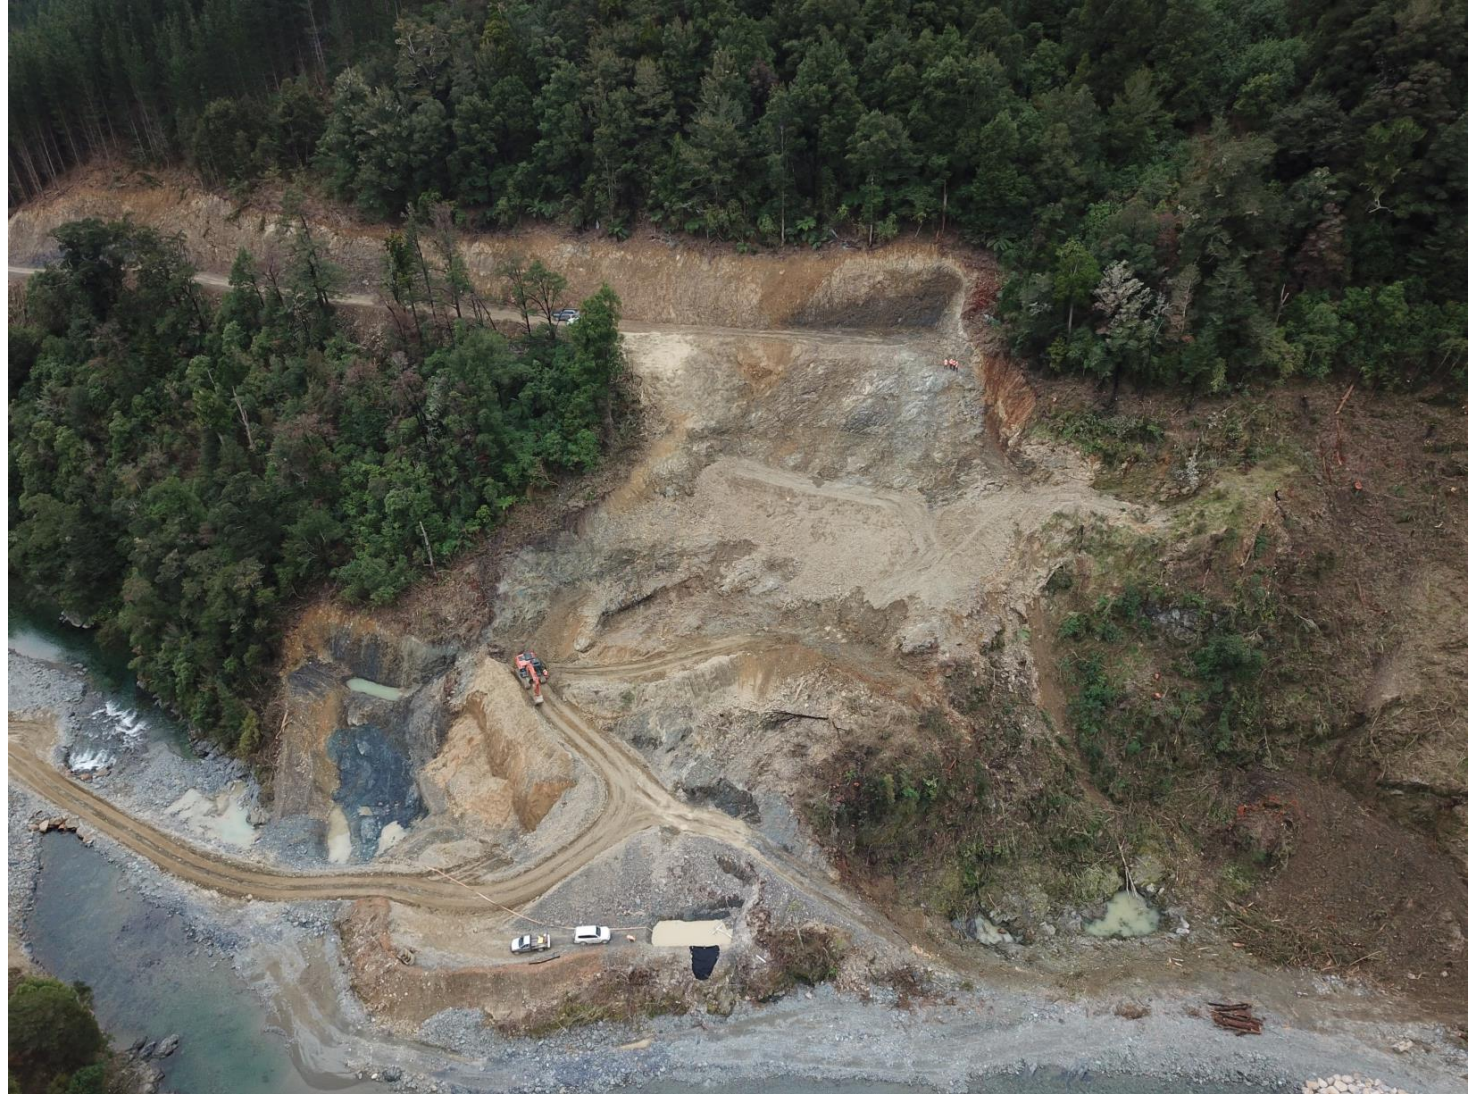
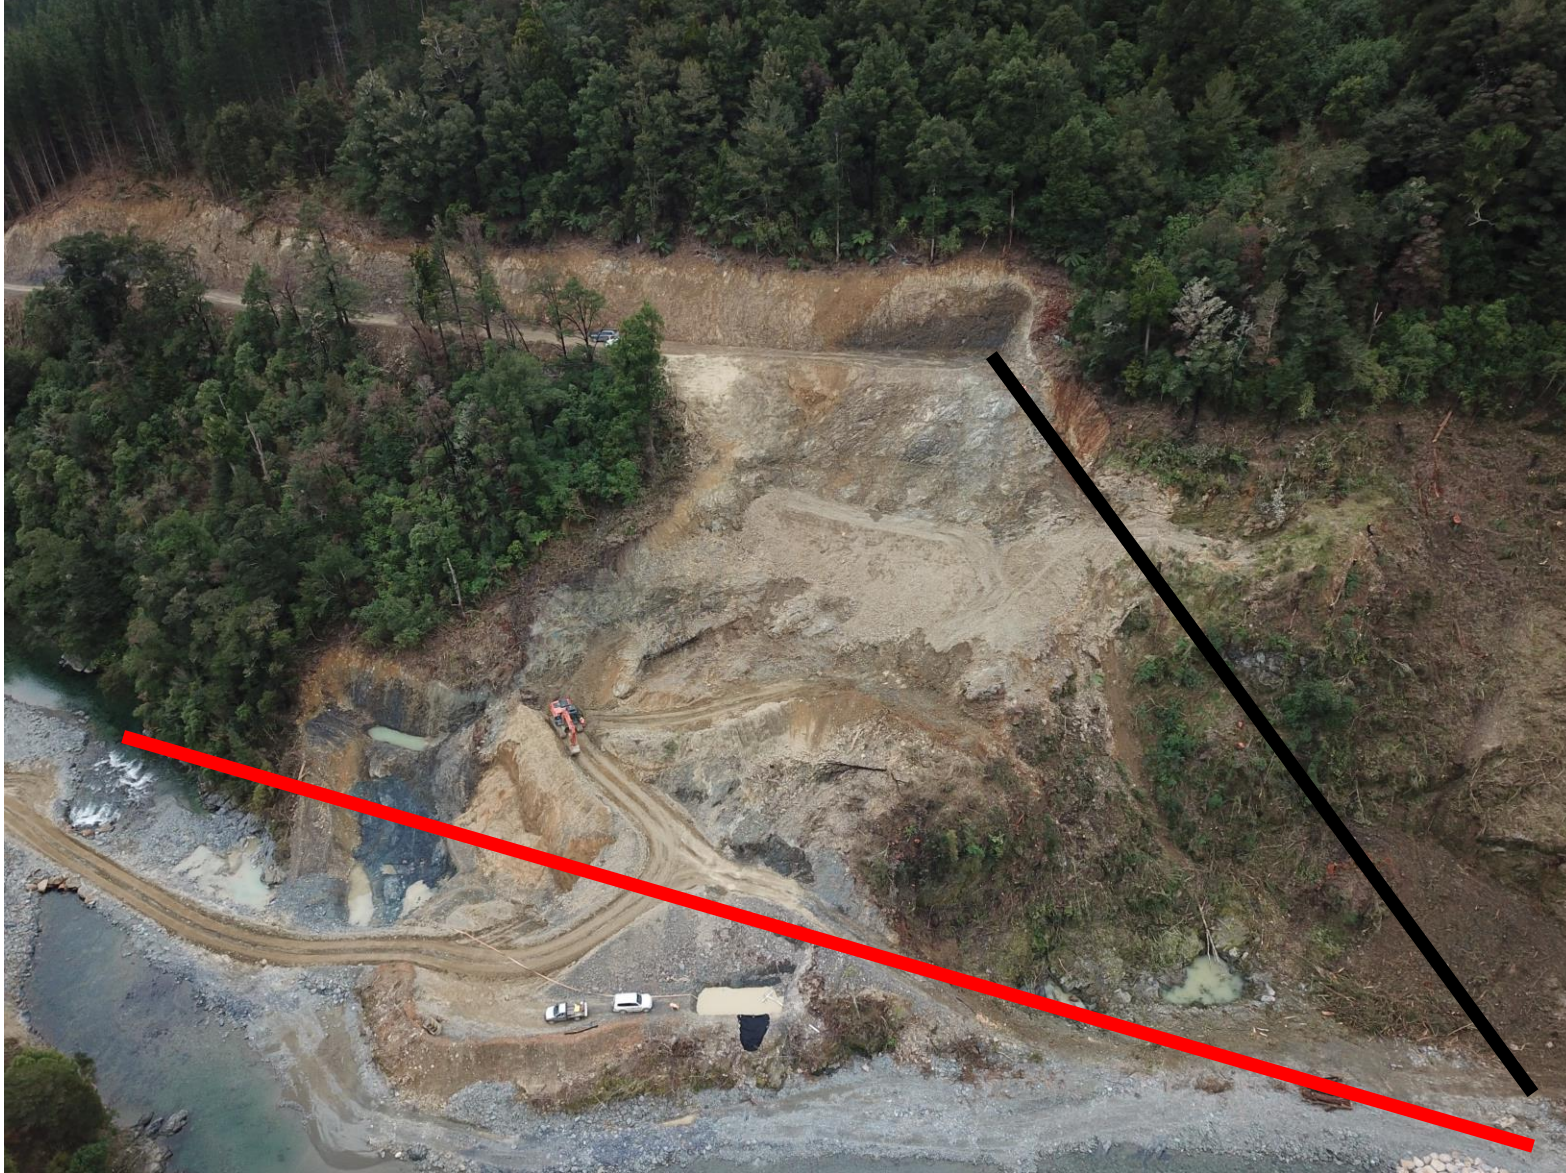
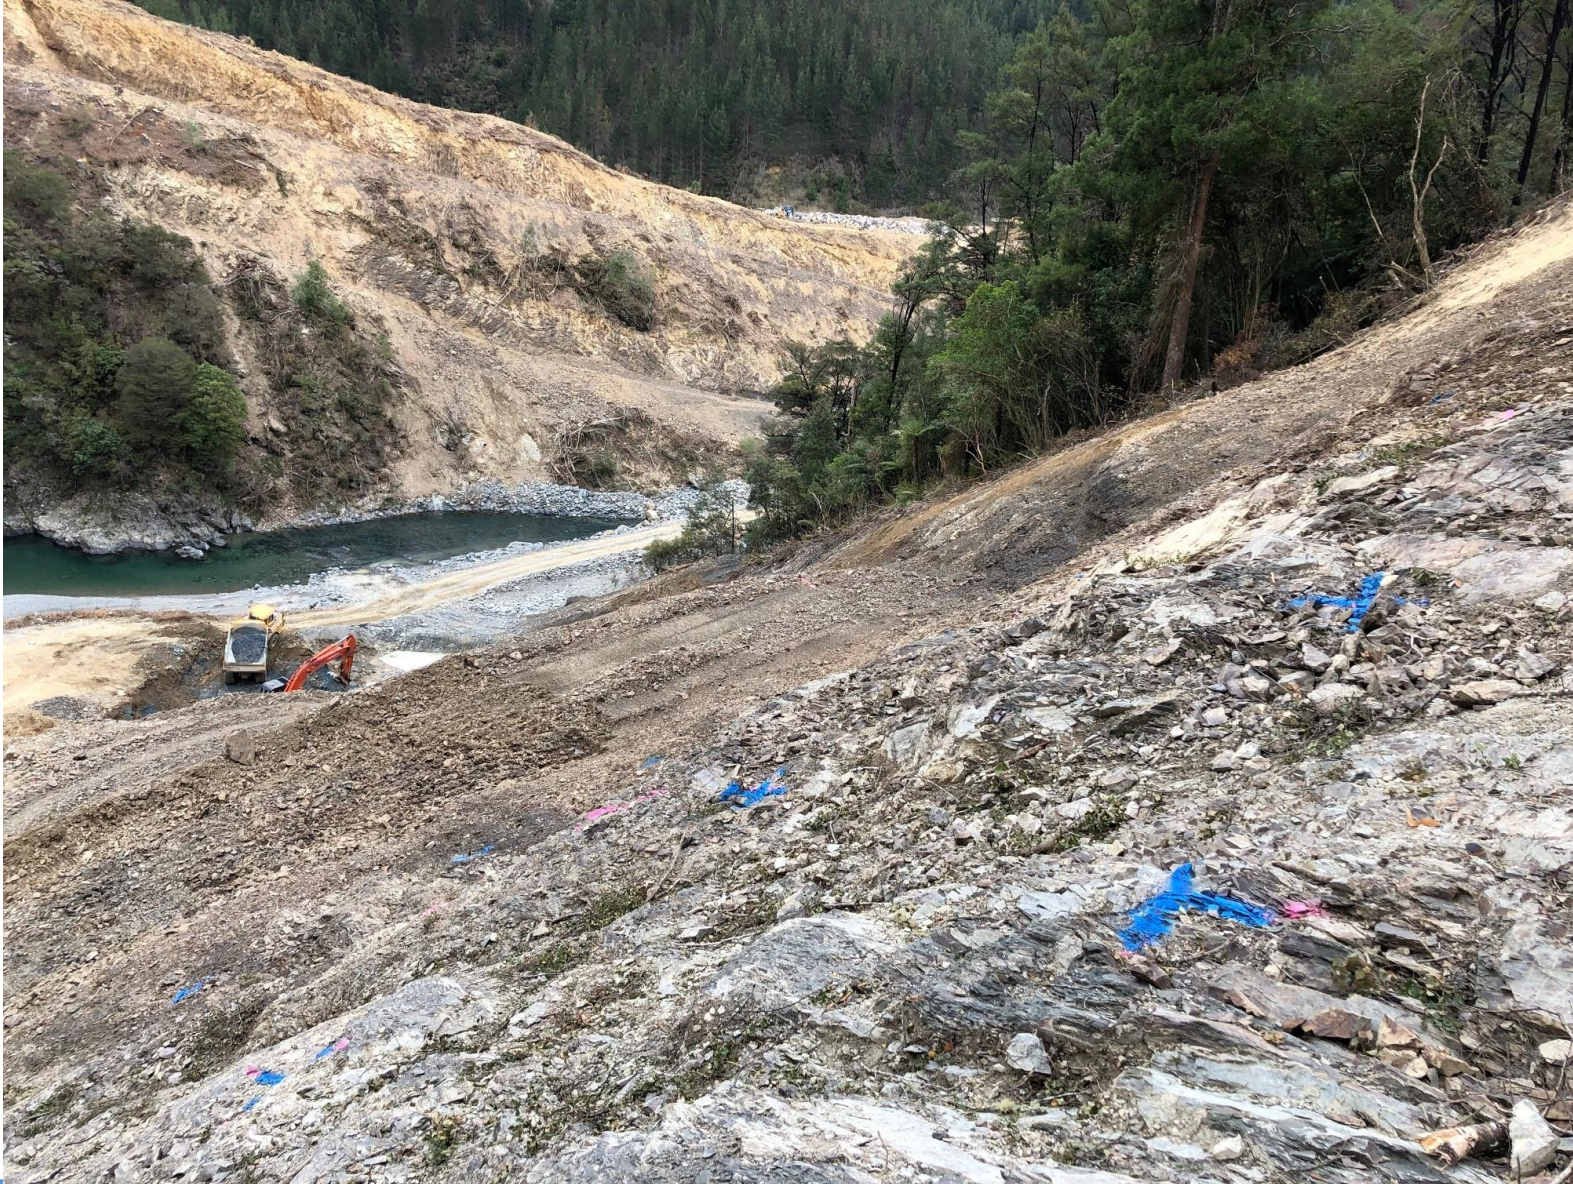
# Construction: Clearing RHS Abutment. As expected
