# Waimea Community Dam Update

25 September 2019

**Waimea Water; Damwatch Engineering; Fulton Hogan Taylors**

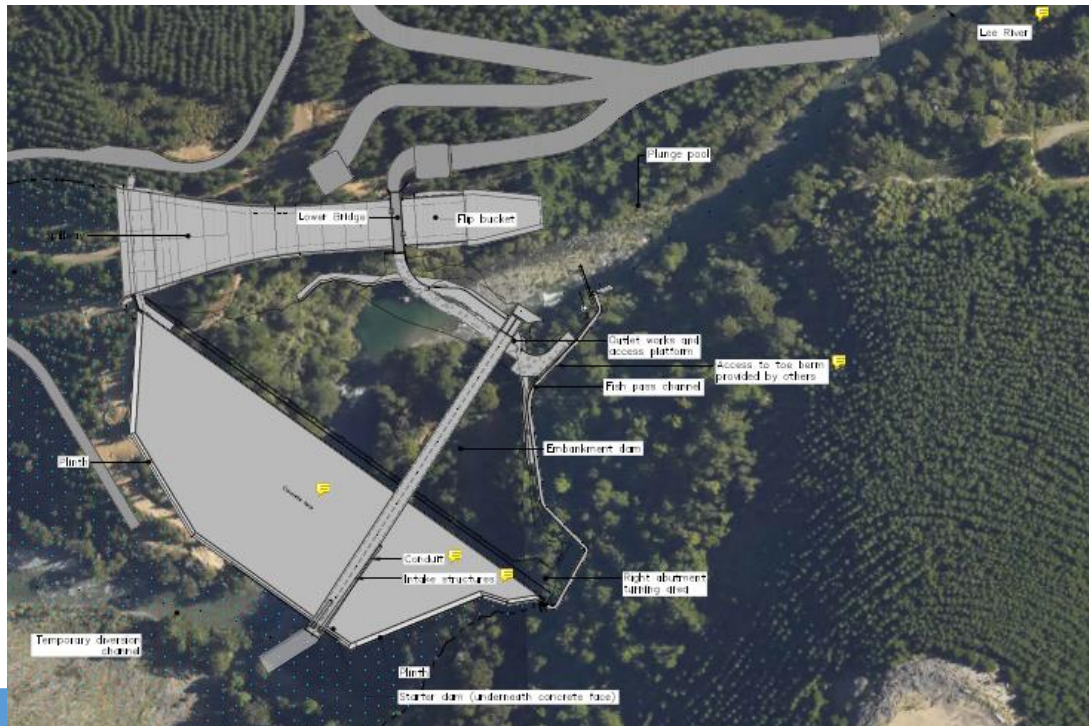
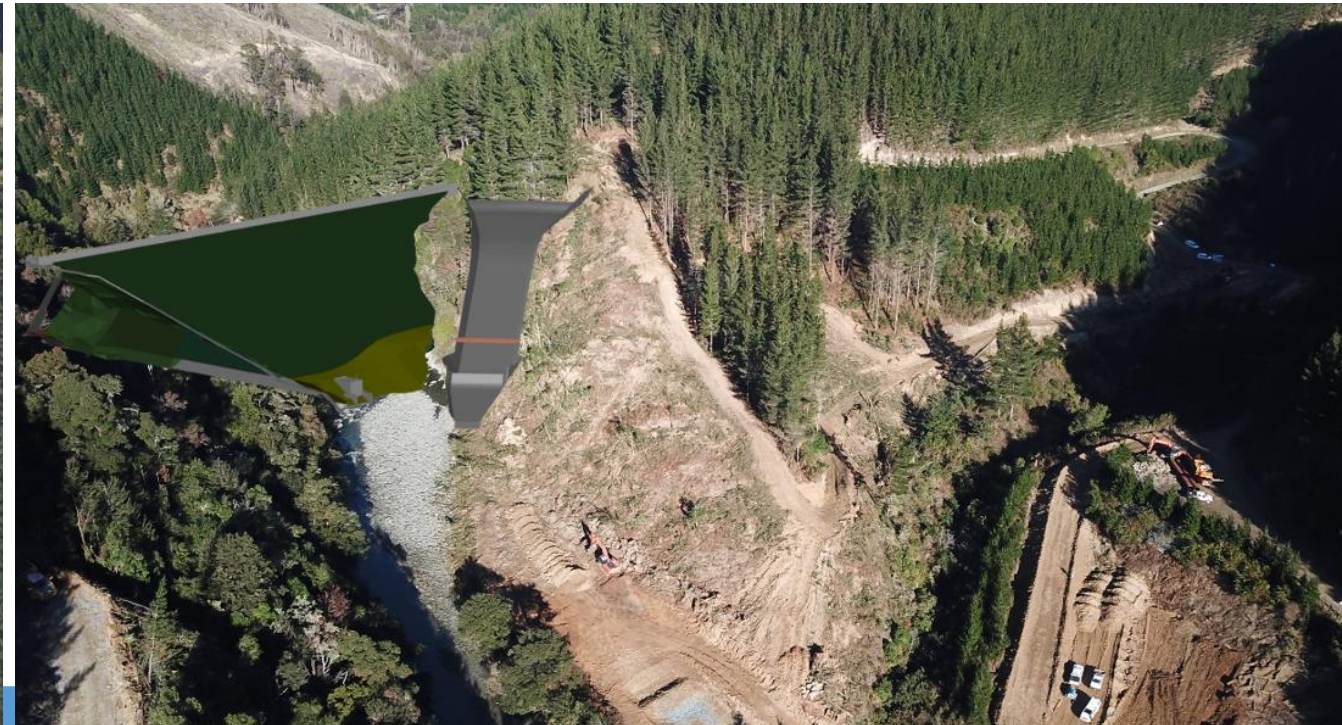
- Clear the RHS and LHS abutments and plinth cut. Rock anchors and slope stabilisation
- Commence forming plinth LHS and RHS
- Construct diversion bunds to move river away from RHS for culvert construction
- Excavate for and commence forming culvert in RHS of riverbed
- Continue vegetation clearance in reservoir footprint
