# Waimea Community Dam Update

8 November 2019

Waimea Water

# Waimea Dam is underway and progressing well

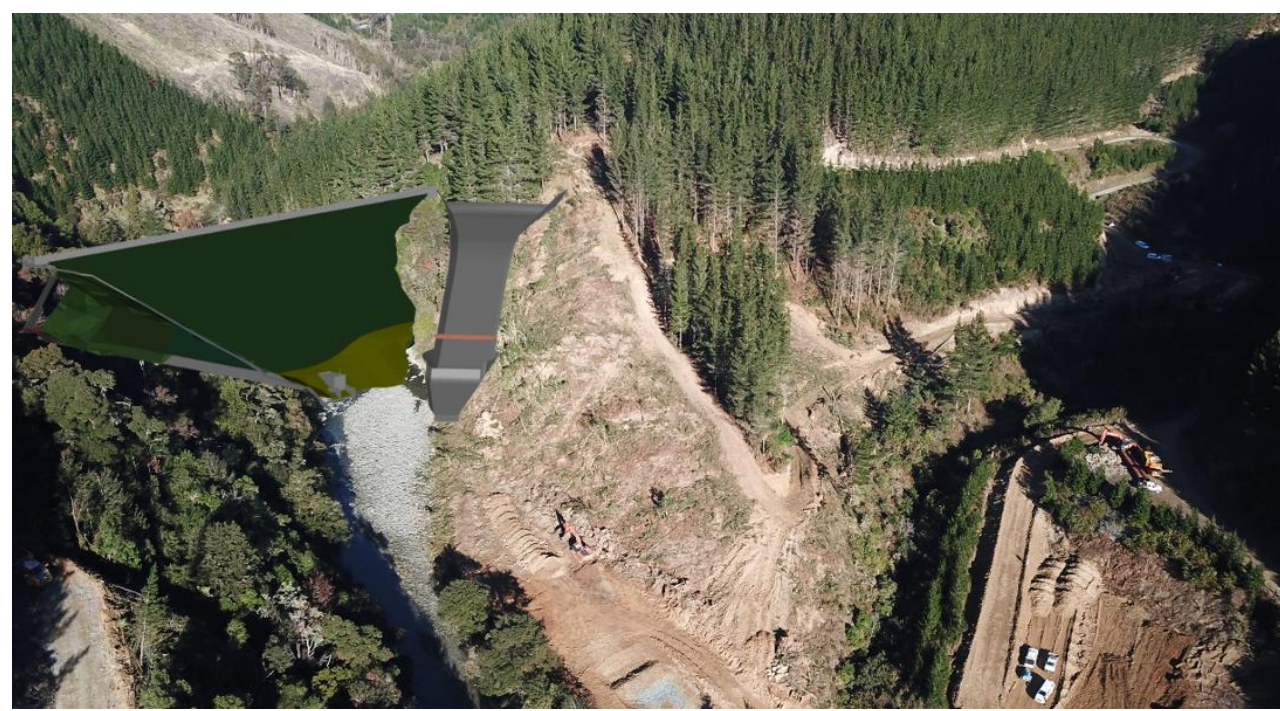
3-D model overlaying existing site topography

- Concrete Faced Rockfill Dam; most robust to seismic loads and uses indigenous material
- 13 Mm<sup>3</sup> (13 billion litre) reservoir; 53m high; 220m crest length; 430,000 m<sup>3</sup> rock
- Earthquake: Operating basis 1:150 AEP (years); Seismic evaluation basis 1:10,000 AEP (years)
- Flood: Probable max: 1094 m<sup>3</sup>/s (100 yr 375 m<sup>3</sup>/s). 12 May 2019 1:50 year 250 m<sup>3</sup>/s (47 mm/hr)

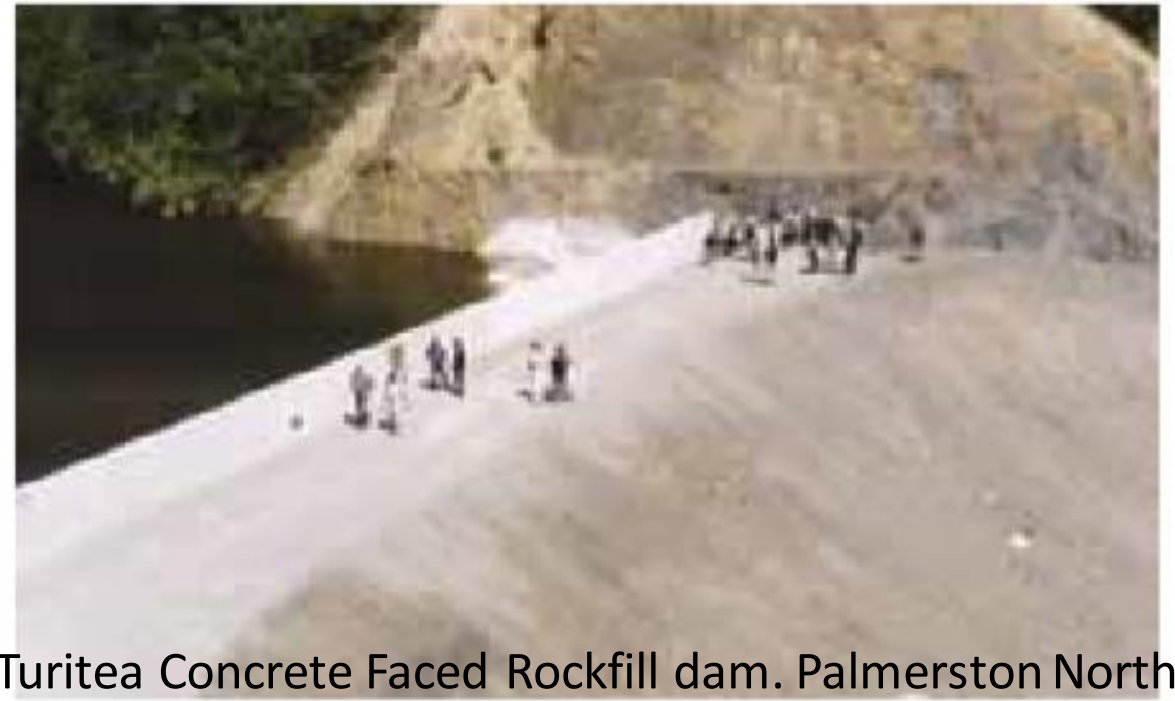
Turitea Concrete Faced Rockfill dam. Palmerston North  
Constructed 1907, 1912, 1996

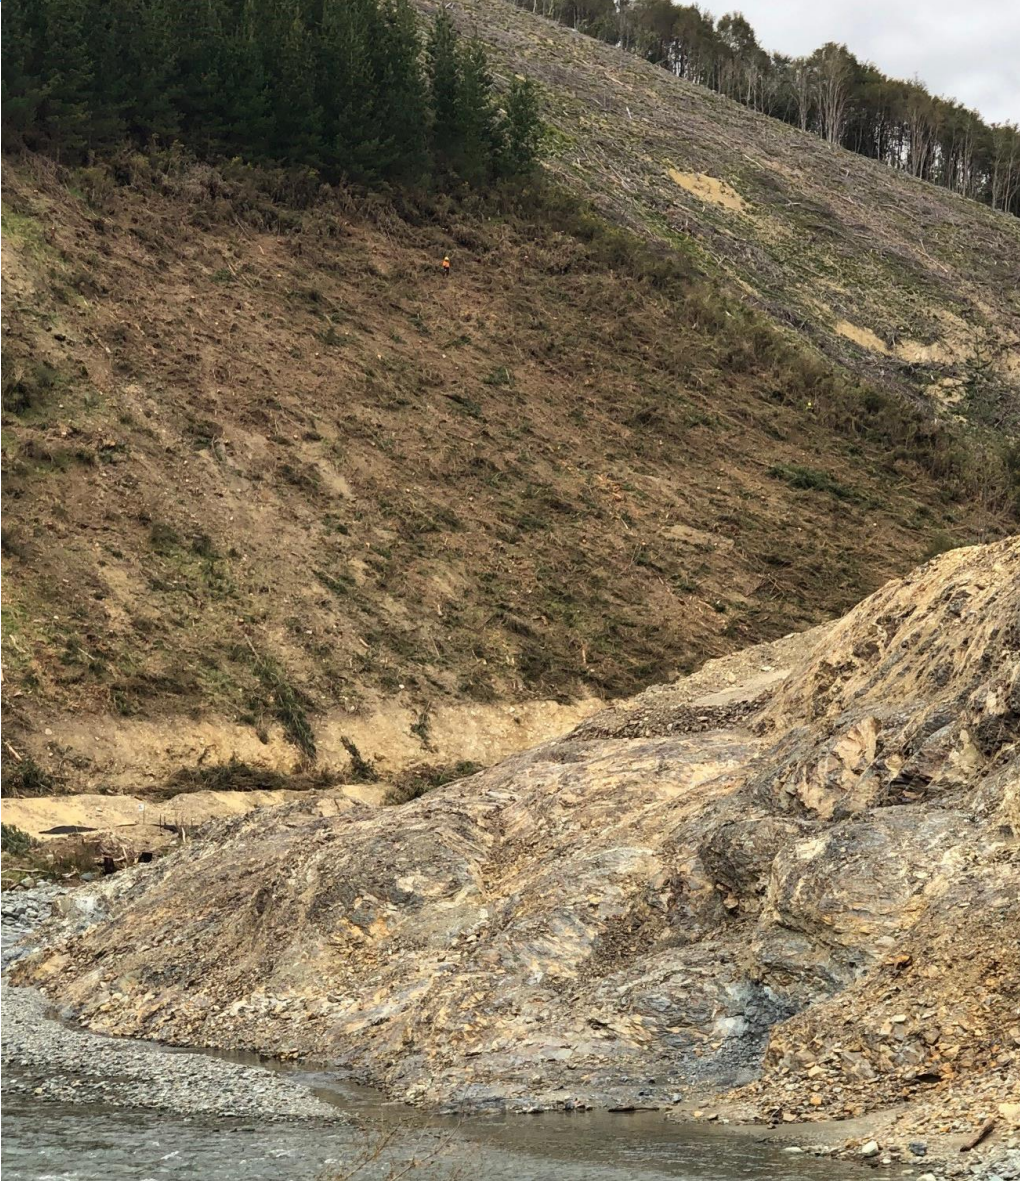
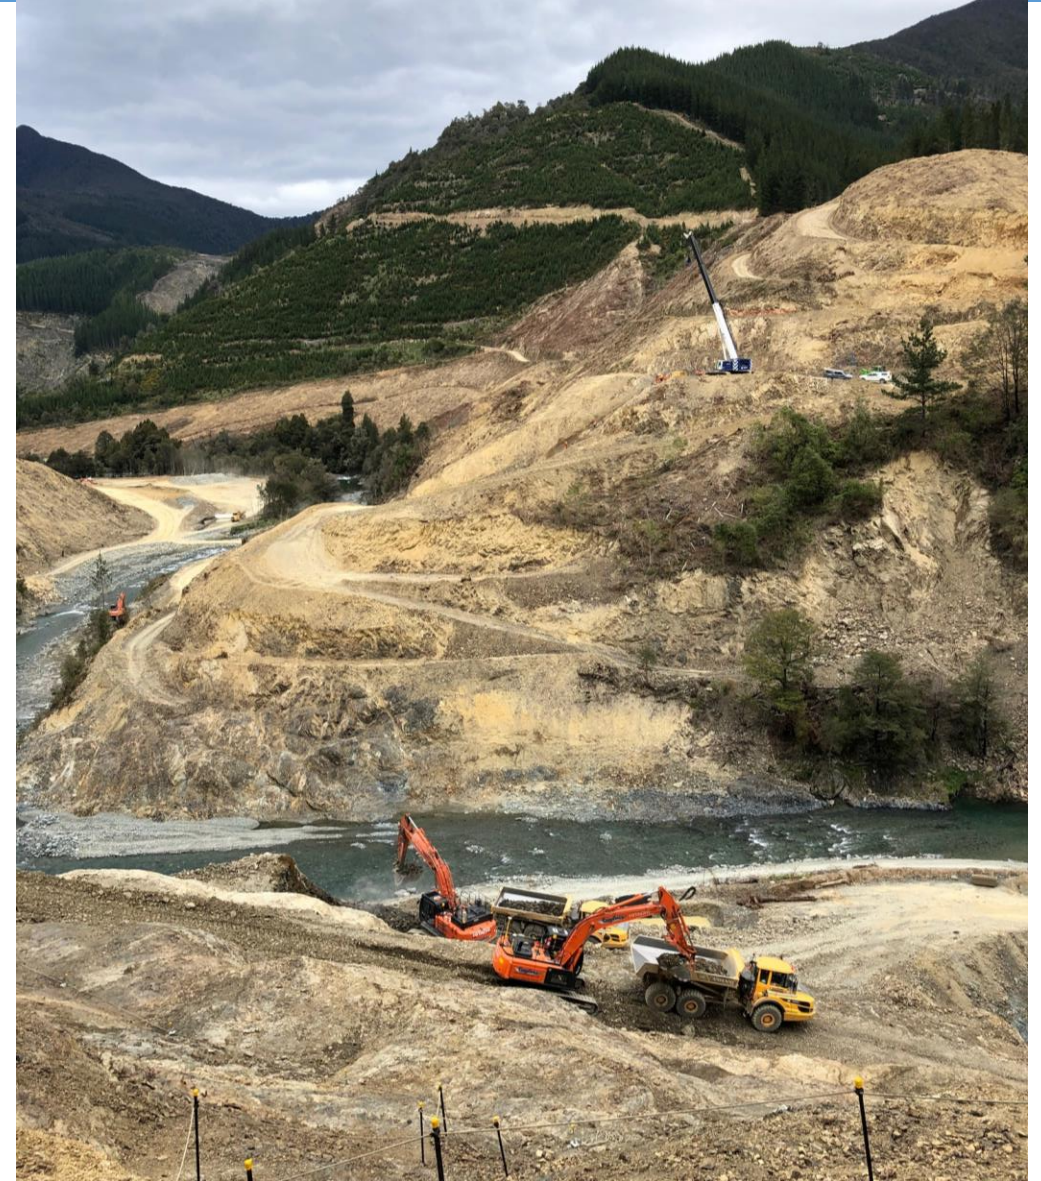
# Construction: Clearing LHS Abutment. As expected

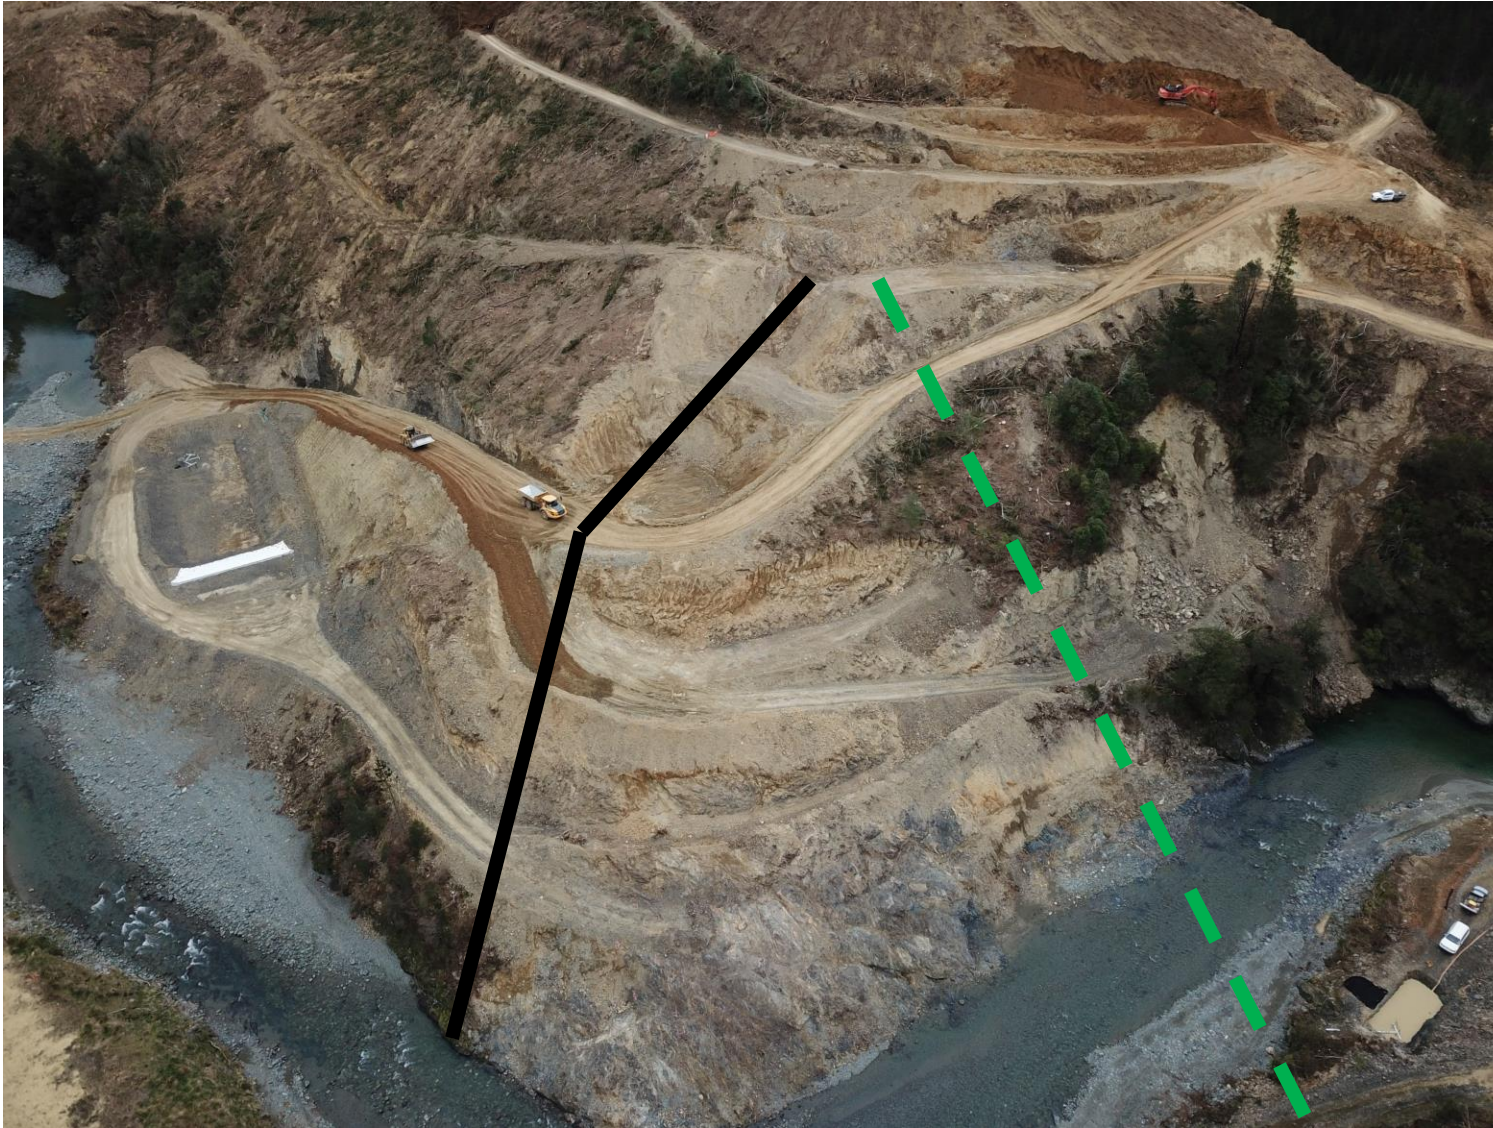
# Construction: Clearing LHS Abutment. As expected

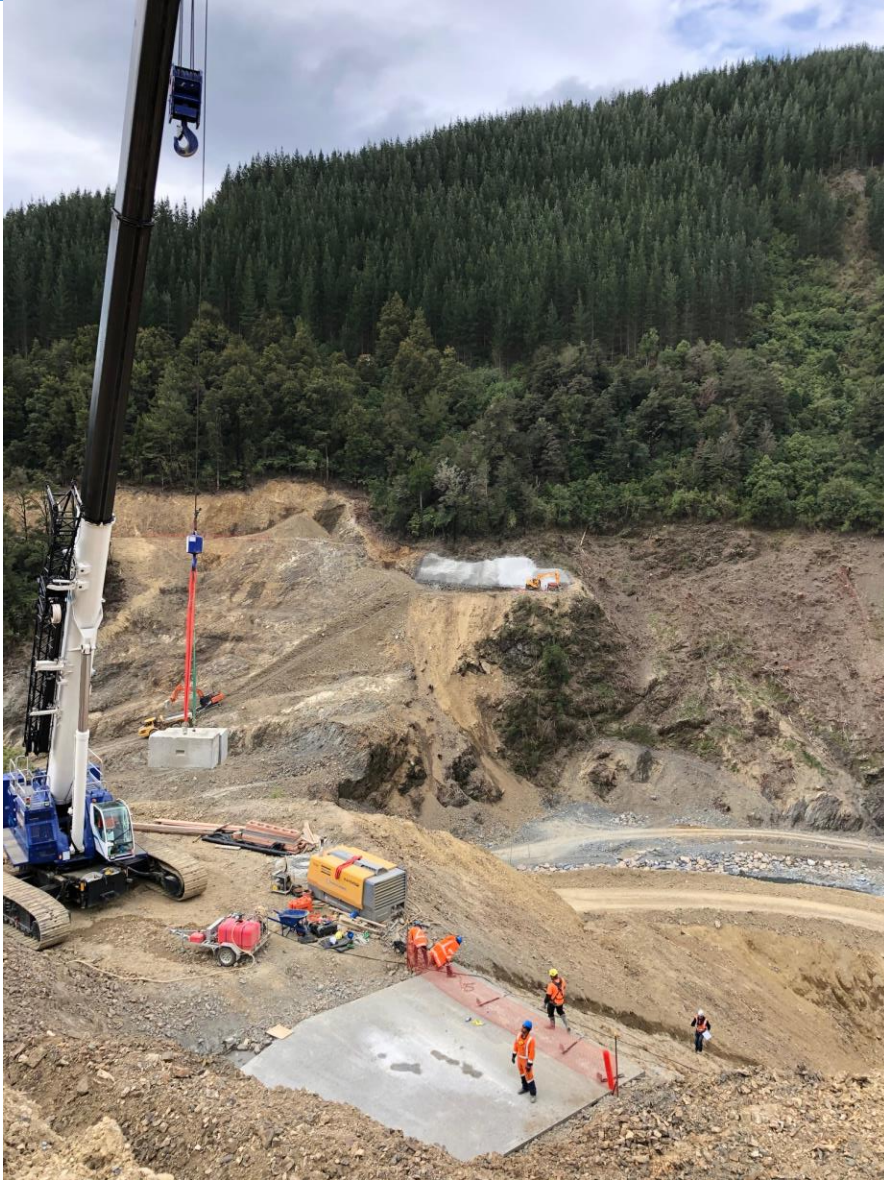
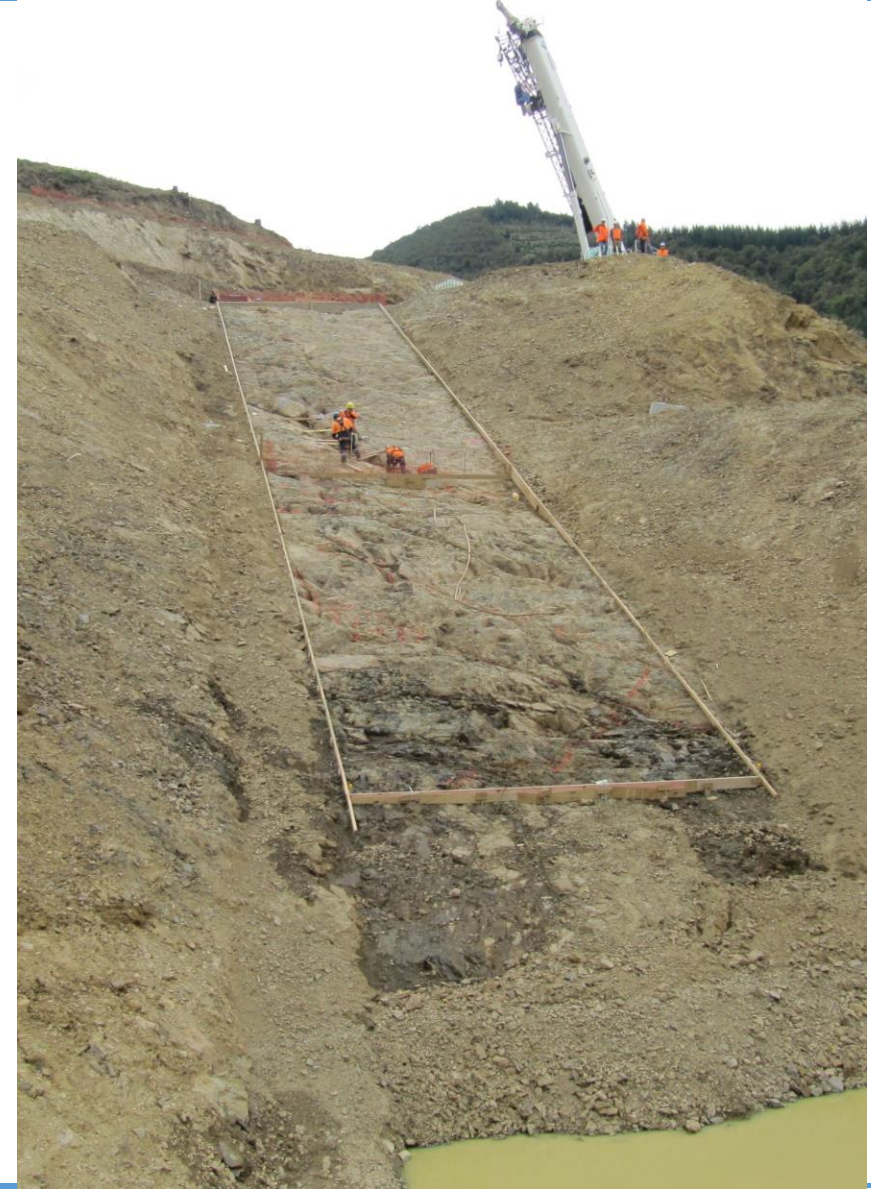
# Construction: Preparing for LHS Plinth. As expected

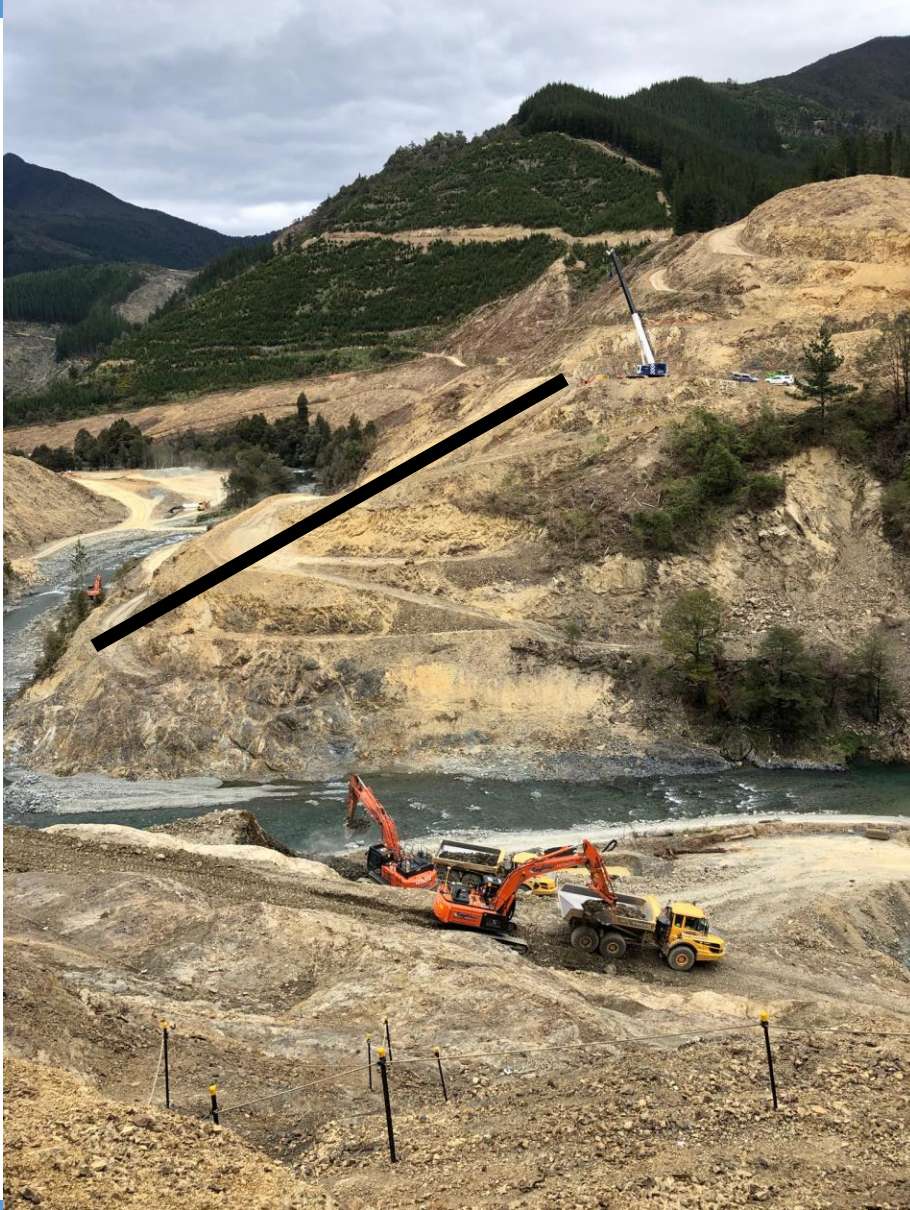
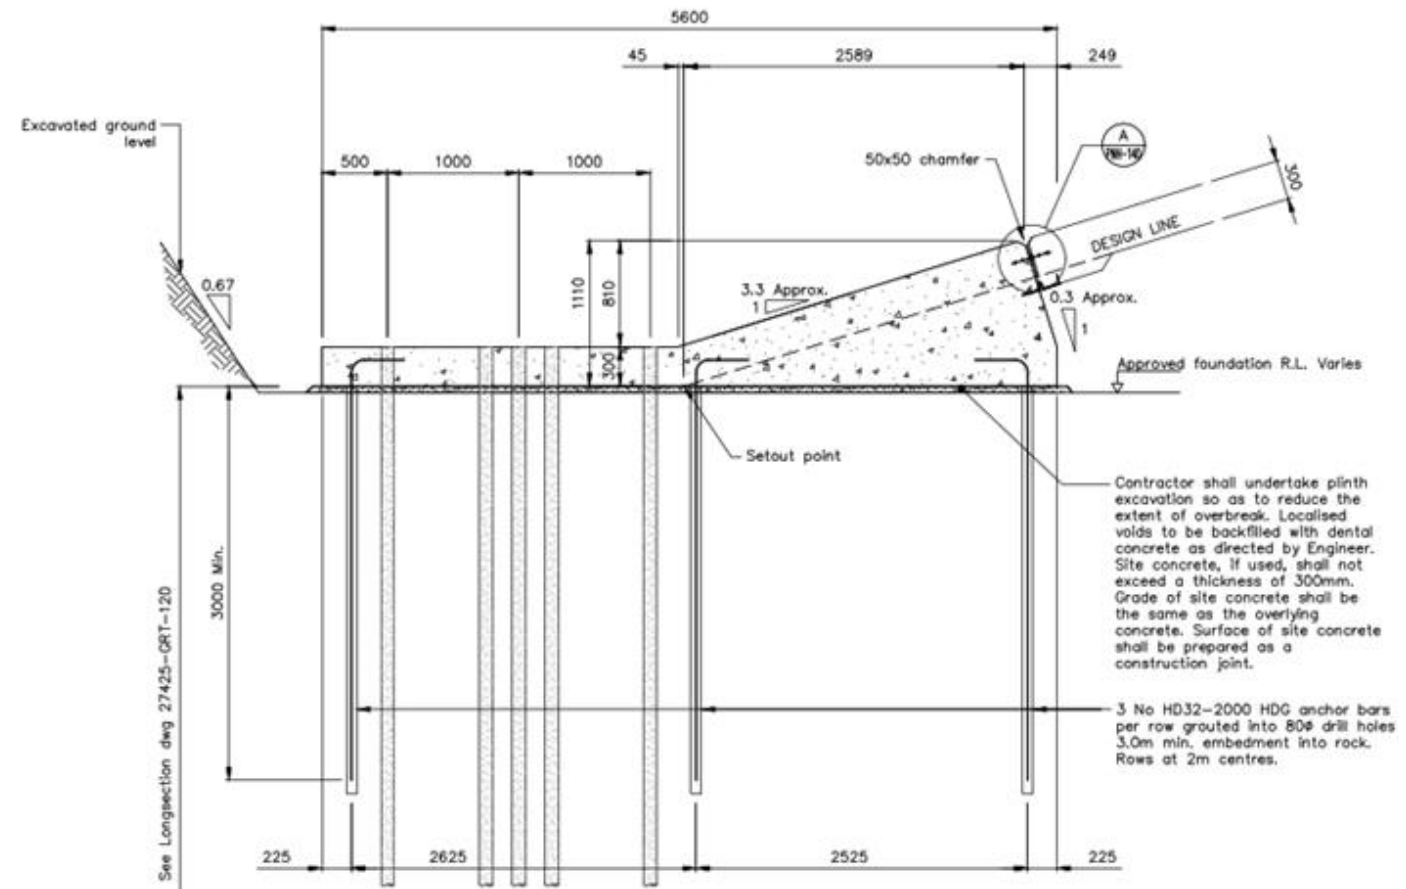
# Construction: Preparing for LHS Plinth. As expected

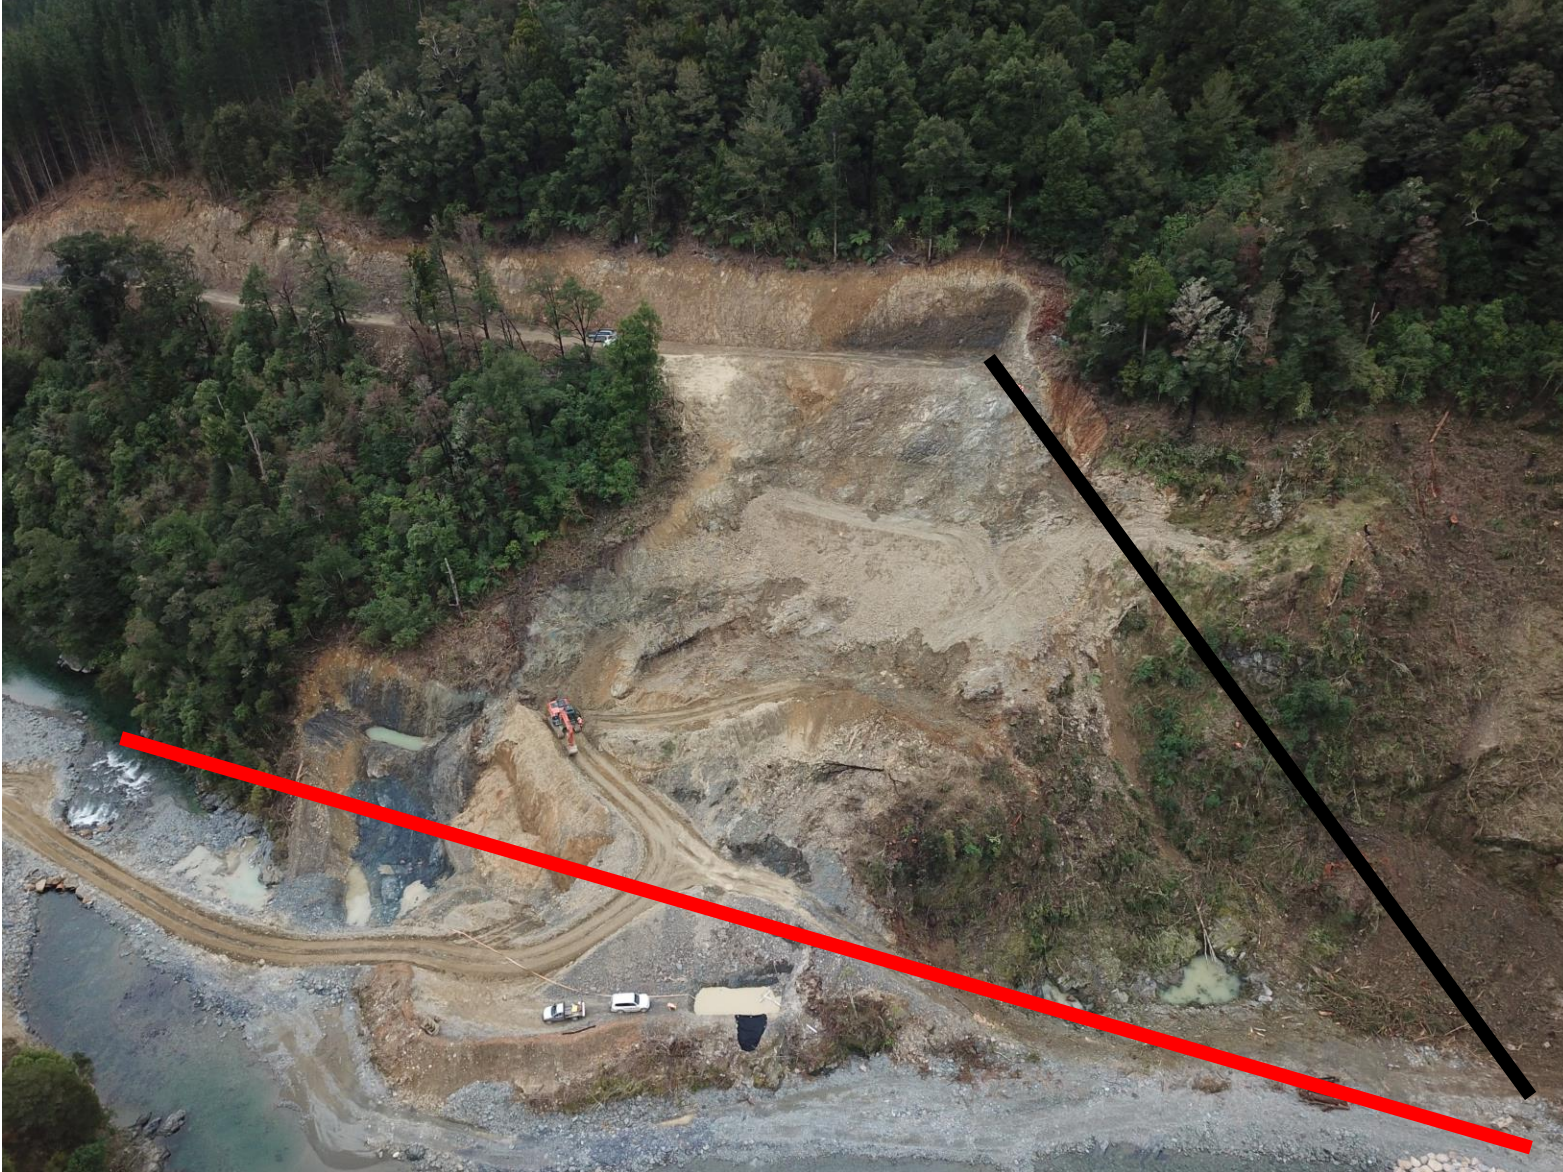
# Construction: Clearing RHS Abutment. As expected

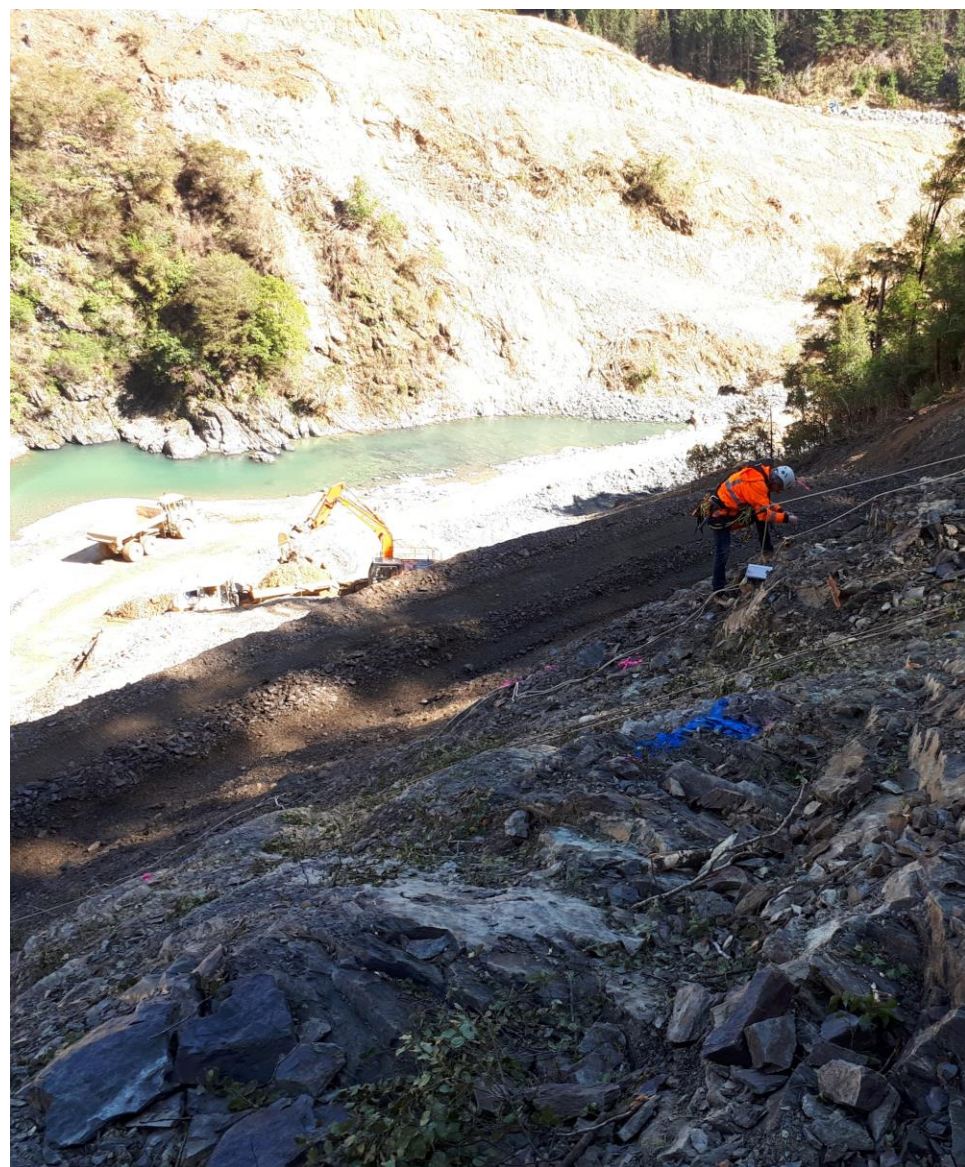
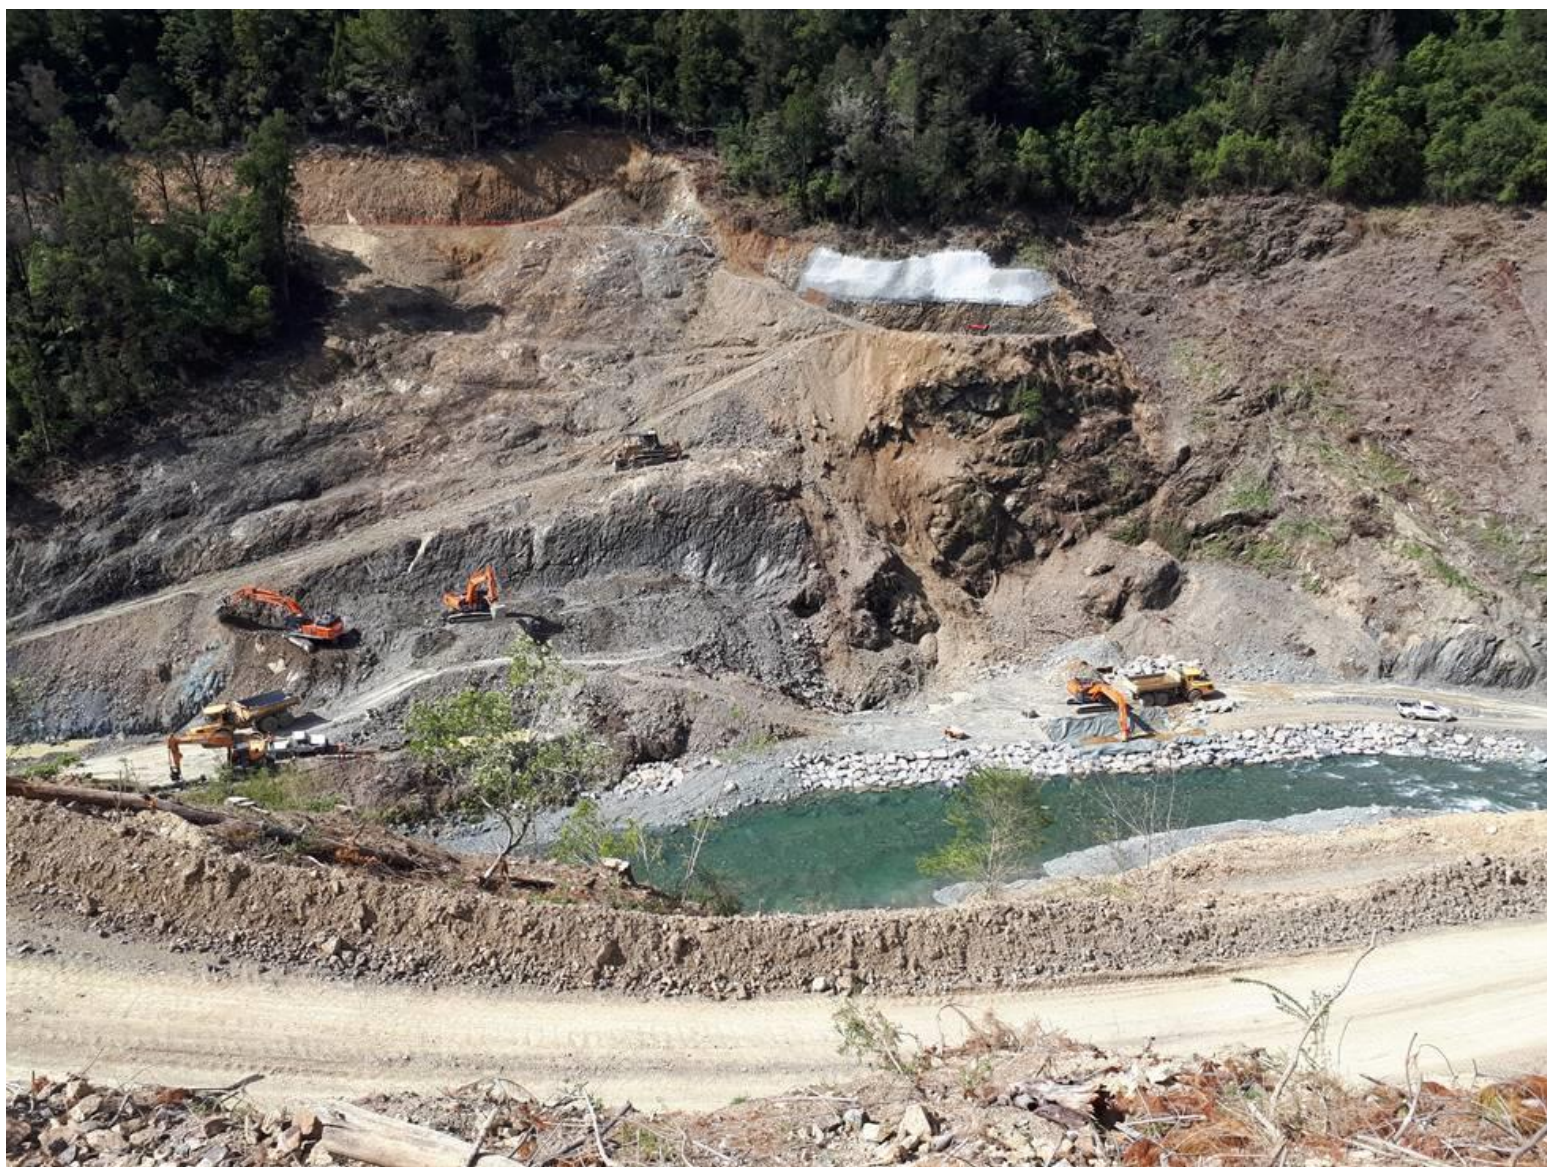
# Construction: Clearing RHS Abutment. As expected

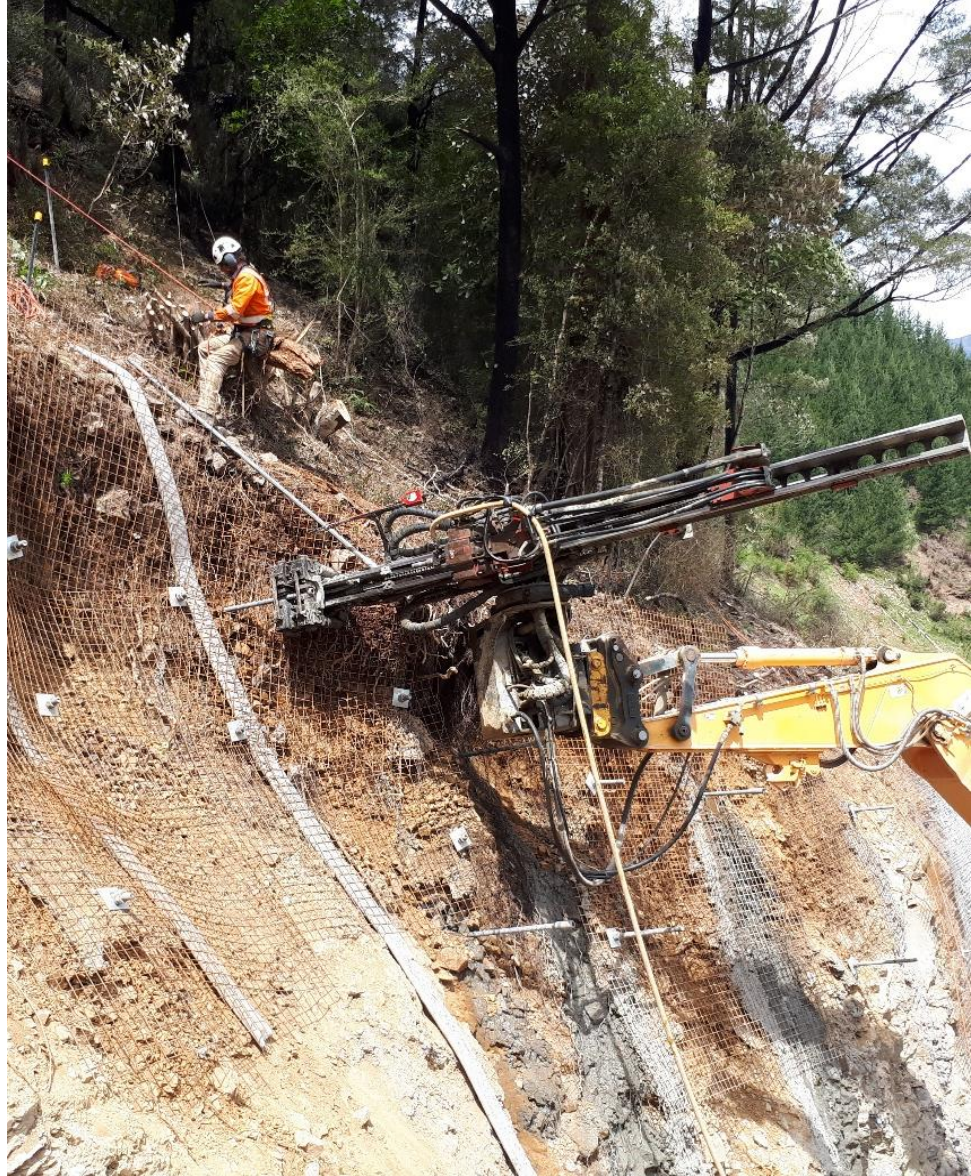
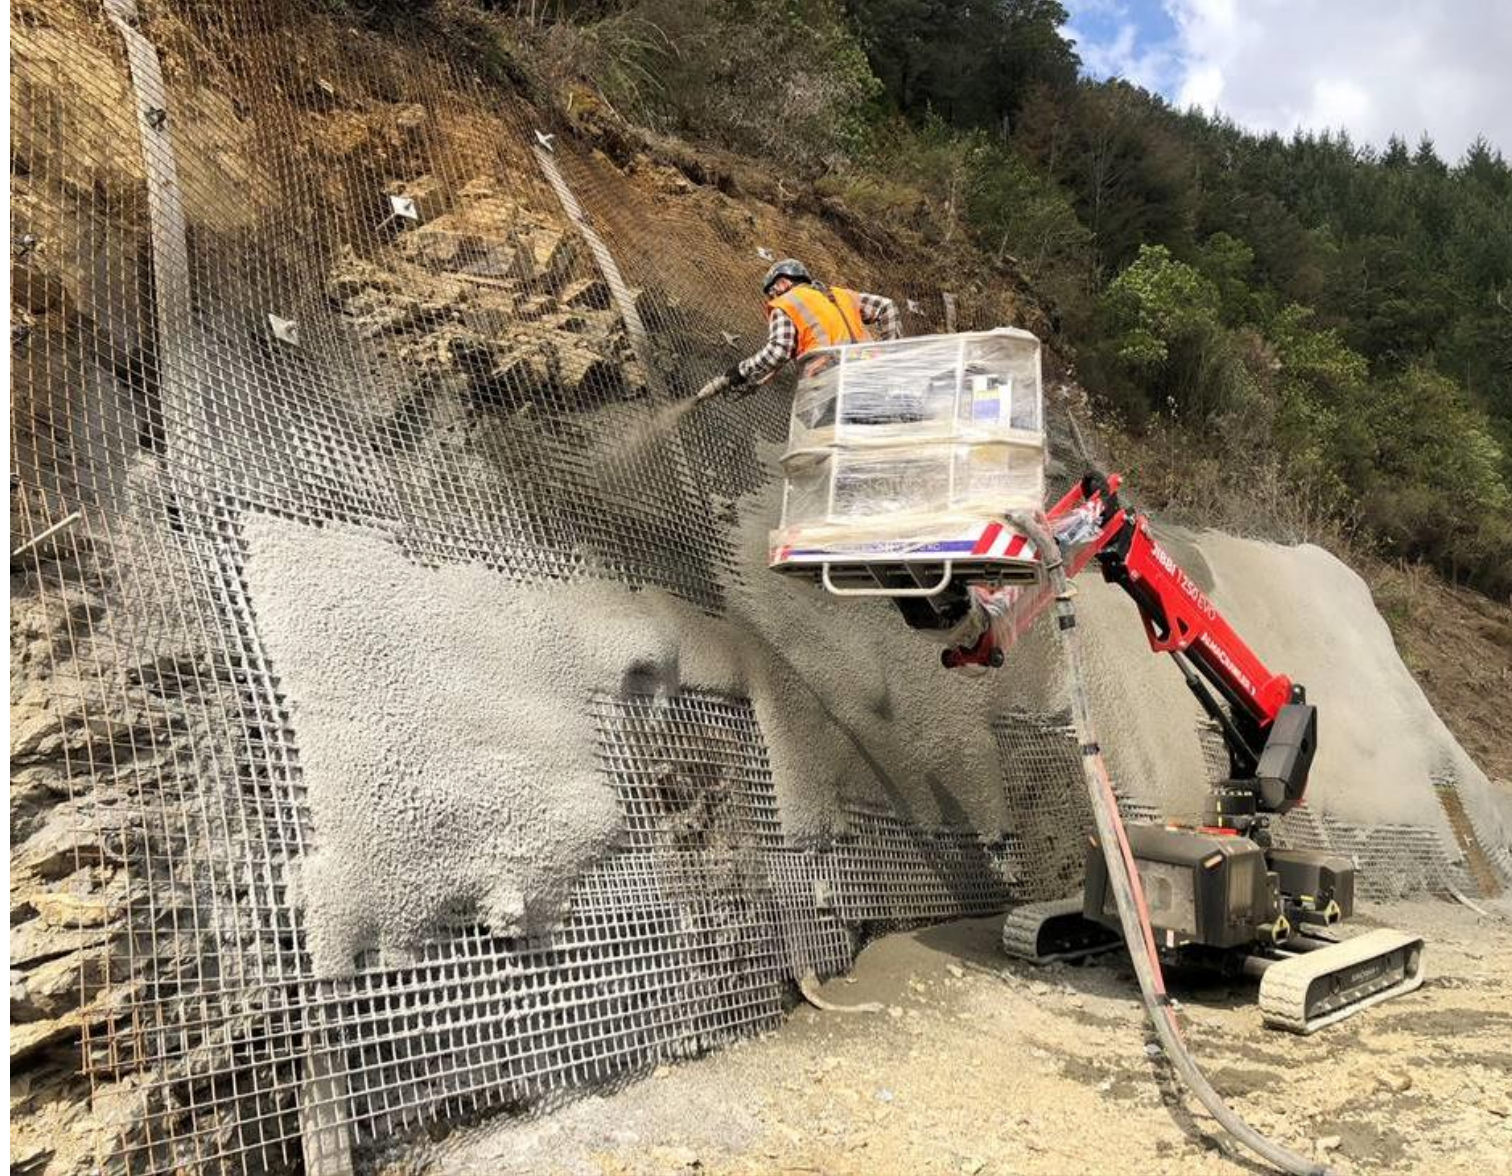
# Construction: Permanent Slope Protection progressing

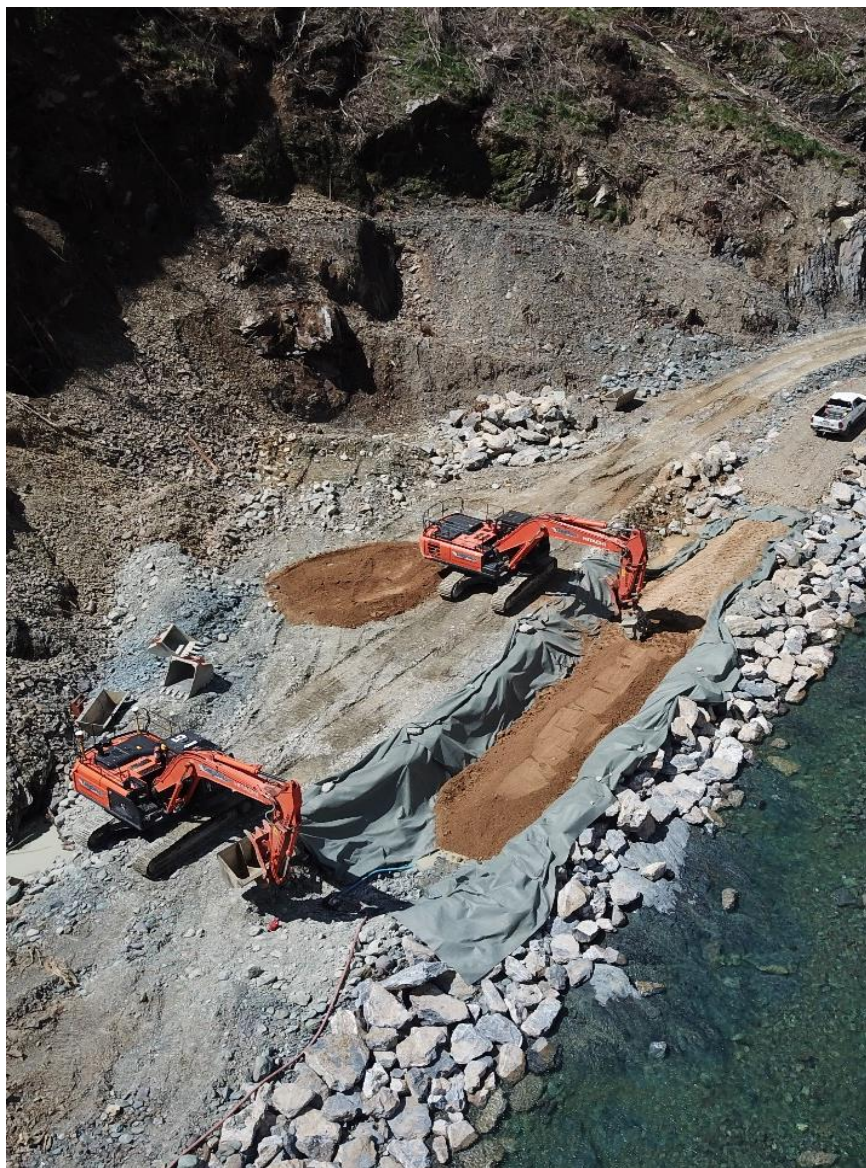
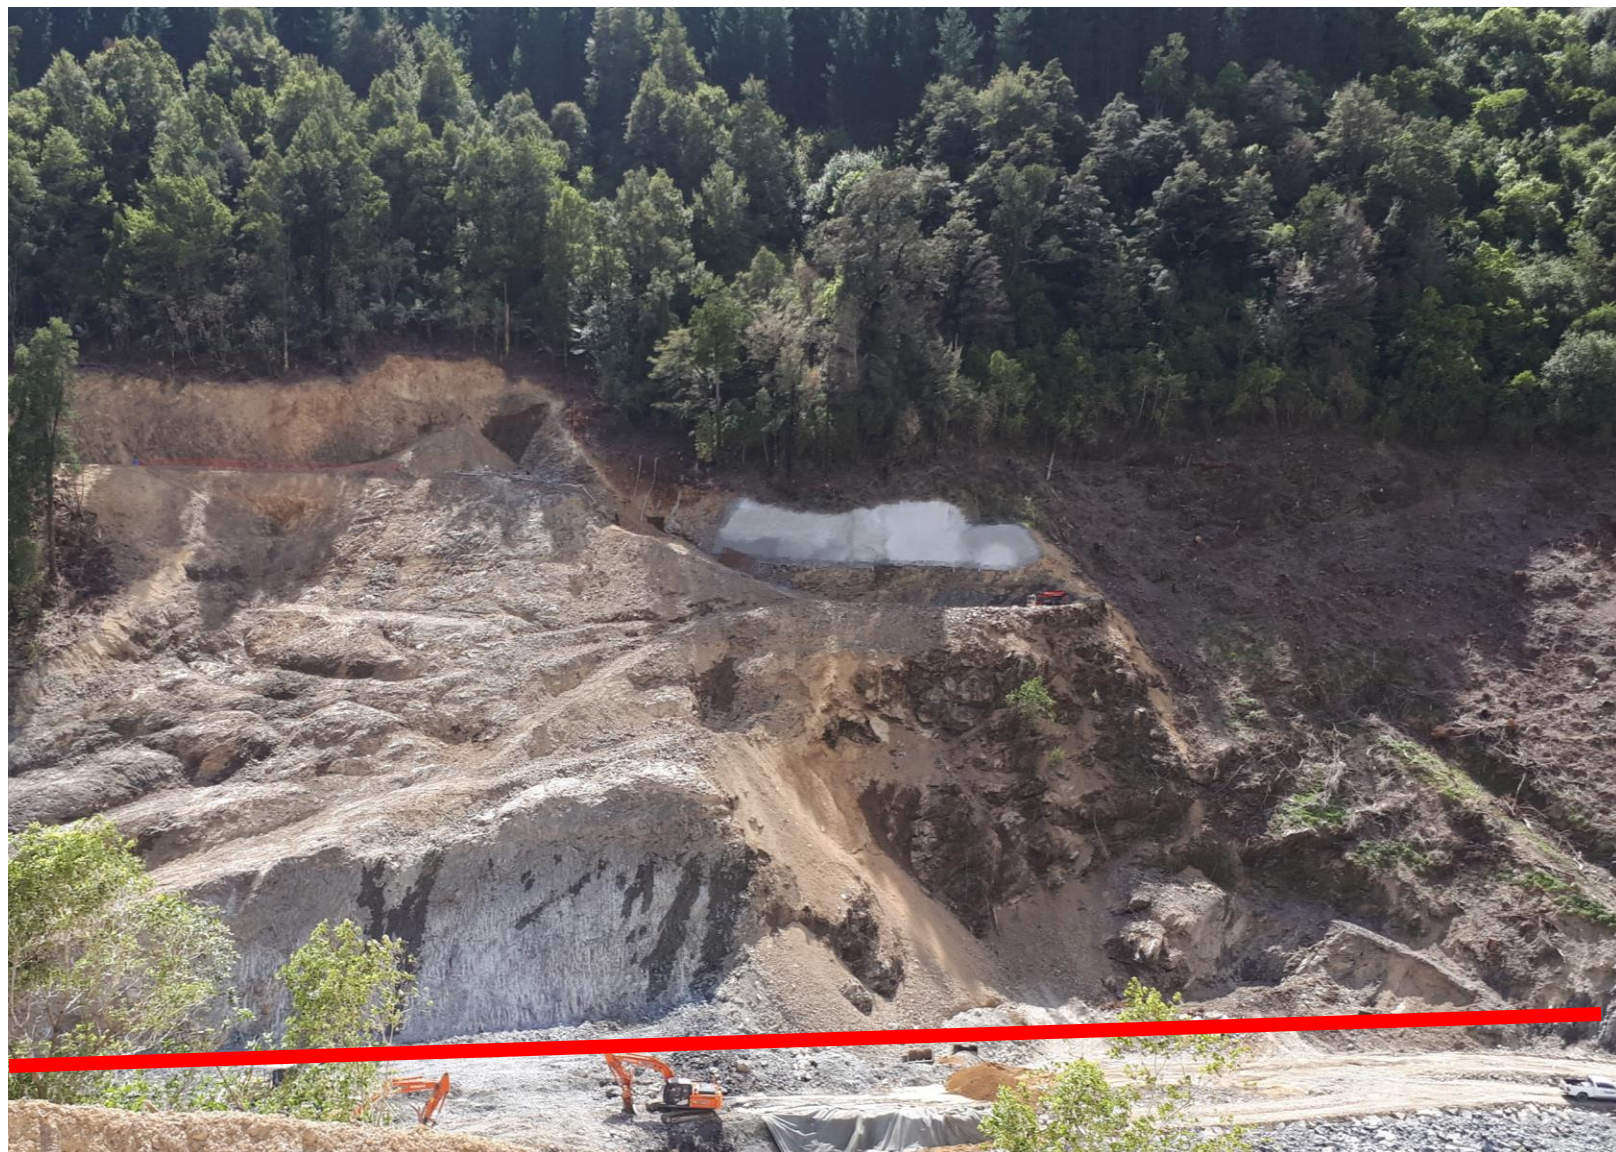
# Construction: Culvert cut progressing
