Waimea Community Dam TDC Council

21 April 2020

Waimea Water

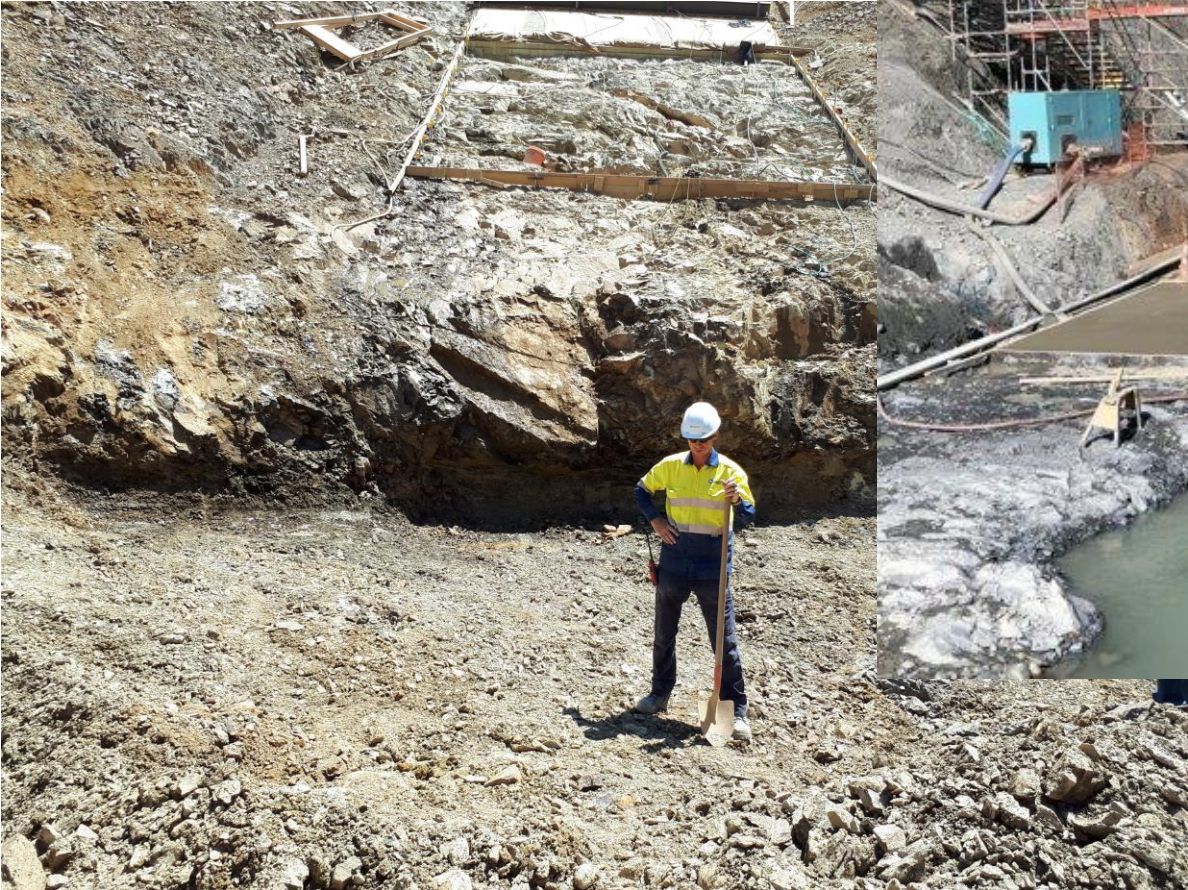
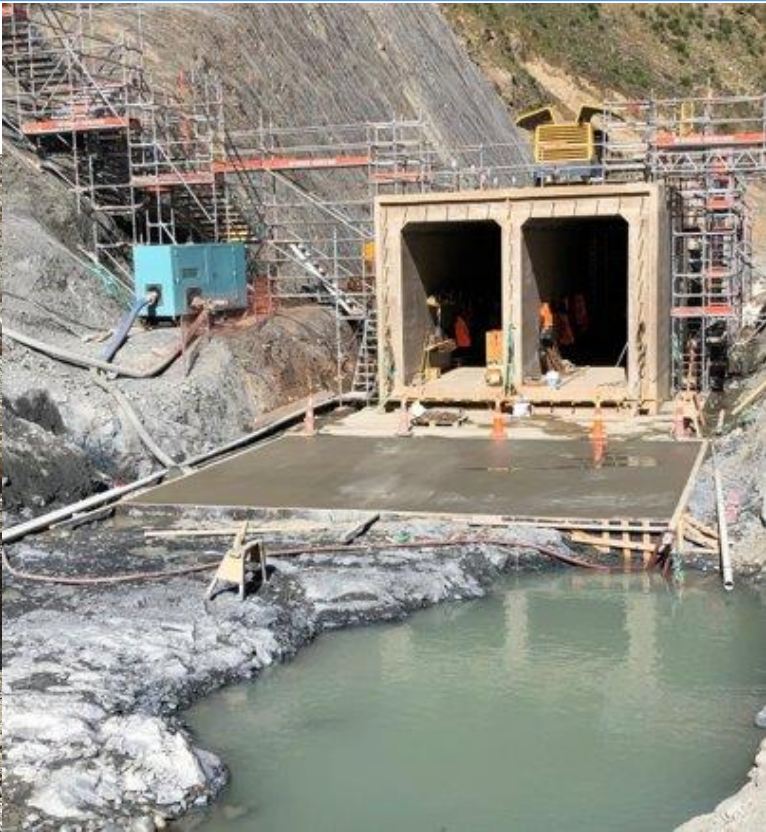
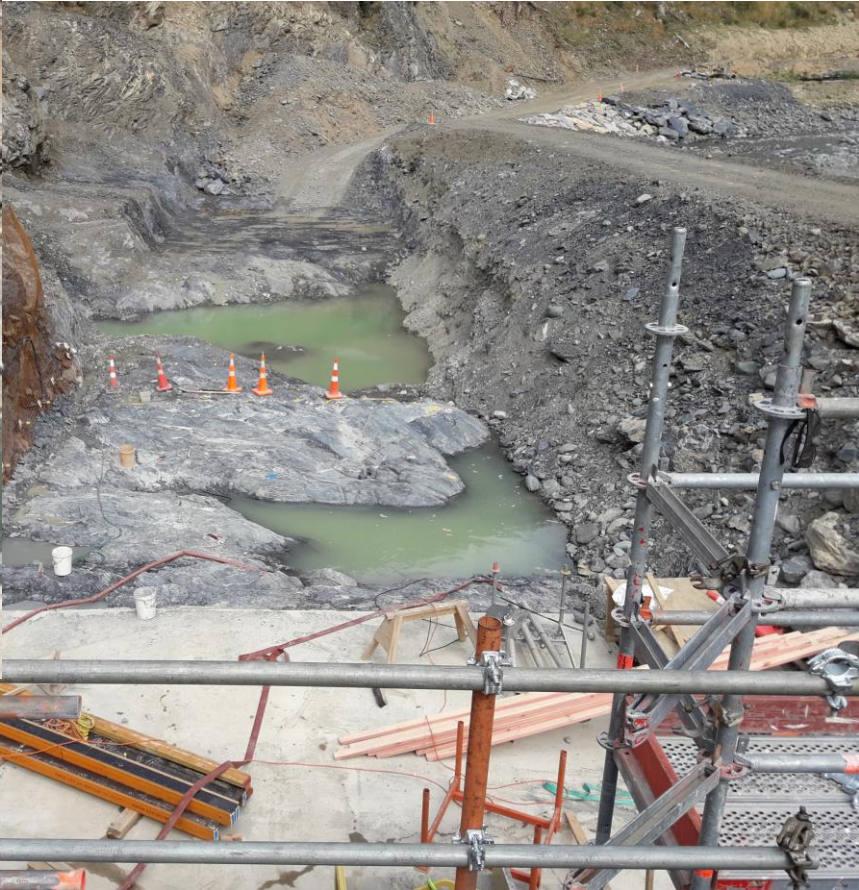
Construction Issues: Voids

Risk	Probable Cost (\$)
1. Unforeseen Conditions	\$19.1
Material for Dam filling	
Void; Plinth, Starter Dam and Culvert	
Additional Slope Stabilisation	
Other Items at risk	
2. Improved Resilience	
Improve drainage beneath the spillway and modify spillway for encounter	
Additional grout curtain, grout specification and plinth modification to red	
Waterstops and sealing of the joints in the culvert	
3. Under / not budgeted	
Mechanical and Electrical not designed or priced at budget	
Office, overhead and construction engineering underbudgeted	
4. Self-Help / Savings (budget of -\$1.8m)	
Carpi	
Bridges, Fibre, Trees	
Total	\$26.5
Contingency	\$3.0
Committed Costs (excludes Budgeted Contingency and Savings)	\$99.8
TOTAL EXPECTED COST TO COMPLETE	\$129.4

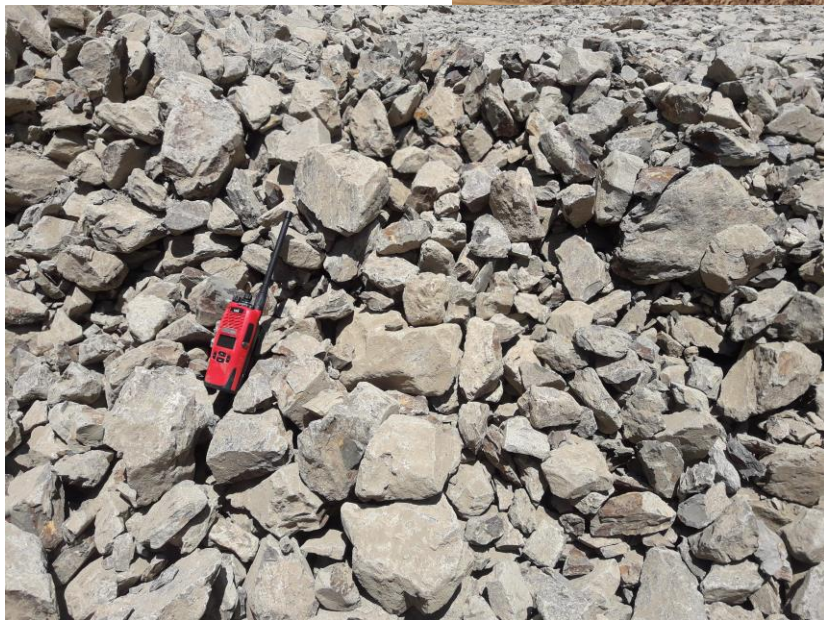
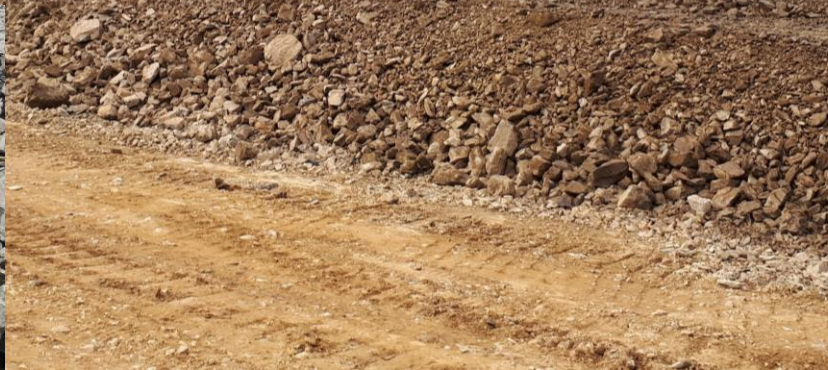
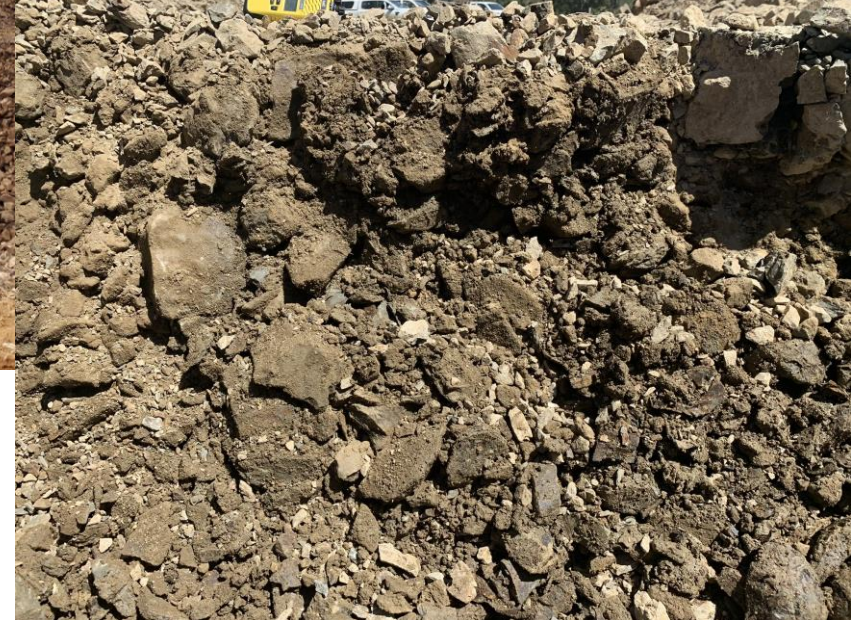
- Embankment trials late December 2019 and early January 2020 identified Rock degradation

Expected and Needed

Discovered

Less broken down– Free draining

Heavily broken down– Not free draining

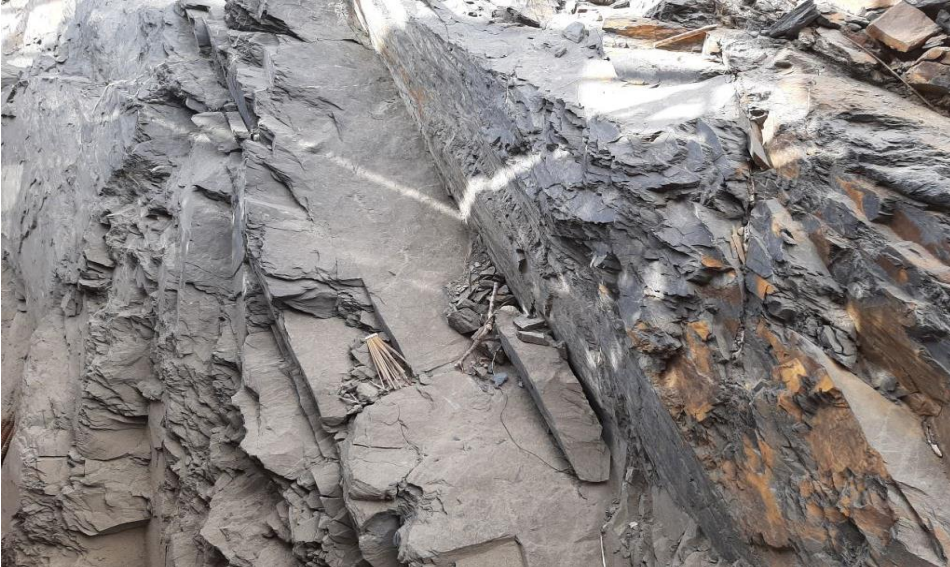
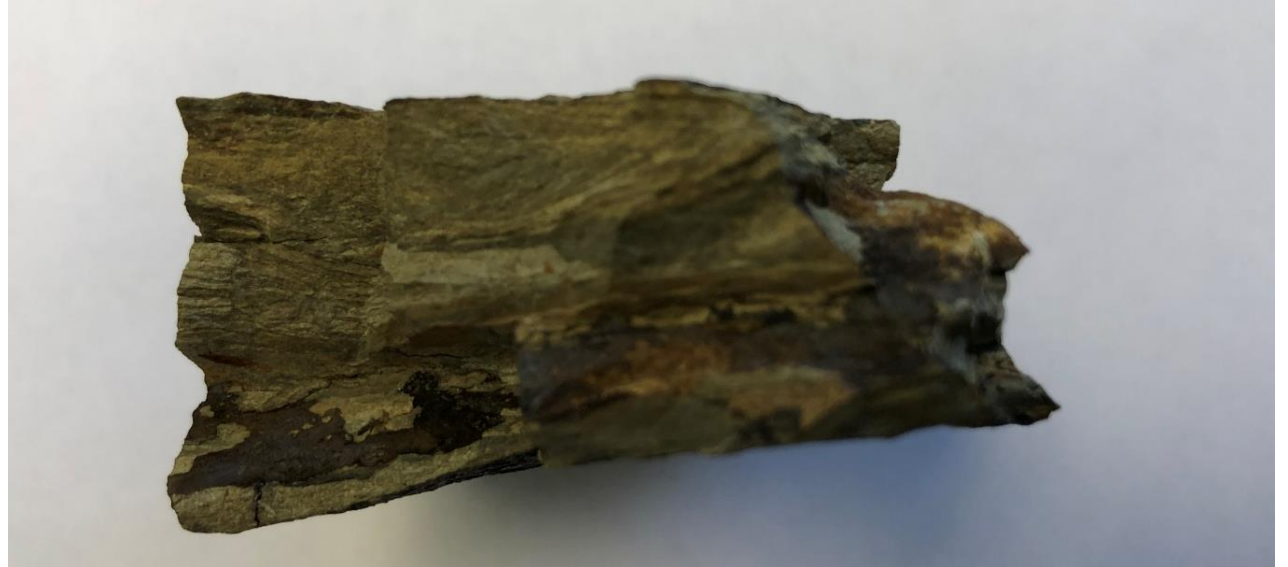
Rockfill: The Geology Challenge

- Discovering more argillite (mud / siltstone) (~70%) and less greywacke (sandstone) than expected
- Greywacke (sandstone) dispersed amongst predominant argillite. Difficult to salvage. (VIDEO)
- Fissile argillite showing tendency to break along insipient foliations
- Spillway Excavation: *“May yield a minimum of 350,000 m³ of rock that will consist of slightly weathered to weathered (Class 1 & 2) greywacke.”* (2014). ➡ Predominantly fissile argillite
- Need to find suitable drainage material from alternative sources (cost)

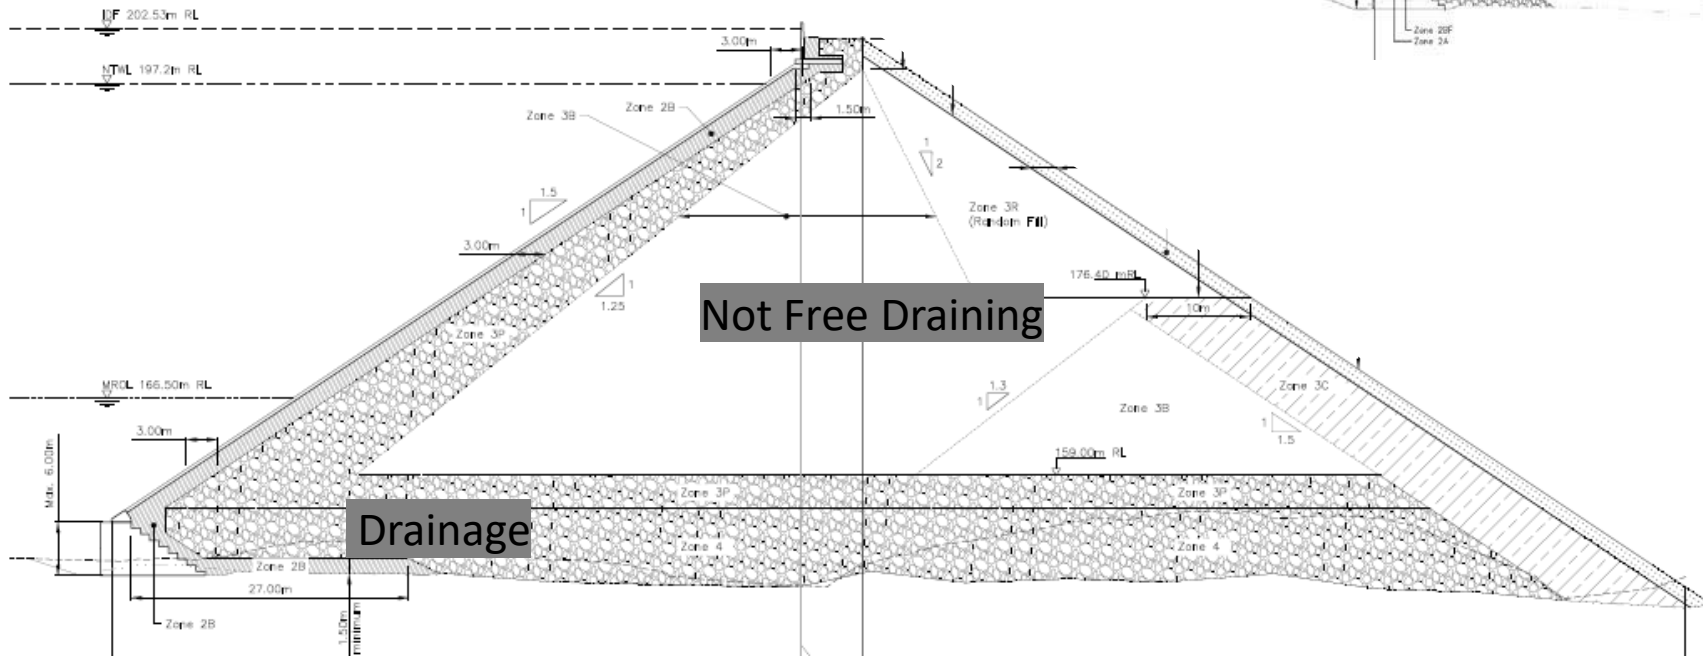
Design: Rezoning embankment to manage geology

- ❖ Expect less harder class-1 material
- ❖ Testing in early 2020 identified breakdown on compaction
- ⇒ Increase drainage layers
- ⇒ Alternatively source drainage rock

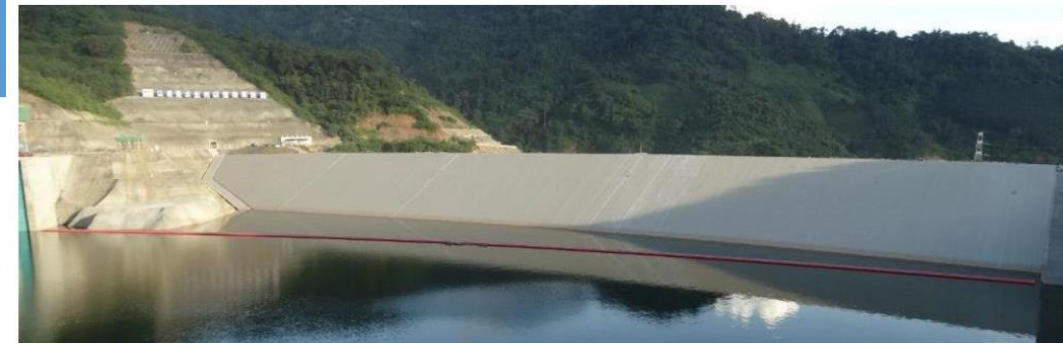
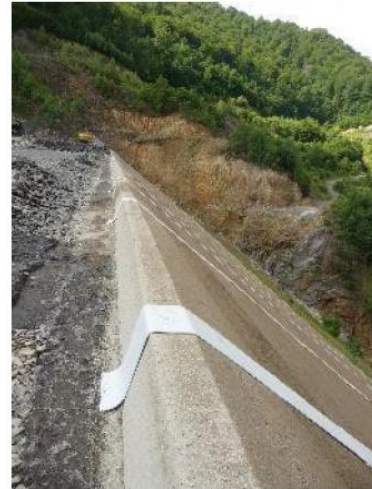
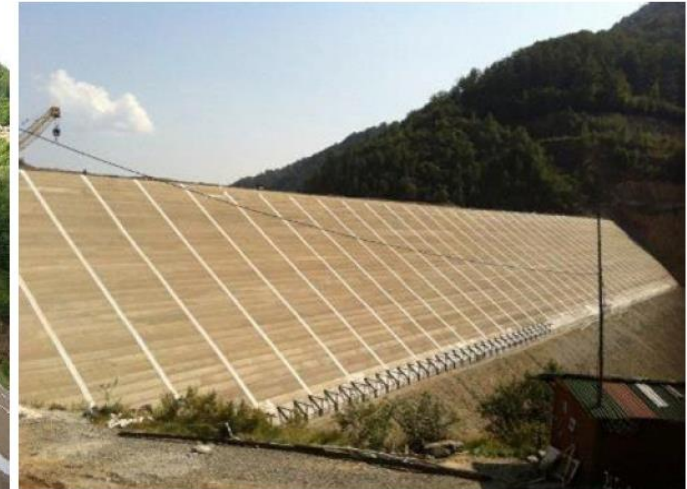
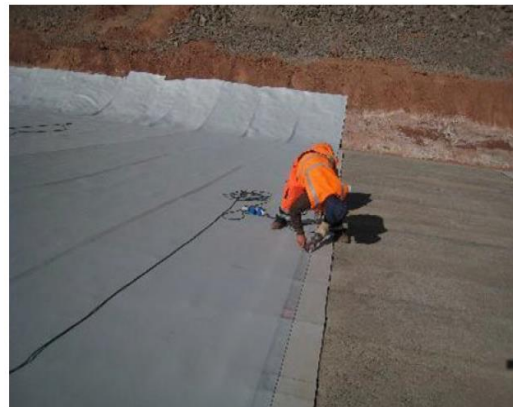
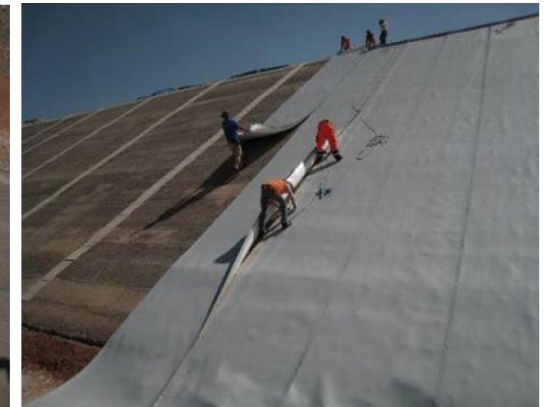
Carpi Ltd: Installed

Replace concrete face with Geosynthetic membrane

- 54 New Dams since 1988 (26 larger than Waimea)
- 142 Retrofitted Dams since 1970 (63 since 2010)
- Used on Tekapo Canals (2013 / 2014)

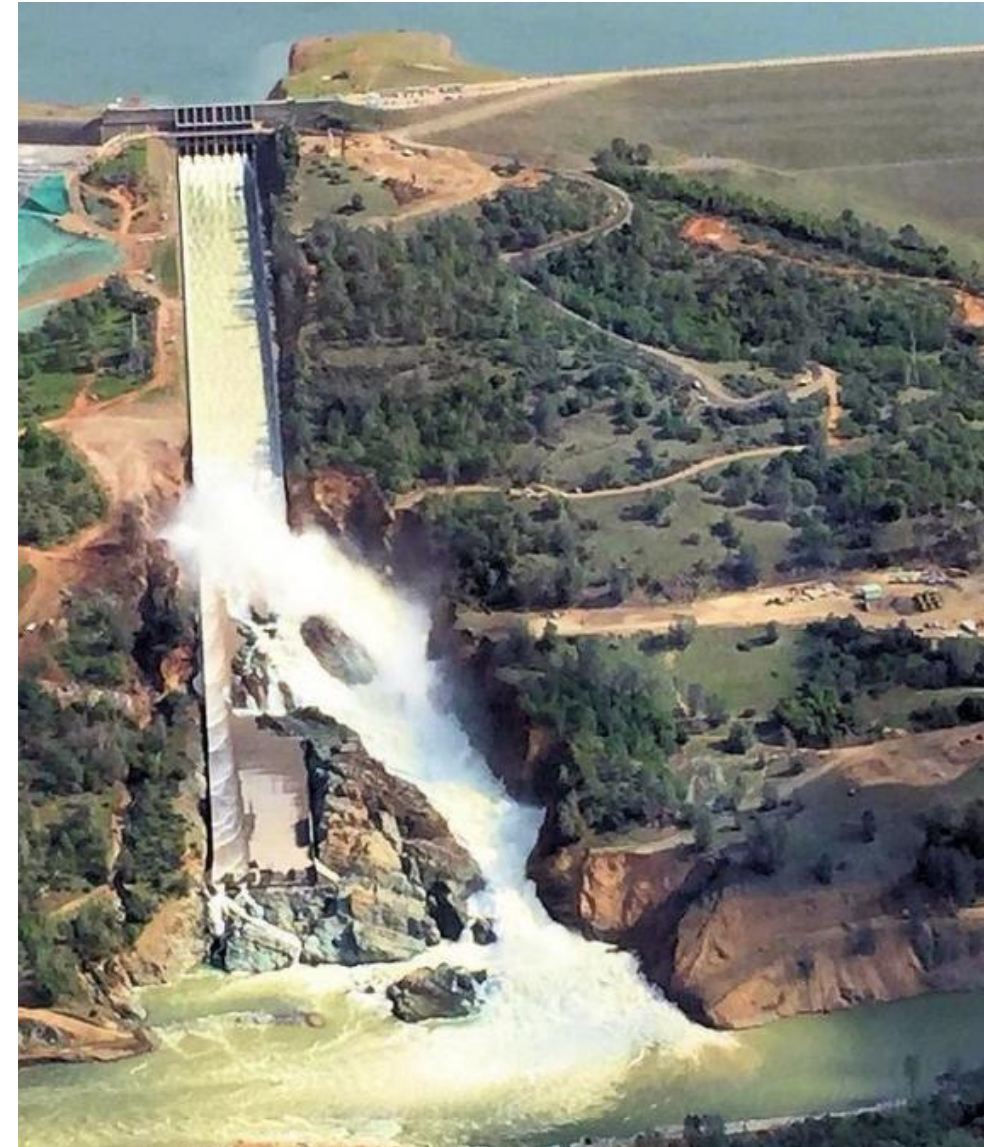
Design: Spillway modified for improved resilience

Design modifications due to recent learnings from international spillway incidents (*international standards*)

- ⇒ Oroville (right) failure due to poor drainage and anchoring detailing (*pressure beneath fn velocity*)
- ⇒ Whaley Bridge (UK) no drainage and poor slab detailing combined with poor maintenance

Modifications for resilience (requested by CIIL):

- ⇒ Drainage reviewed and upgraded
- ⇒ Anchoring design reviewed and upgraded

Additional modifications driven by topography and encountered geology.

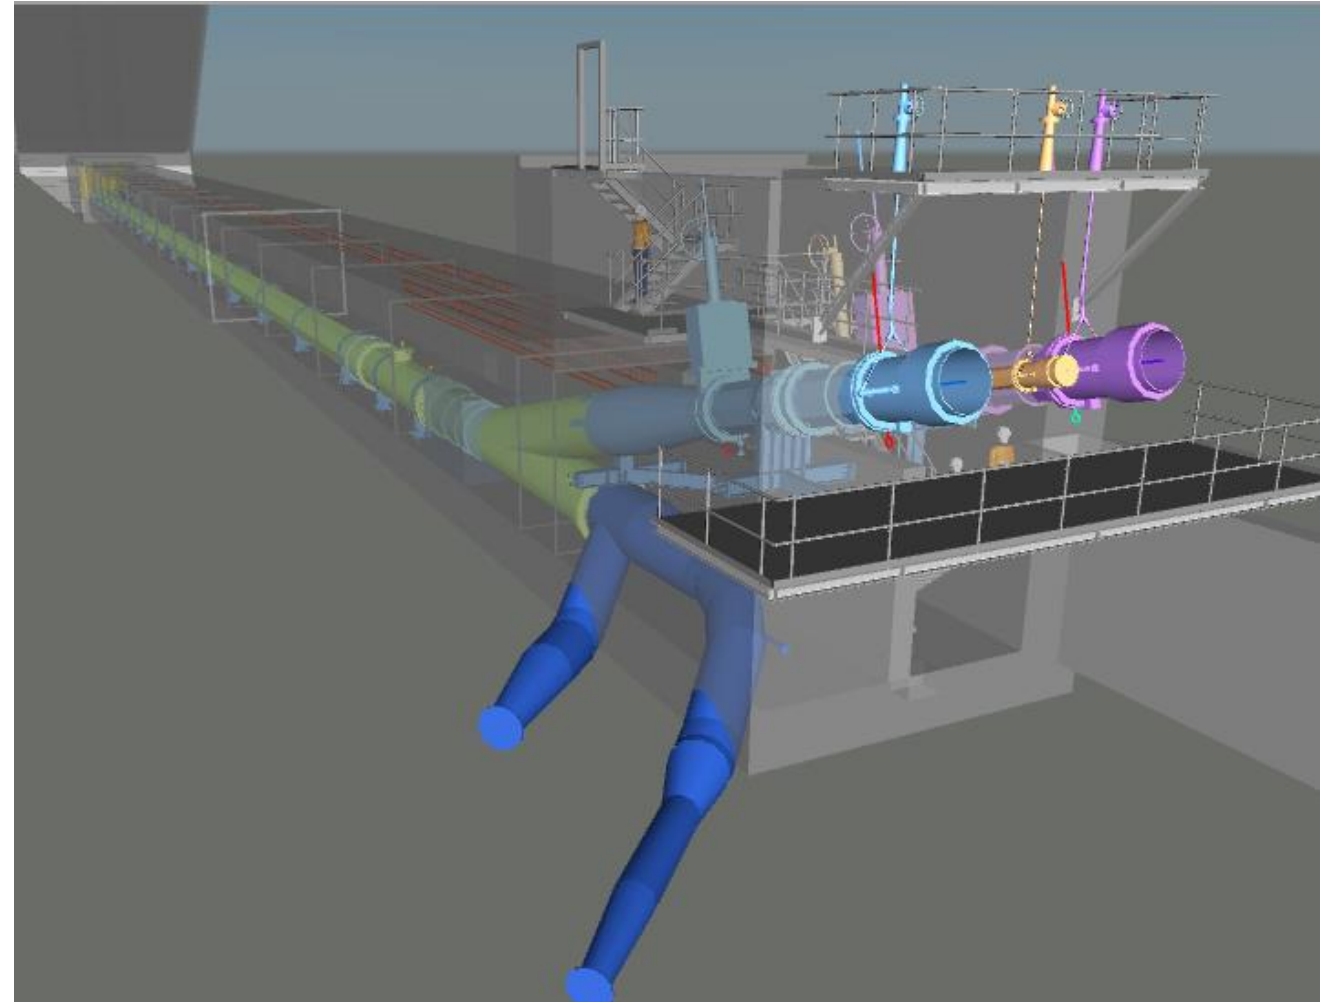
Mechanical and Electrical

- ❖ Not designed or priced at commencement of work
 - ⇒ Provision Sum challenged
 - ⇒ To be priced ~3rd Quarter 2020
- Progressing detailed design
 - ⇒ Switch to single outlet pipe aiming to realise cost savings
 - ⇒ Modifications for future hydropower installation

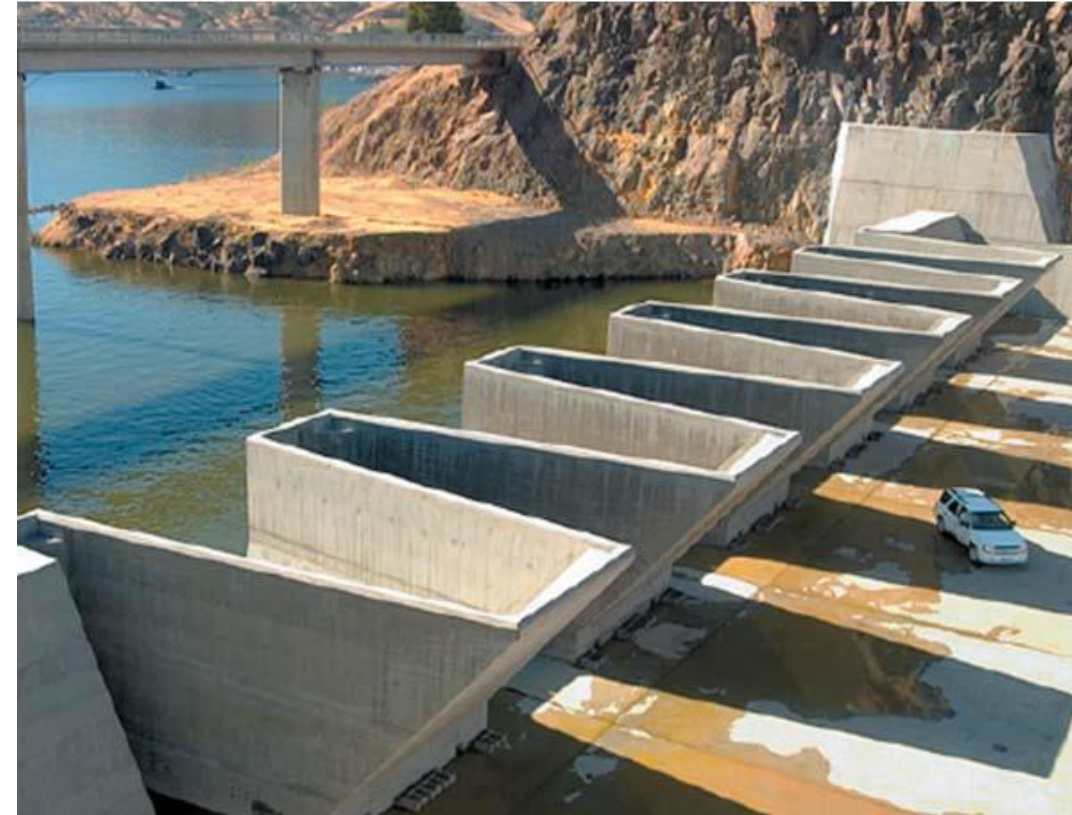
Enlarge Reservoir / Powergen

- Fuse Gate to utilise 2.3m / 5m of flood reservoir
- Activate in event of large flood say 1:10,000 yr AEP (55% - 70% of PMF 1094 m³/s)
- + 1.5Mm³ storage to ~15Mm³ (15%)
 - ⇒ Storage increases powergen utilisation
 - ⇒ Increase resilience to droughts / growth / demand
