Waimea Community Dam TDC Council

25 June 2020

Waimea Water

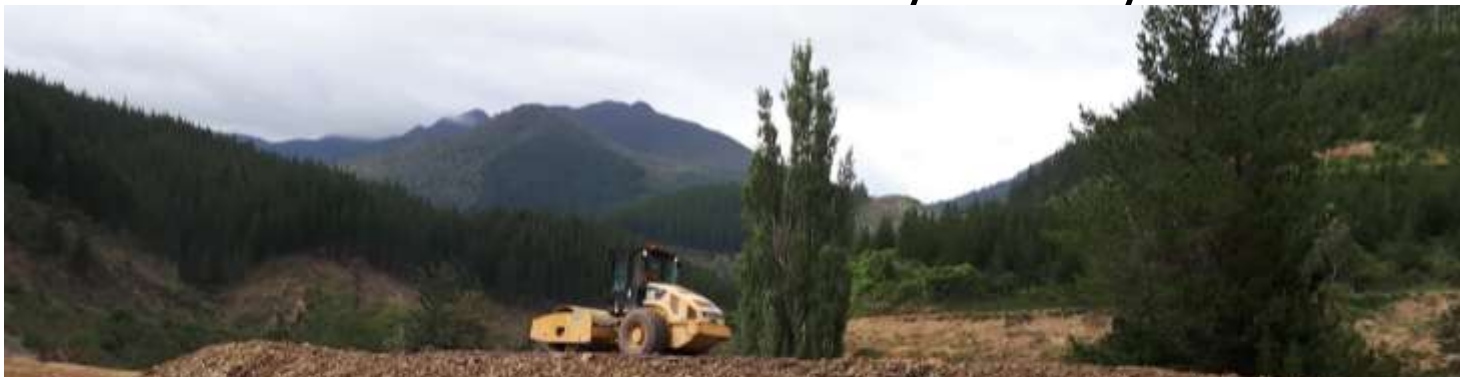
Rockfill: The Geology Challenge

- Embankment trials late December 2019 and early January 2020 identified Rock degradation

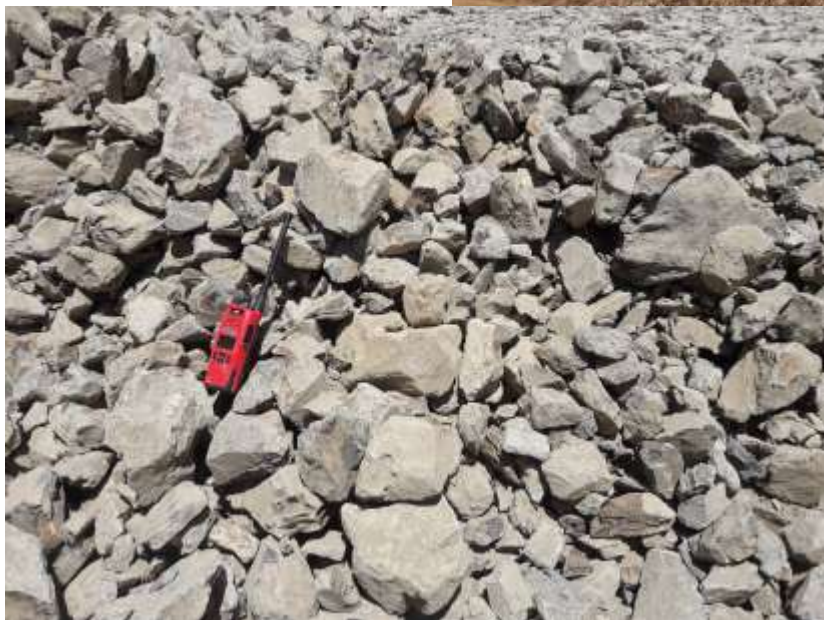
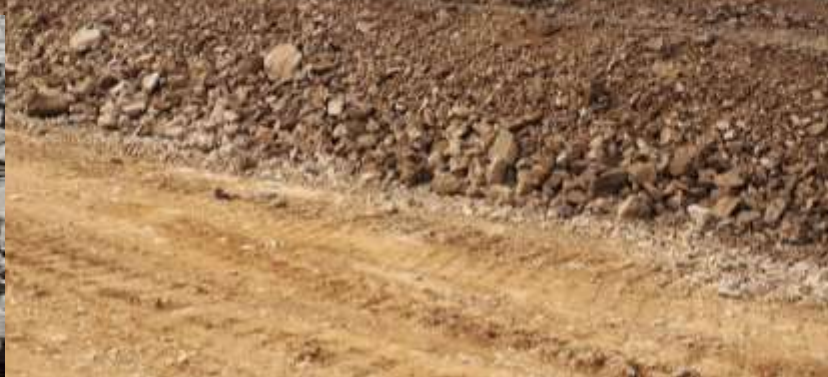
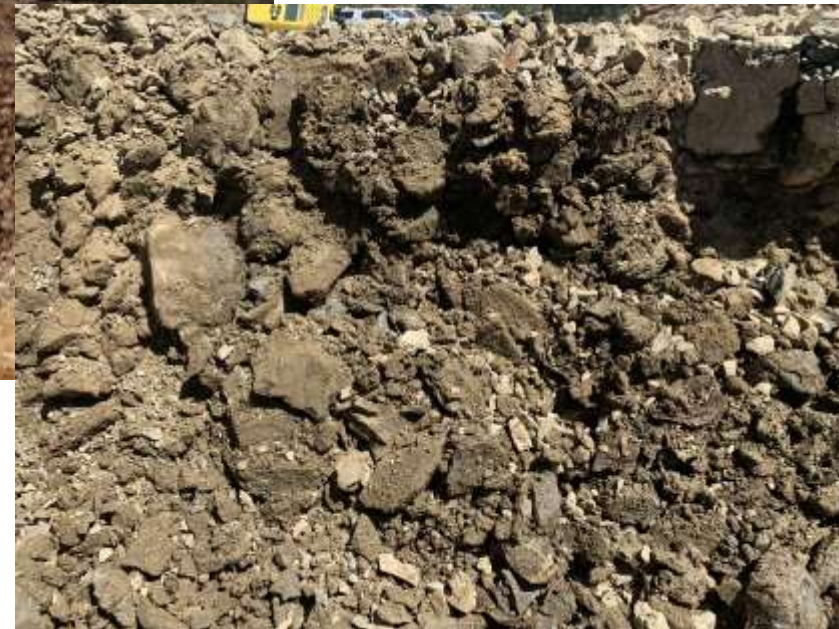
Expected and Needed

Discovered

Less broken down– Free draining

Heavily broken down– Not free draining

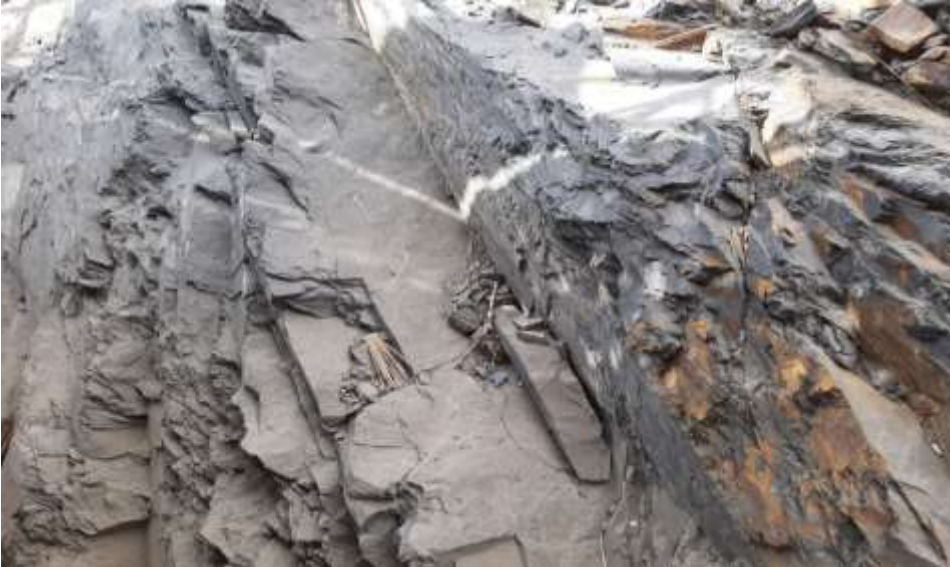
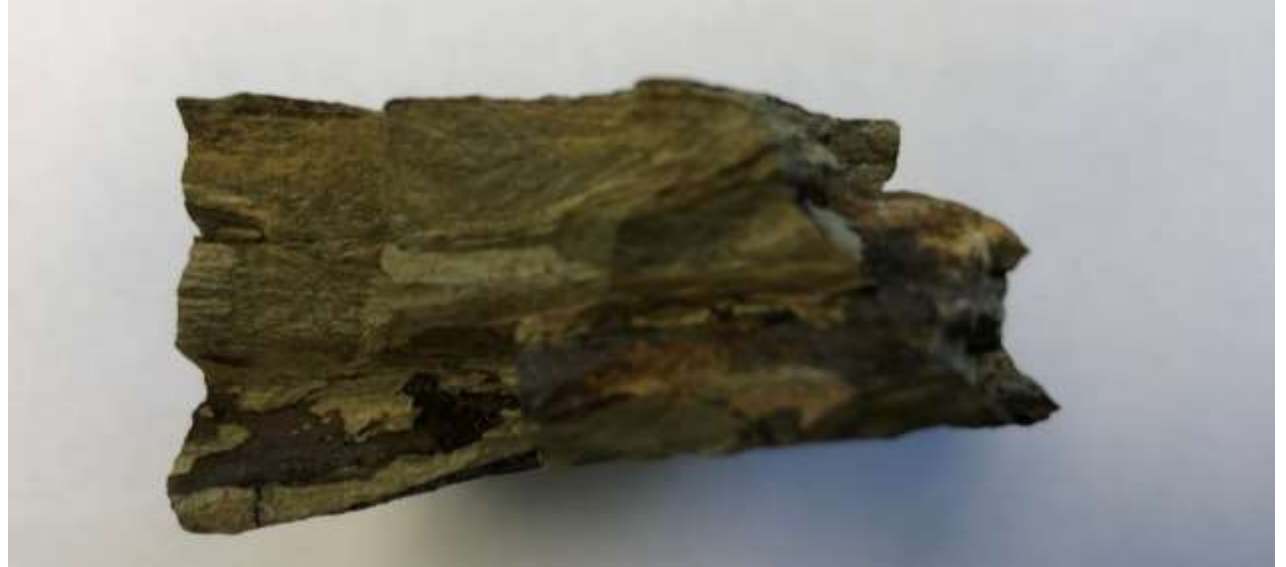
Rockfill: The Geology Challenge

- Discovering more argillite (mud / siltstone) (~70%) and less greywacke (sandstone) than expected
- Greywacke (sandstone) dispersed amongst predominant argillite. Difficult to salvage. (VIDEO)
- Fissile argillite showing tendency to break along insipient foliations
- Spillway Excavation: *“May yield a minimum of 350,000 m³ of rock that will consist of slightly weathered to weathered (Class 1 & 2) greywacke.”* (2014). ➡ Predominantly fissile argillite
- Need to find suitable drainage material from alternative sources (cost)

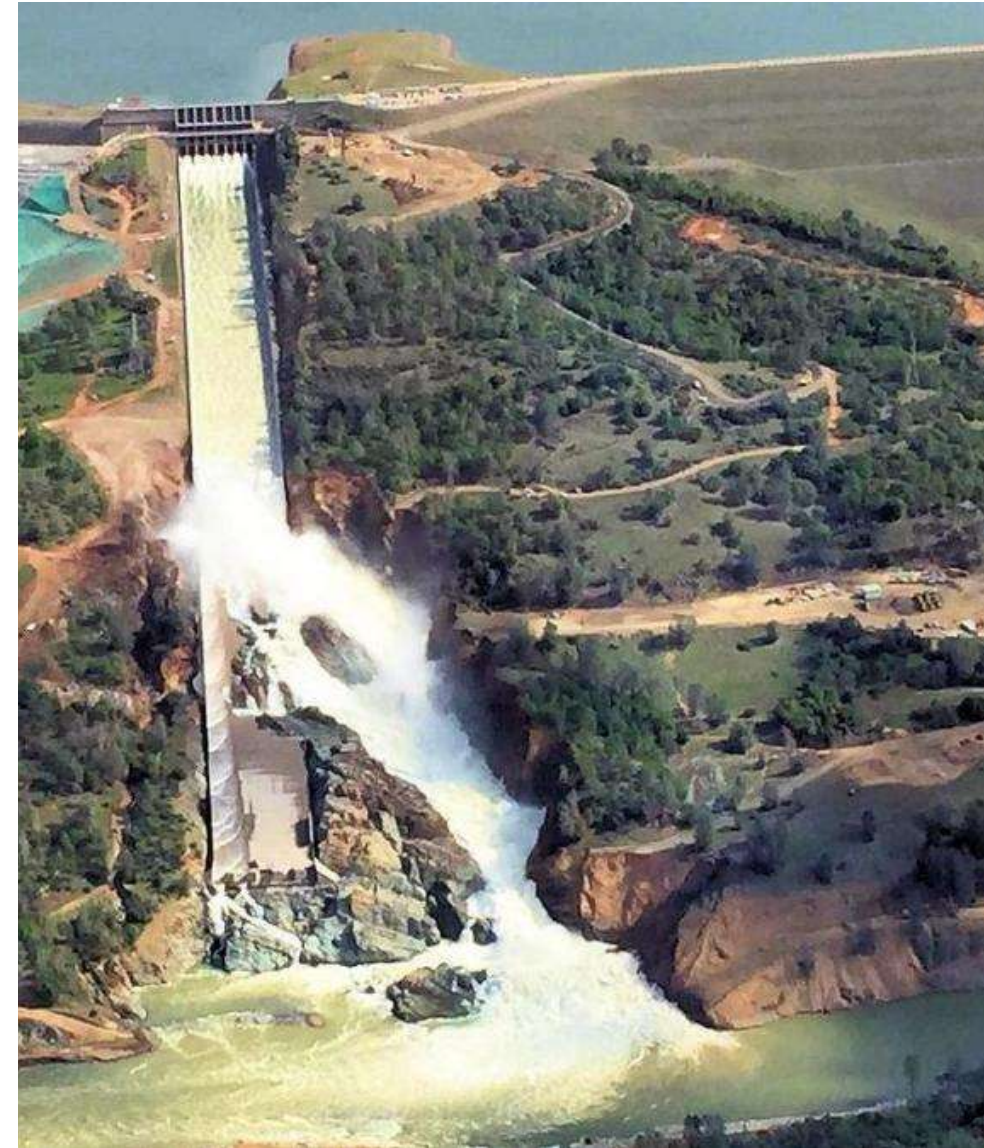
Design: Spillway modified for improved resilience

Design modifications due to recent learnings from international spillway incidents (*international standards*)

- ⇒ Oroville (right) failure due to poor drainage and anchoring detailing (*pressure beneath fn velocity*)
- ⇒ Whaley Bridge (UK) no drainage and poor slab detailing combined with poor maintenance

- ⇒ Drainage reviewed and upgraded
- ⇒ Anchoring design reviewed and upgraded

Additional modifications driven by topography and encountered geology.

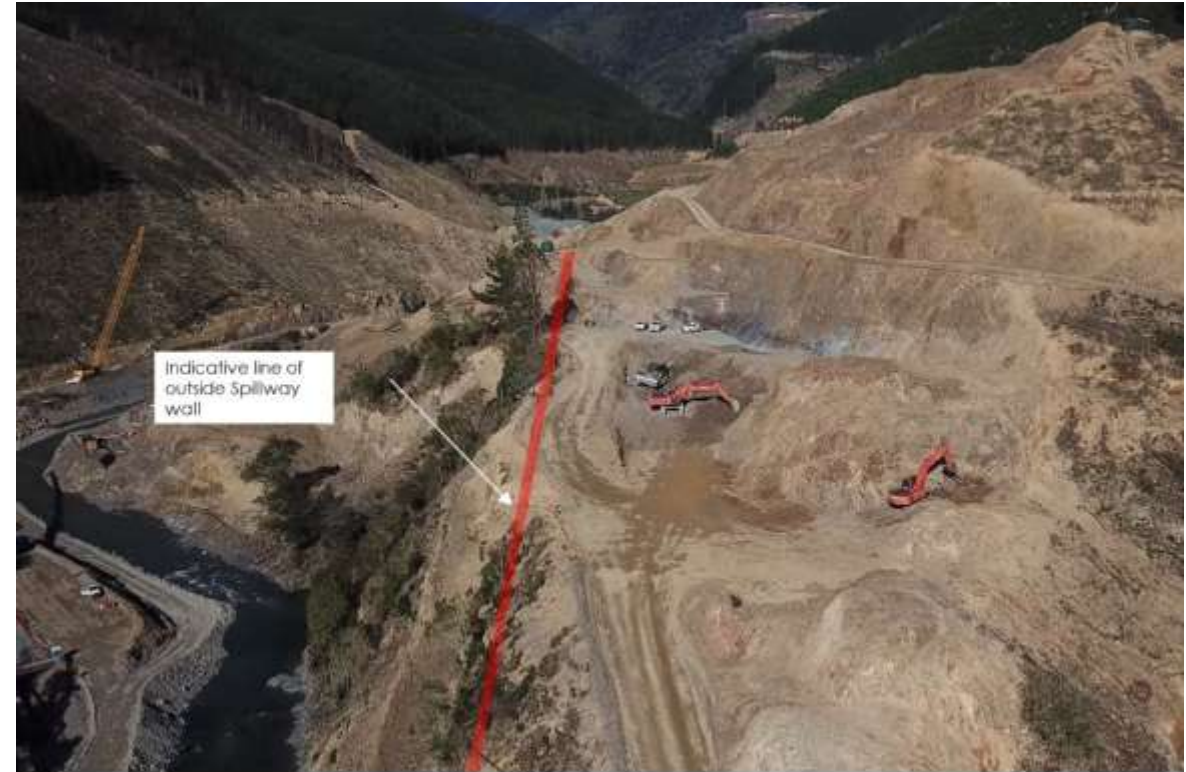
Design Update

- ✓ Spillway:
 - Redesigned with vertical walls to mitigate topography / geology risks RHS
 - Increased drainage per recent standard
 - Completed and peer reviewed

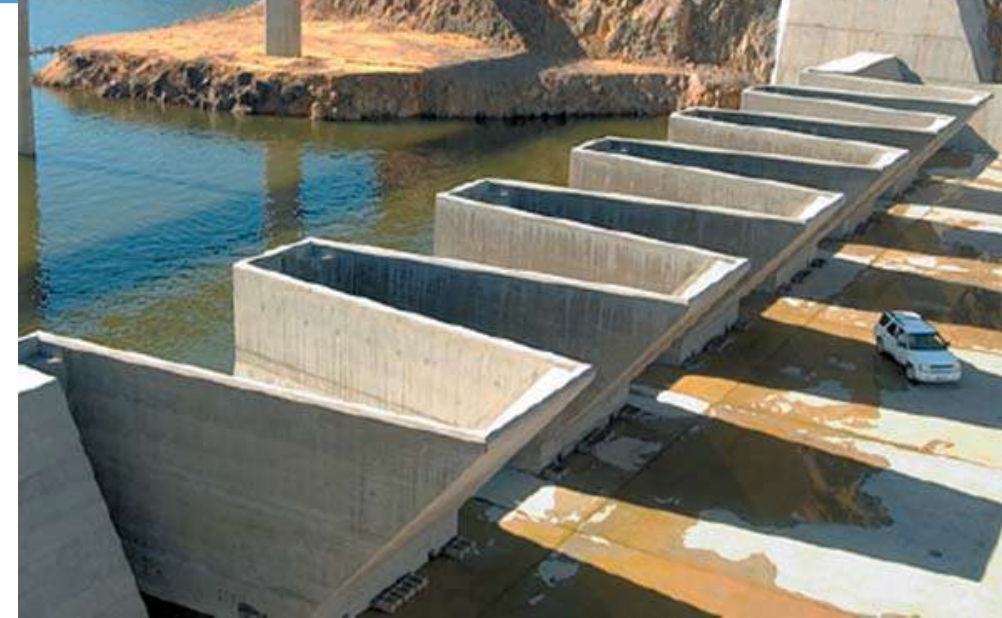
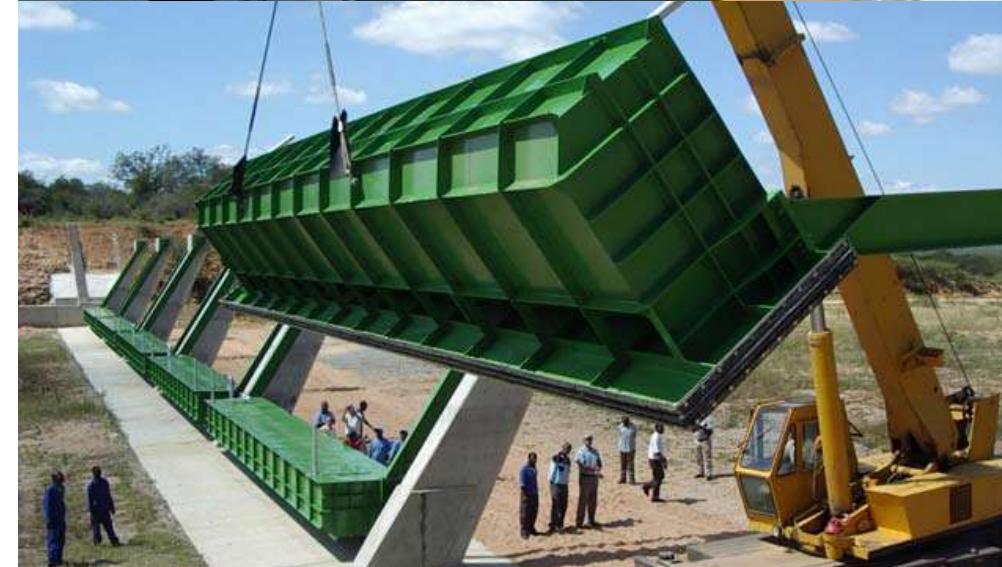
Enlarge Reservoir / Powergen

- Fuse Gate to utilise 2.3m / 5m of flood reservoir
- Activate in event of large flood say 1:10,000 yr AEP (55% - 70% of PMF 1094 m³/s)
- + 1.5Mm³ storage to ~15Mm³ (15%)
 - ⇒ Storage increases powergen utilisation
 - ⇒ Increase resilience to droughts / growth / demand

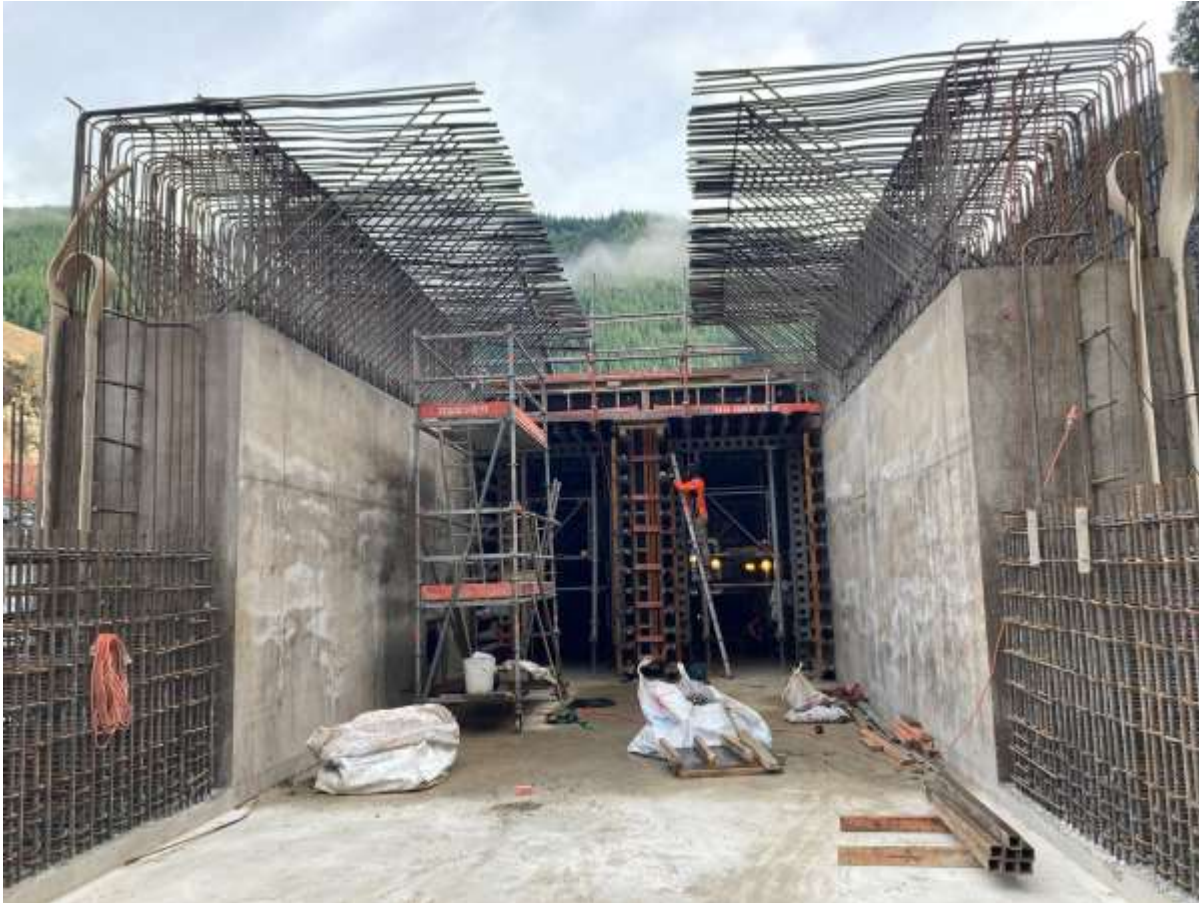
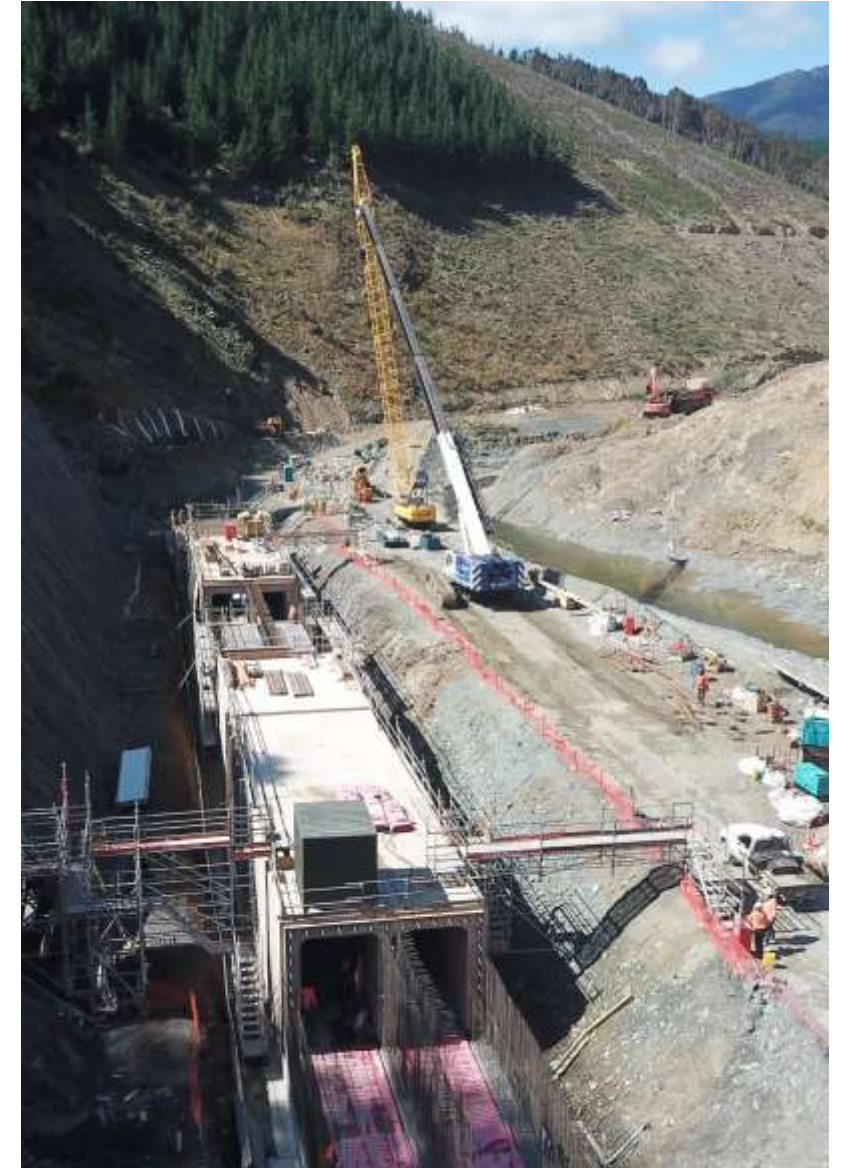
Diversion Culvert: ~80% complete

- ✓ Completed Floor
- ✓ 12/17 wall & roof sections completed
- Expect to complete by Aug and divert river September 2020

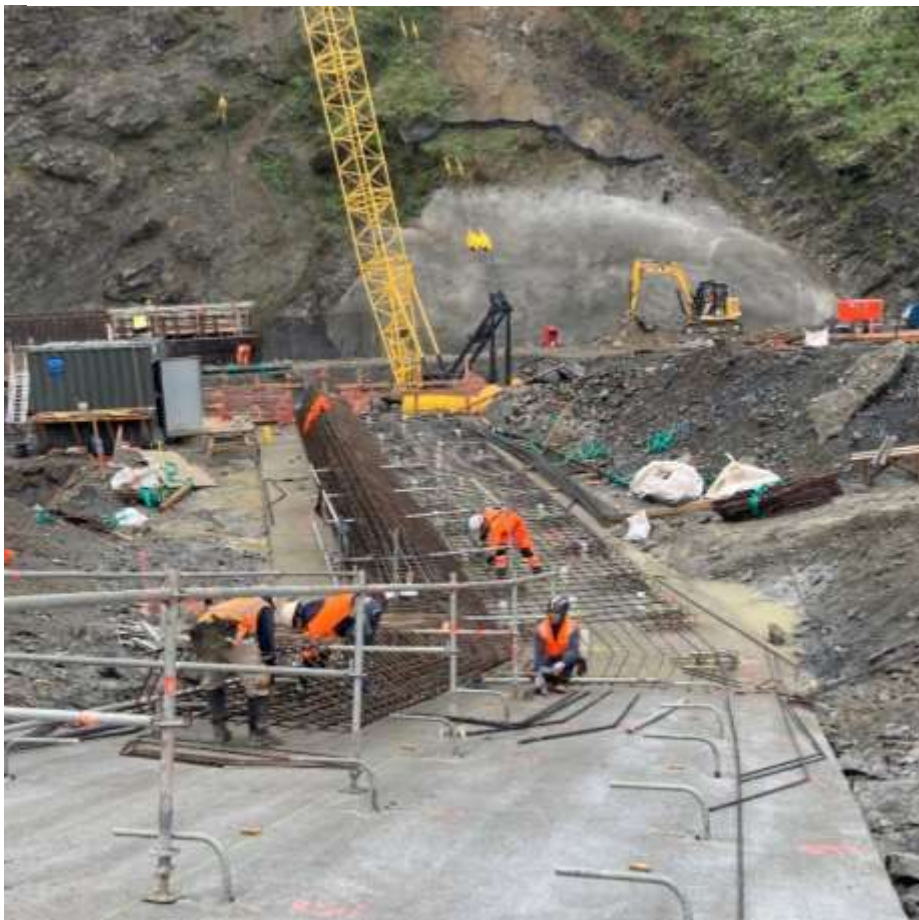
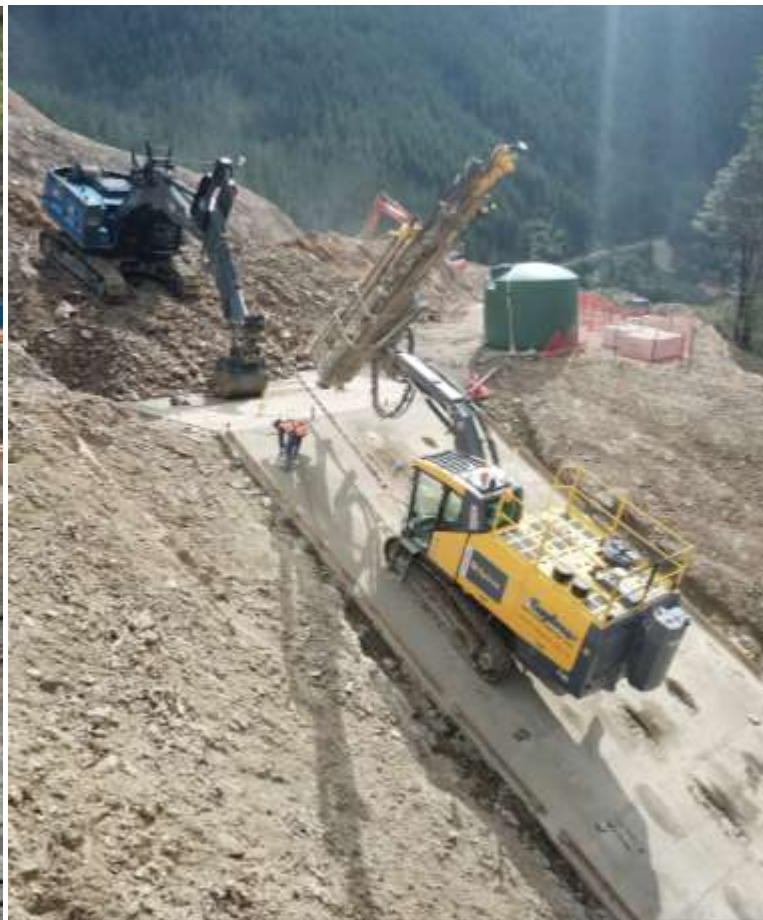
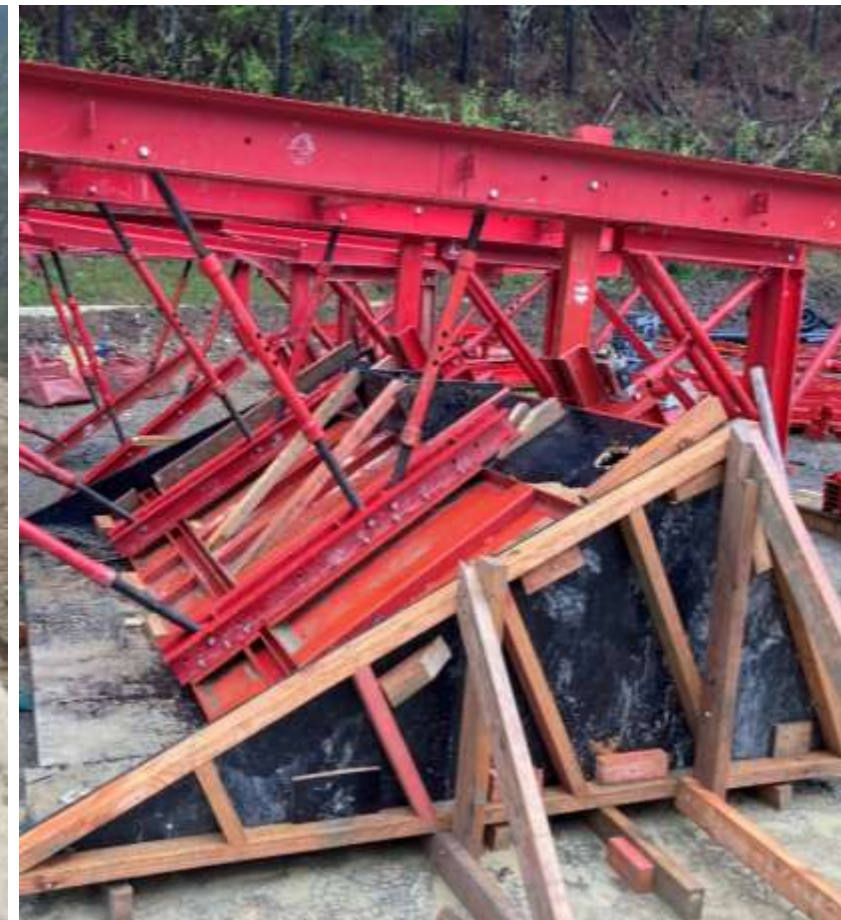
Construction Update: Forming LHS Plinth

- ✓ Foundation treated and site blinding concrete complete
- ✓ Commenced forming plinth

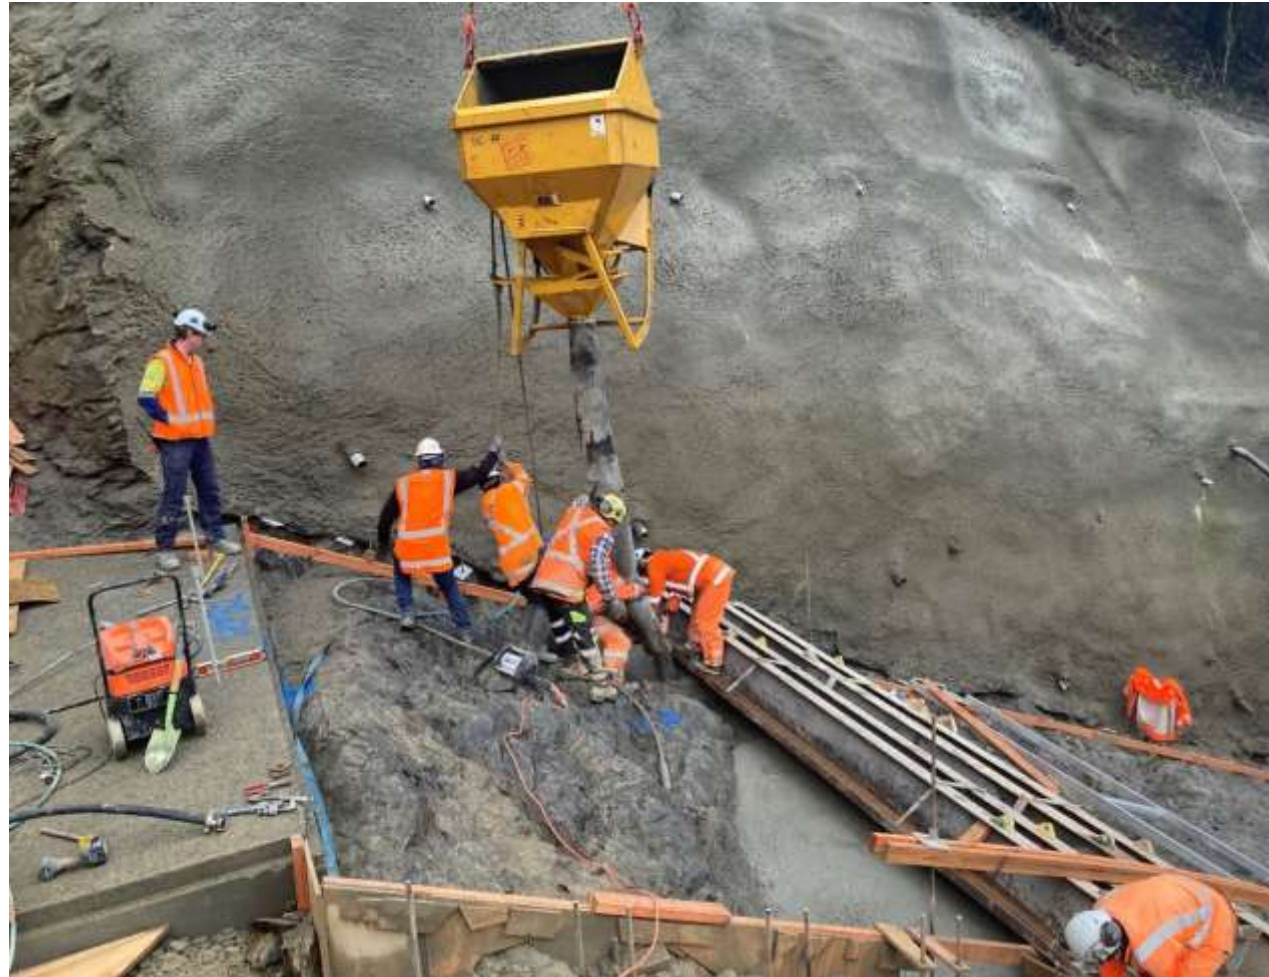
Construction Update: Preparing RHS Plinth

- ✓ Foundation treatment and treatment underway

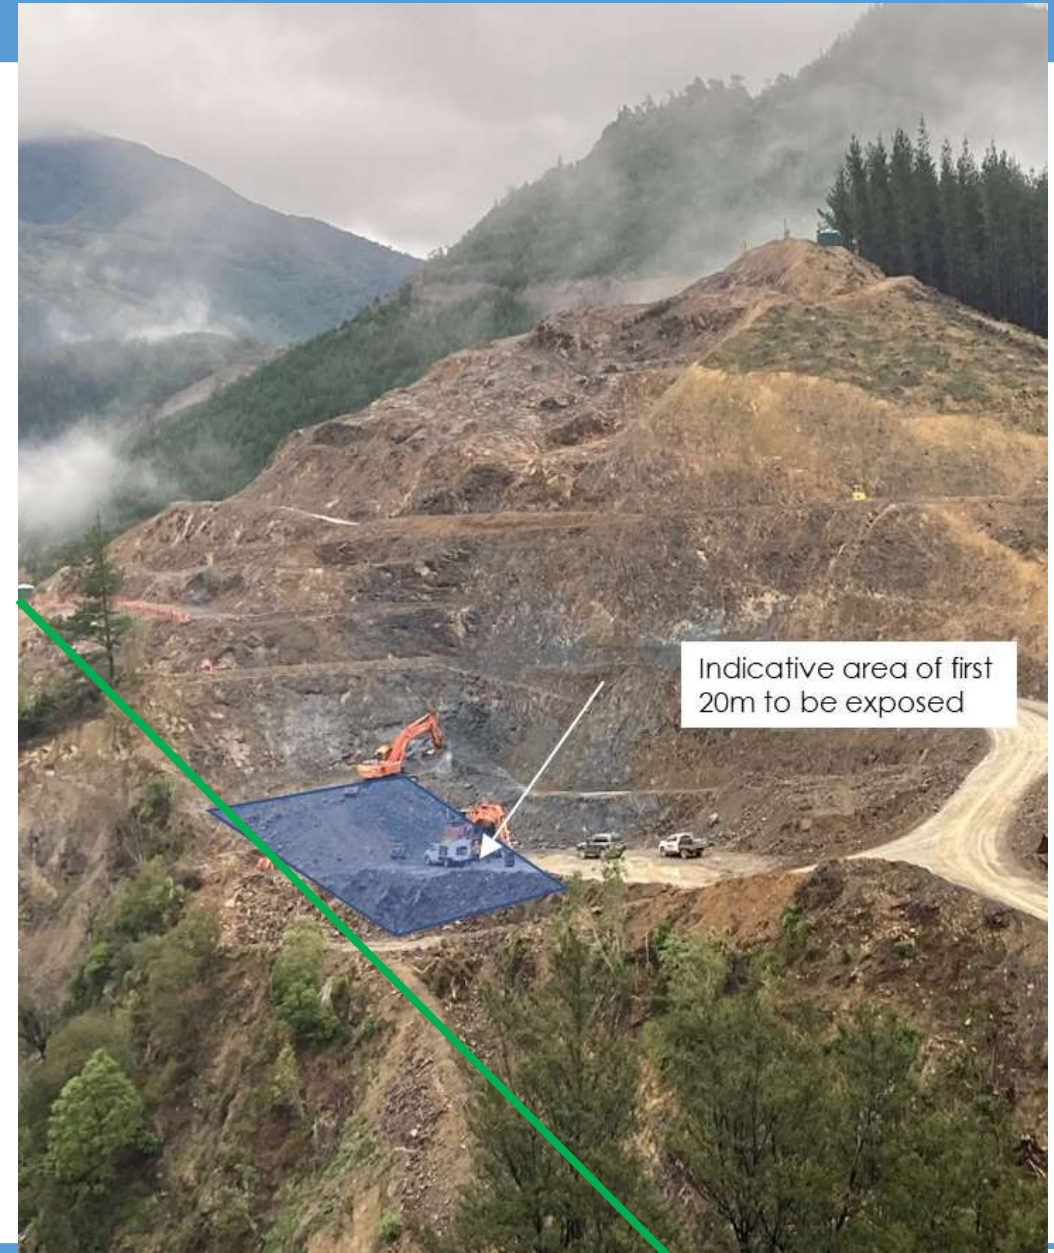
Construction Update: Spillway

- Spillway cut underway
 - Exposed first 20 m section of foundation
- ❖ Uncovering significantly weathered foundation that will require treatment
- Close to cliff edge
 - ✓ Supports change in design to self-supporting vertical walls, rather than a liner
- Will evaluate extent of any edge support

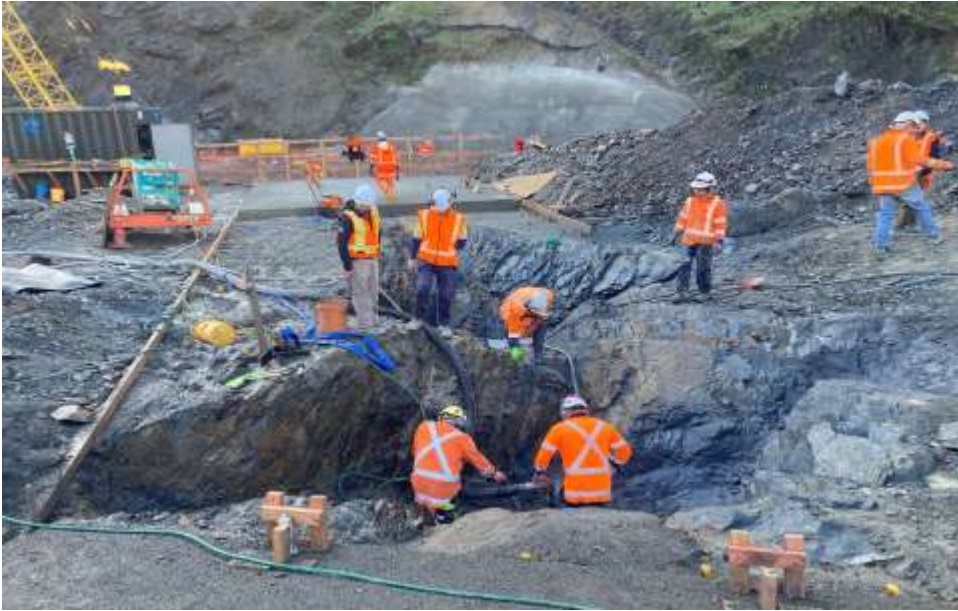
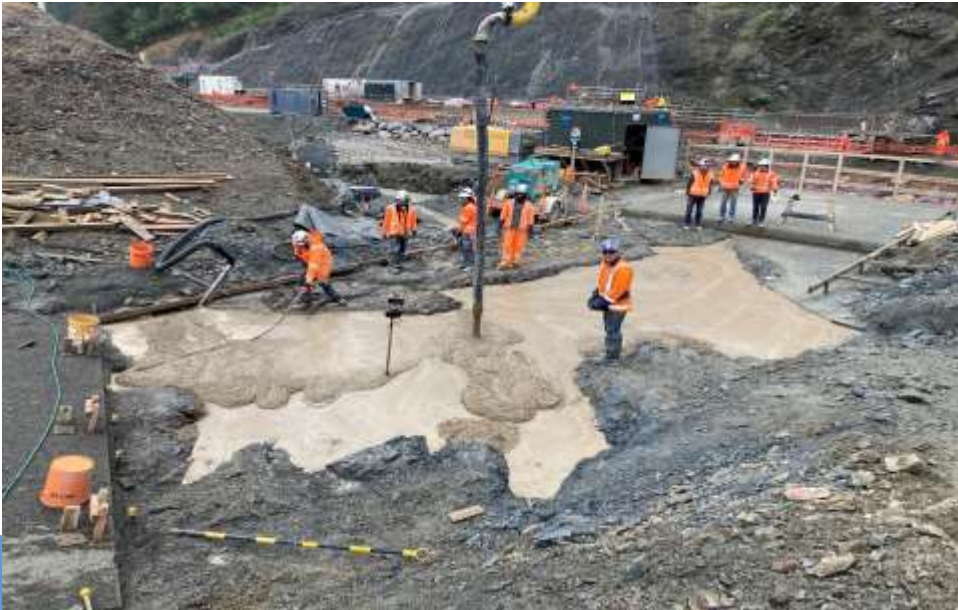
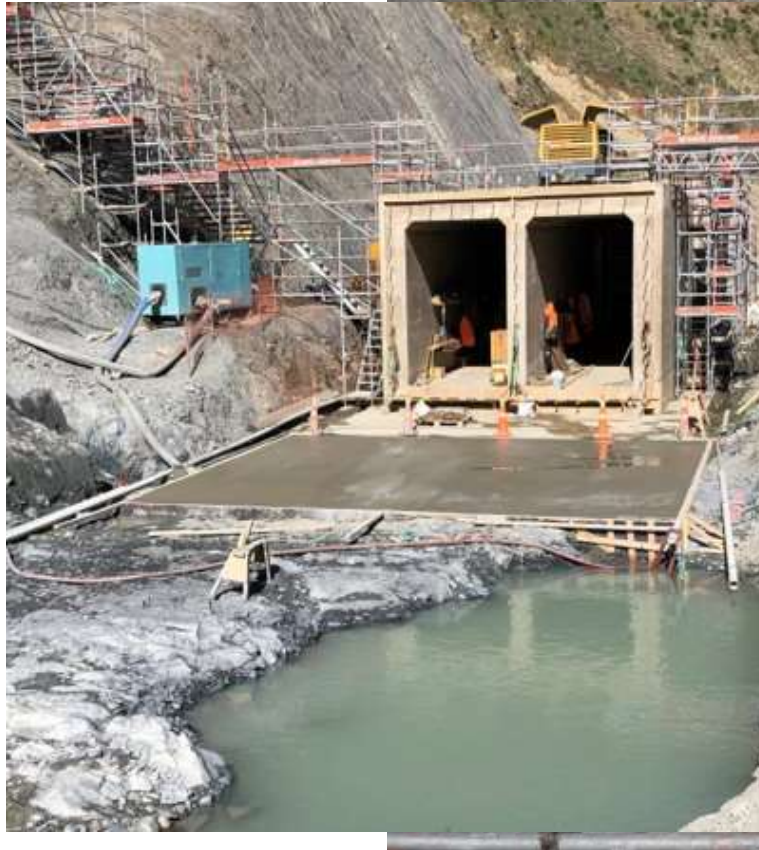
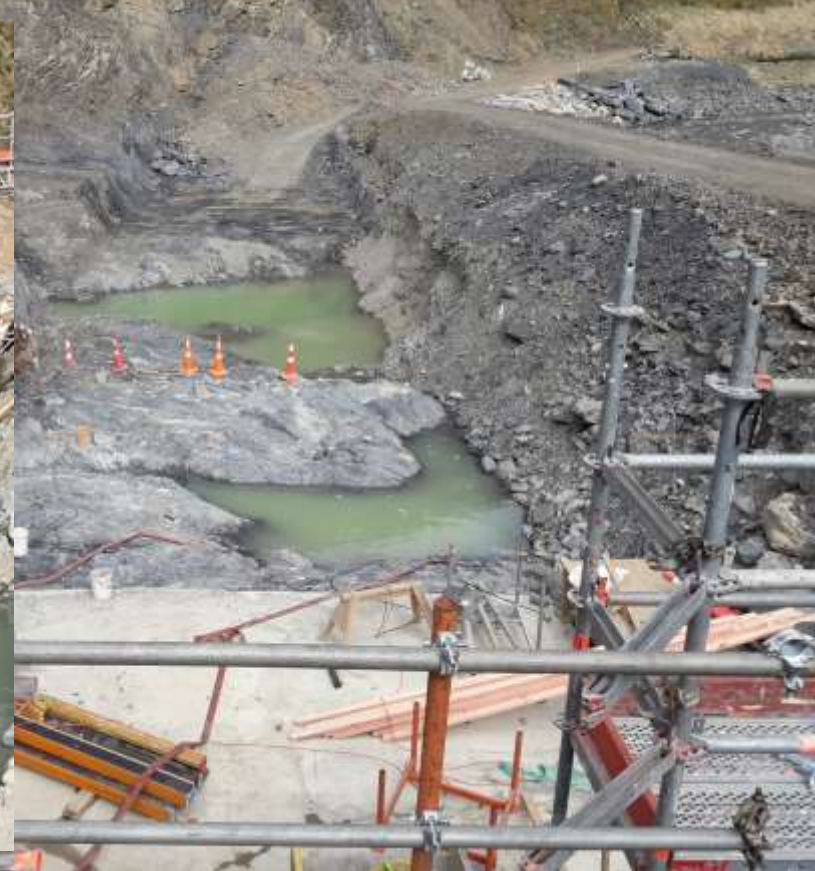
Construction Issues: Unexpected Voids

- ❖ >1000 m³ concrete
- ✓ LHS & Culvert done
- ❖ RHS, Spillway and starter dam to do

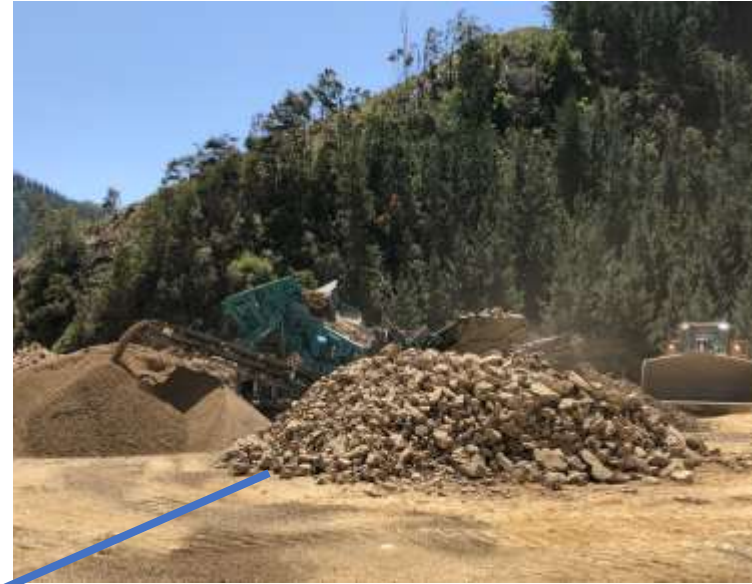
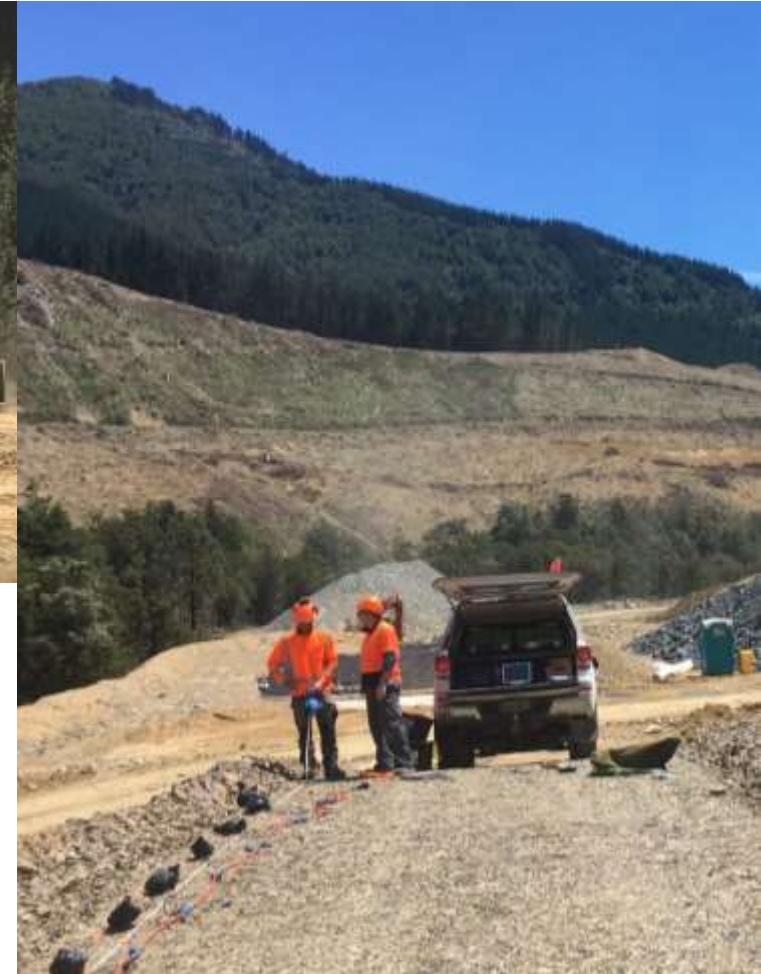
17 Dec 2019: Rezoning embankment to manage geology

- ❖ Expect less harder class-1 material
- ❖ Experiencing more fines
- ⇒ Increase drainage layers with
- ⇒ Processed (screened) out fines

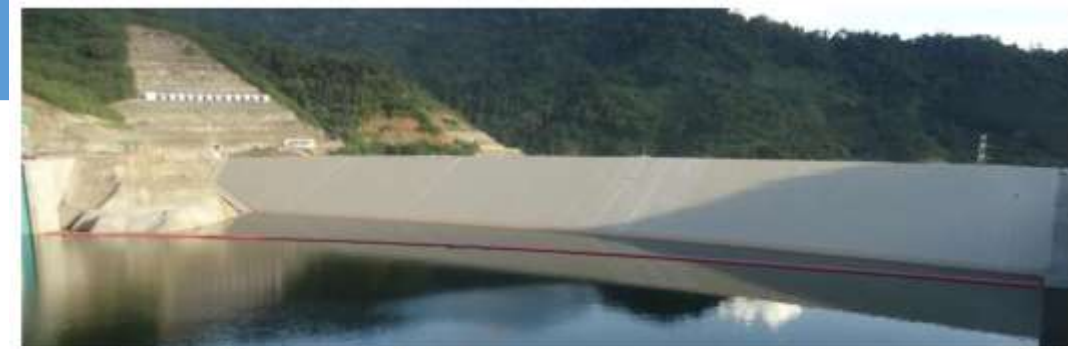
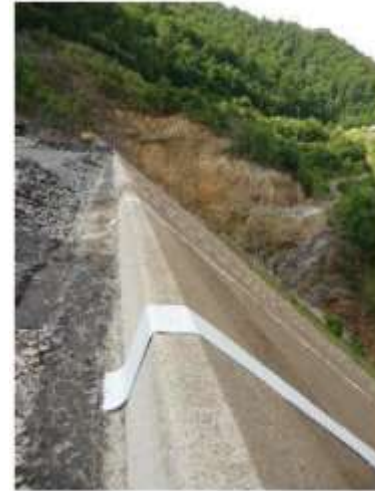
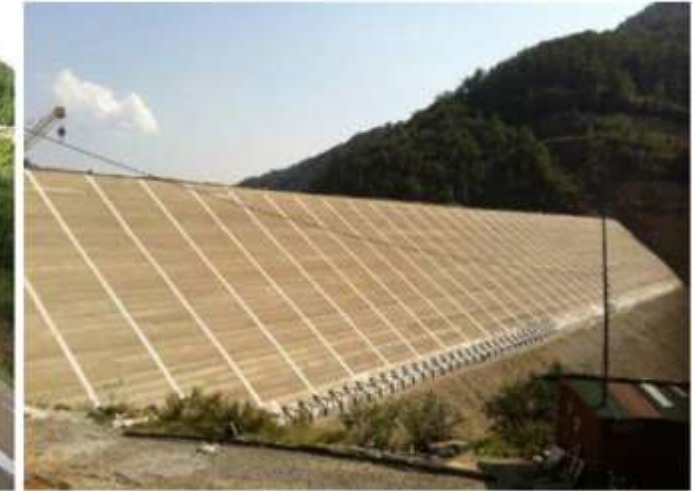
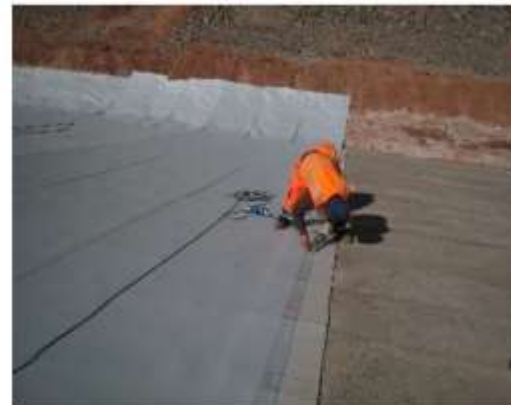
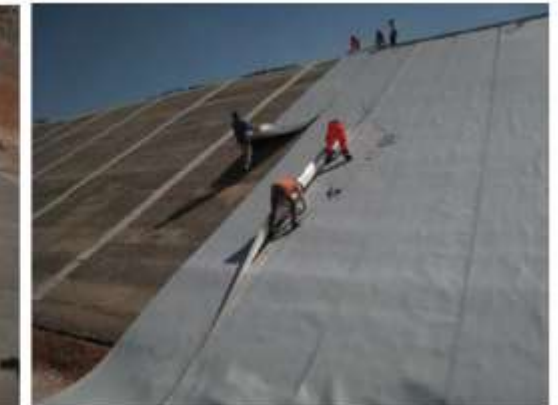
Design: Geosynthetic membrane

Replace concrete face with Geosynthetic membrane

- ⇒ Improved **resilience** to settlement and seismic (elasticity), benefit accentuated by softer rock
- ⇒ CO2, Cost and Schedule **savings**
- ⇒ Easy to repair; performance warranty
- ⇒ Testing demonstrates expected life 50-100 years (robust to UV)
- ⇒ Meets EU and International standards for Health and Environmental impacts

Carpi Ltd: Installed

- 54 New Dams since 1988 (26 larger than Waimea)
- 142 Retrofitted Dams since 1970 (63 since 2010)
- Used on Tekapo Canals (2013 / 2014)
