# SECURING OUR REGION'S FUTURE

CONSTRUCTING THE WAIMEA COMMUNITY DAM

Constructing New Zealand's  
largest dam in 25 years to  
secure Tasman's water supply.

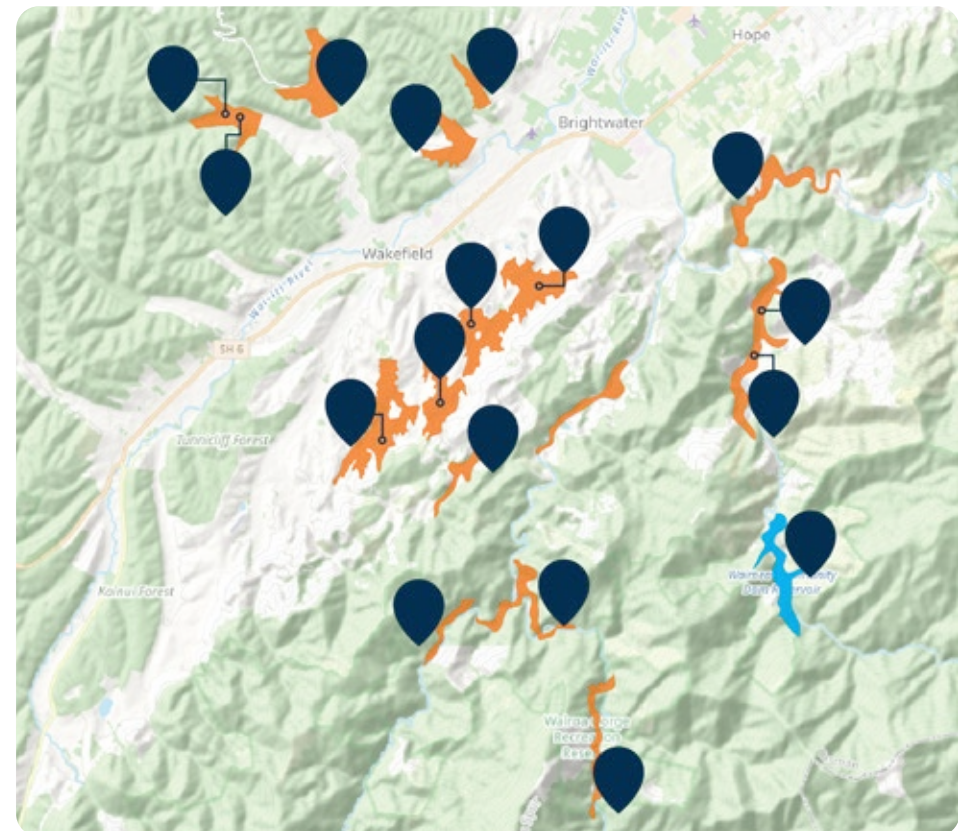
The 18 sites in Tasman investigated for an augmented water solution.

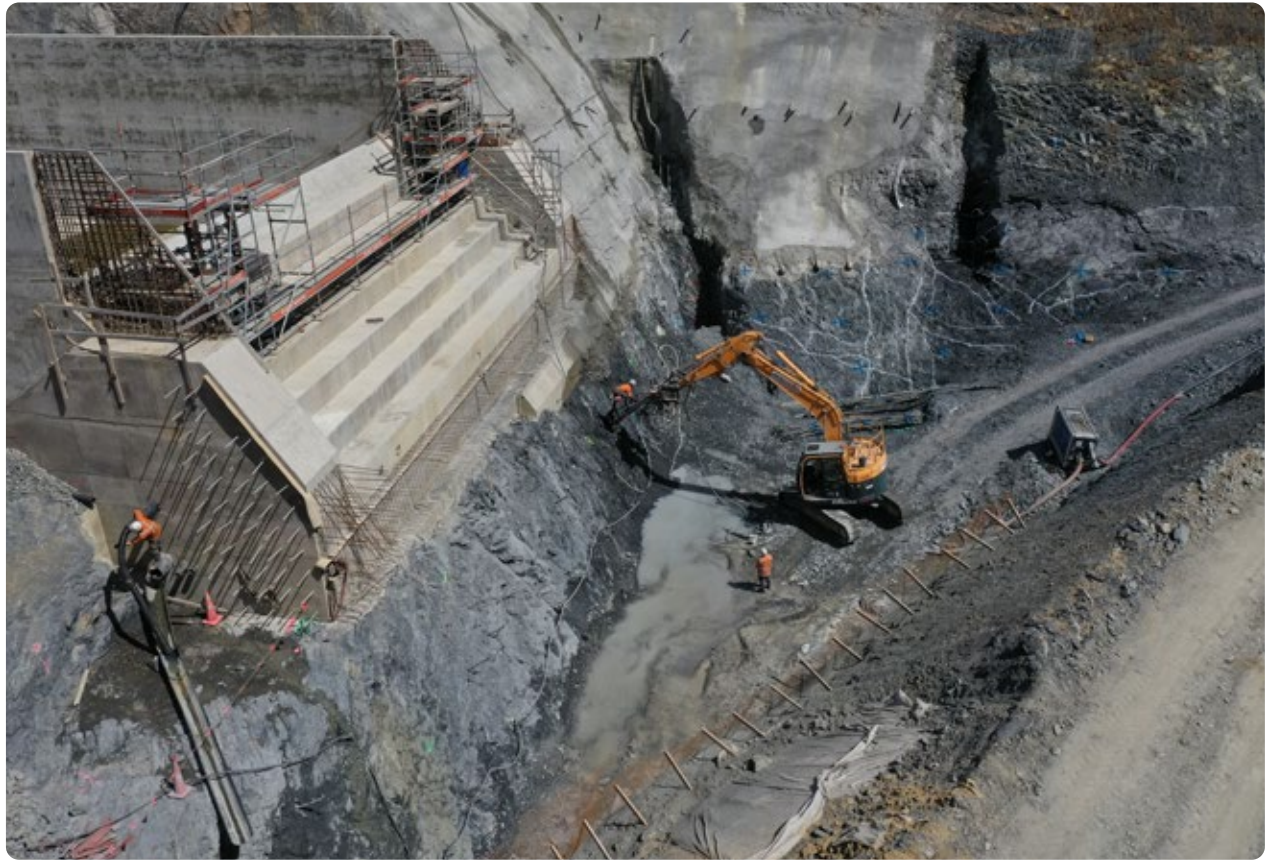
*Extensive remedial work required at the base of the spillway and plunge pool.*

Upon excavation of the plunge pool and cut-off wall at the downstream end of the spillway, poor rock conditions, including a network of shear zones, were encountered. This raised concerns about the depth of potential scour within the plunge pool and the stability of the cut-off wall.

Undercutting of the flip bucket foundation could occur if the depth of scour in the plunge pool is greater than expected or deep scour of the shear zones occurs. If untreated, this could have led to major damage or loss of the cut-off wall and flip bucket.

Significant effort was put into assessing and understanding both the geological conditions at the cut-off wall and the hydraulic performance of the flip bucket and plunge pool.

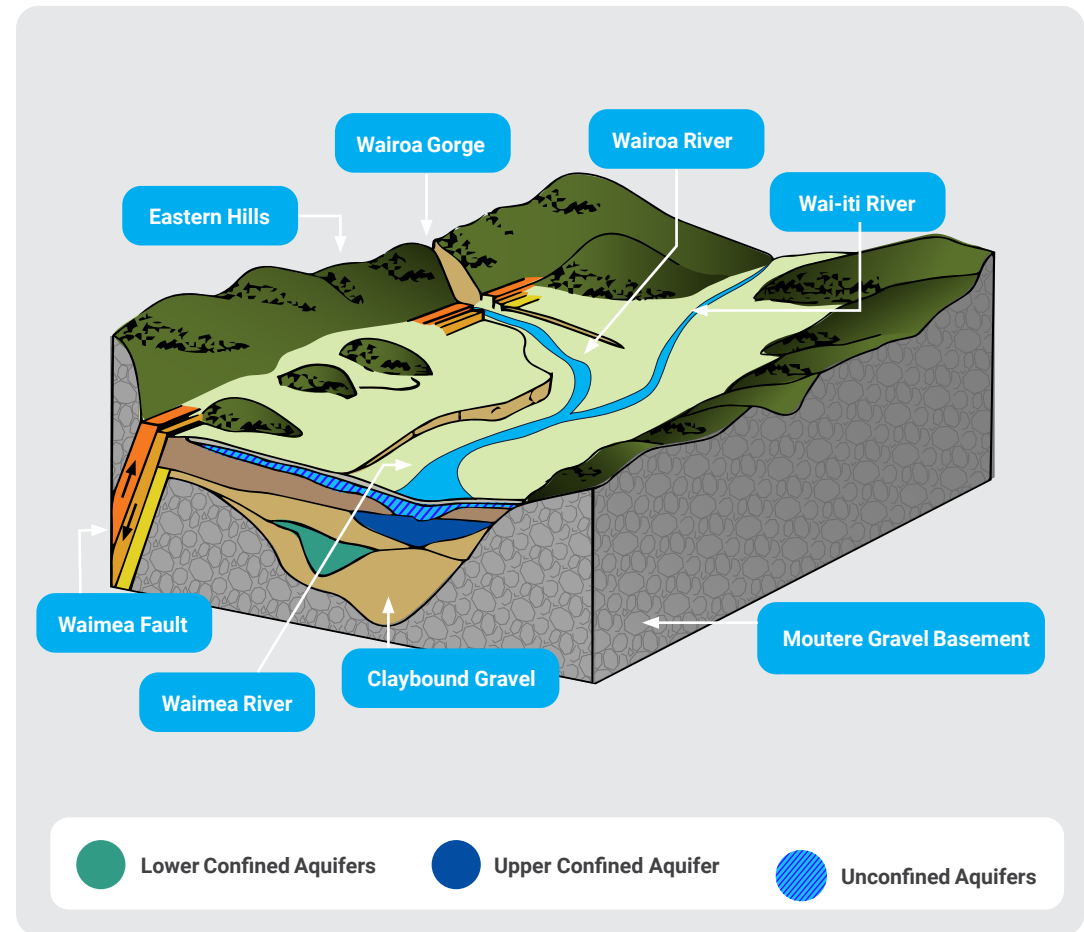
Three-dimensional hydrogeology of the Waimea Plains.

The flow from the dam supports both horticulture and the domestic water wells near Appleby that supply water to the combined Richmond-Nelson water network. Māpua, Ruby Bay, Brightwater and Wakefield also use bores in the Waimea Plains and benefit from the recharged aquifers.

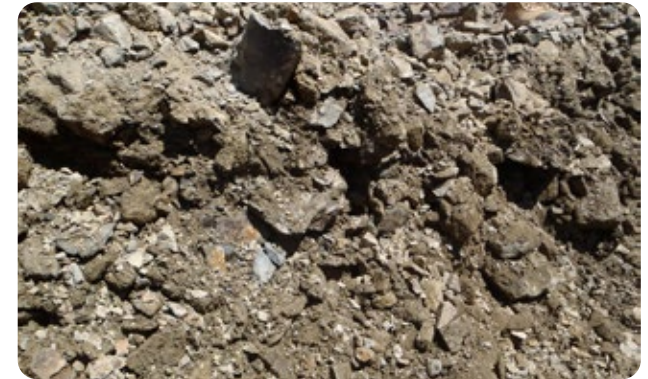
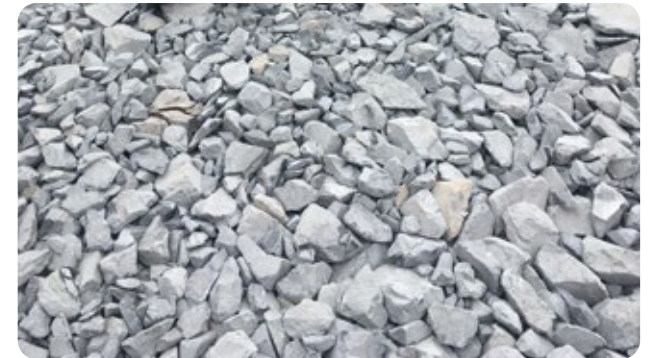
Encountered indigenous rockfill (top) and imported rockfill (bottom).

As excavation progressed, rather than a strong, clean, free-draining sandstone, the indigenous rock was found to be predominately a foliated silt or mudstone argillite that broke down on handling and processing.

This encountered 'dirty rockfill' posed risks with both drainage inside the dam embankment and erosion under and around the dam structures, although the undisturbed foundation rock on which the embankment sits was sufficient and as expected. The poor onsite rock meant the engineers needed to adapt the embankment design to use dedicated drainage layers, with 110,000 m<sup>3</sup> of drainage rock imported from a neighbouring quarry.

Despite the challenges with the encountered poor rockfill, we re-engineered the embankment to maintain the integrity of the rockfilled dam design.

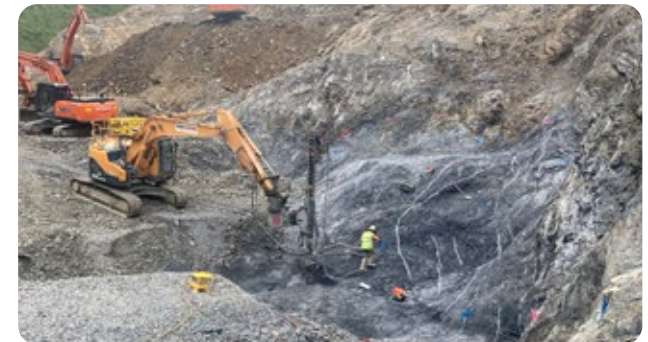
Shear zones on the LHS.

- ~60,000 m<sup>3</sup> more rockfill was required within the embankment, increasing its size to ~490,000 m<sup>3</sup>, 13 per cent larger than planned.
- The true left-hand side (LHS) was highly fractured and defective, needing 50 per cent more flow-limiting material than anticipated to treat defects and 25,000 tonnes of sand to be imported from around Te Taihu.

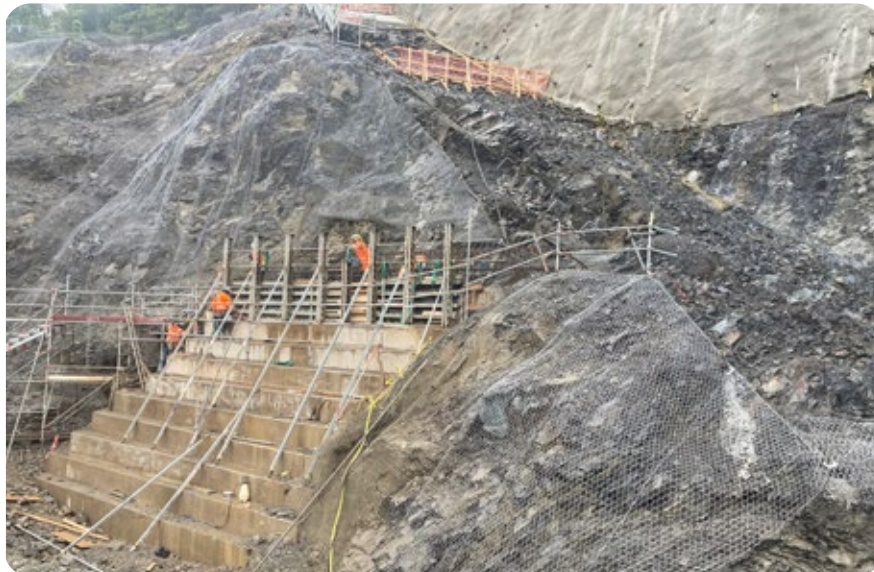
*Stabilising structures under the RHS plinth.*

Also, a lower section of the RHS plinth, ~12 metres above the embankment foundation, was found to have deficient rock to build the plinth on.

This deficiency was rectified by replacing the missing rock with a concrete beam, and constructing a concrete 'staircase' to mitigate differential settlement of the rockfill against the plinth. Additionally, voids beneath the plinth required remediation.

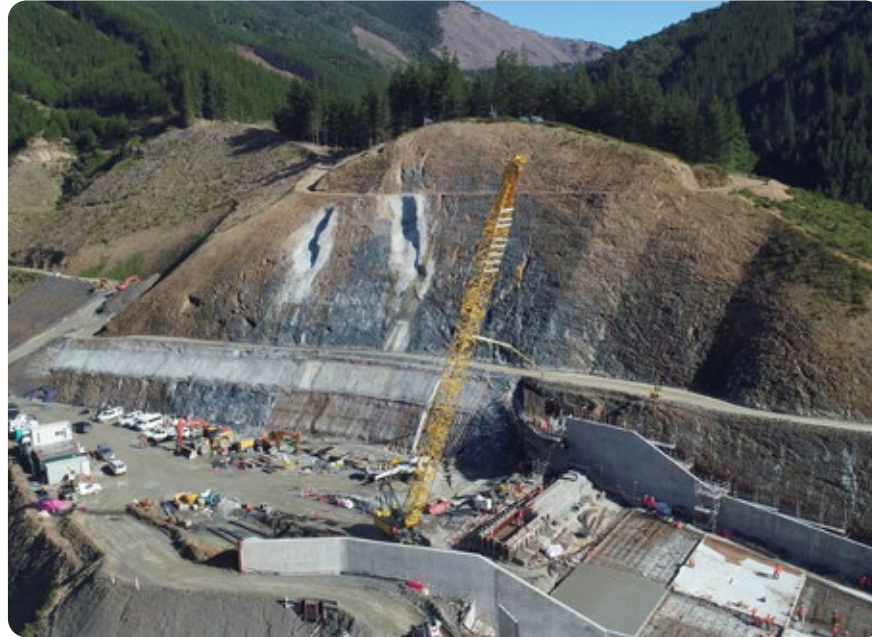
*A view of the fractured true LHS with shear zones above the spillway.*

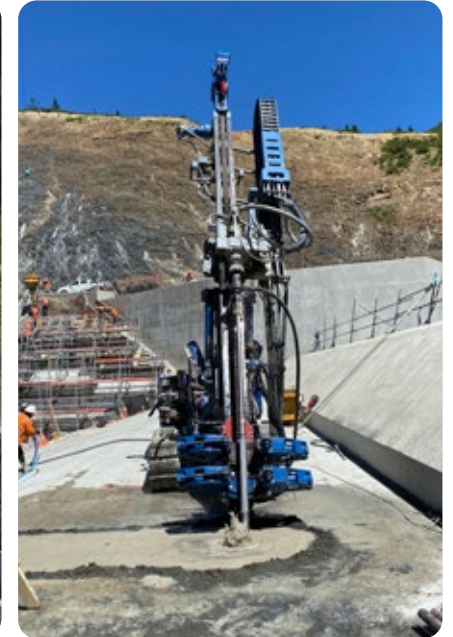
*Drilling holes for the grout curtain in front of the ogee weir.*

To further strengthen the waterproofing and prevent seepage beneath the dam, greater quantities of drilling and grout were needed to close the subsurface. The original plan had been to drill ~300 bores and undertake ~5,000 metres of drilling, but more than 880 bores and 18,000 metres of drilling were needed to sufficiently reduce the permeability of the subsurface beneath the dam.

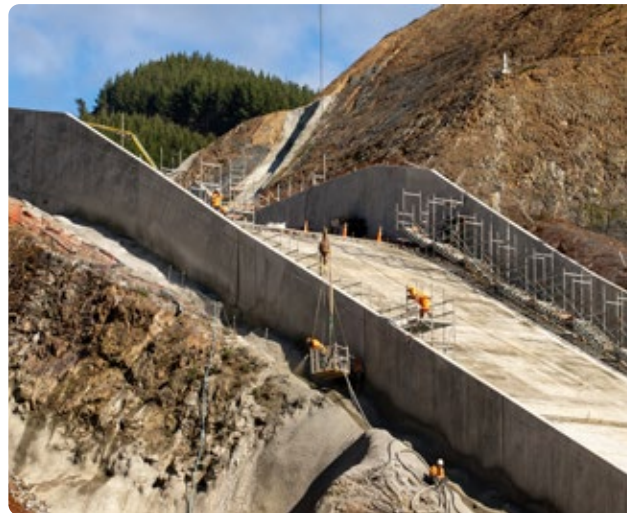
*Free-standing cantilevered spillway walls above the steep topography.*

Instead, the spillway's walls were redesigned to be free-standing cantilevered concrete walls, with additional drainage and foundation treatment.

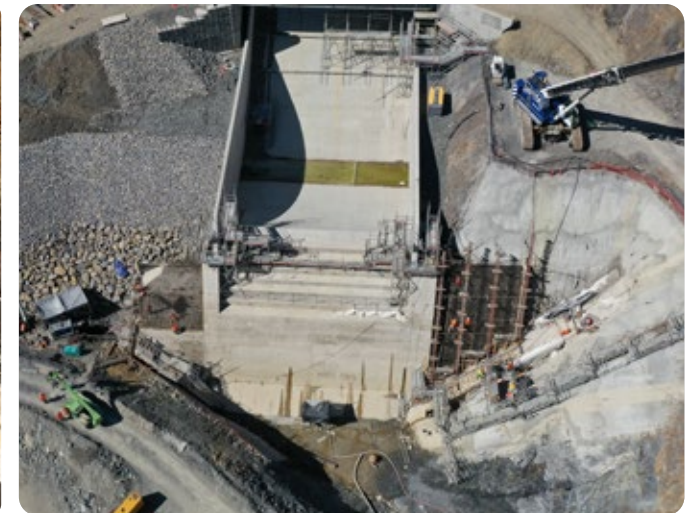
*Spillway cut-off wall and shotcrete around the plunge pool to protect the spillway.*

Greater erosion of the plunge pool meant it was deepened to six metres below river level and the cut-off wall was extended a further three metres below the plunge pool. Shotcrete was used to treat the shear zones immediately in front of the cut-off wall.

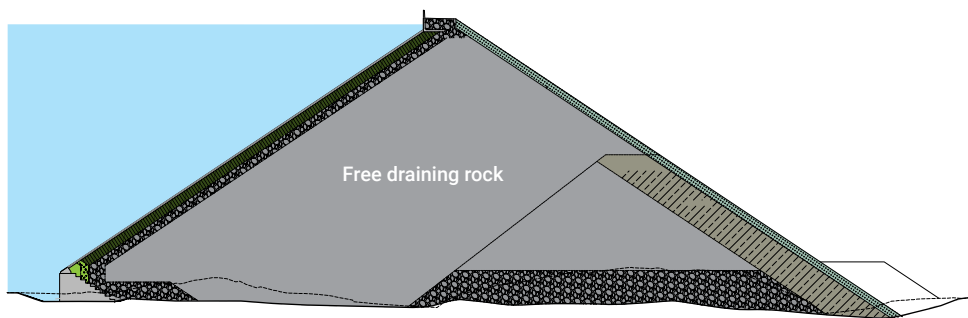
Original design based on free-draining rockfill found onsite.

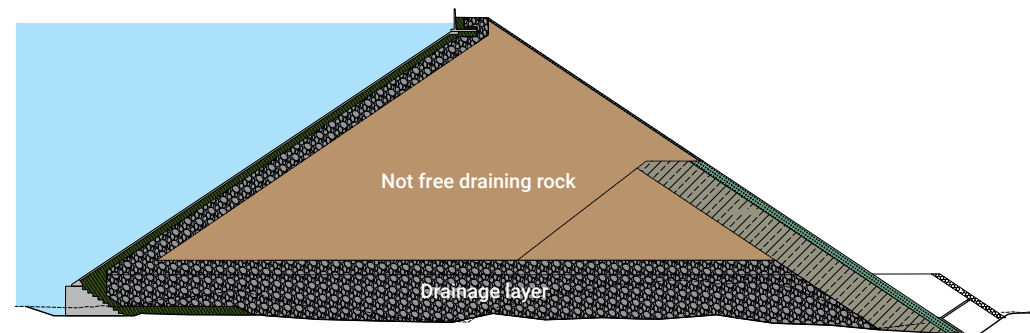
Updated design with increased drainage layers.

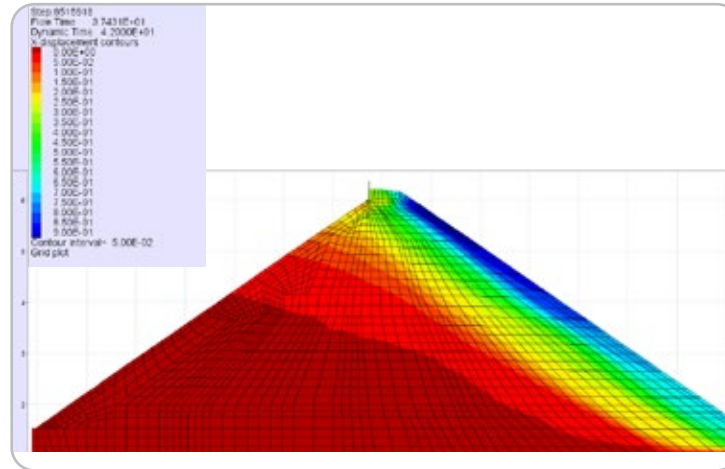
FLAC diagram (Credit: Damwatch Engineering Ltd.)

The dam and spillway have been designed to not fail under seismic loads, estimated by GNS Science, from the nearby Waimea-Flaxmore Fault System (approximately eight kilometres from the site) and the Wairau and Alpine faults (approximately 21-22 kilometres from the site) during 1:10,000-year events. In 2020, a detailed Fast Lagrangian Analysis of Continua (FLAC) of deformation under design seismic loads was completed. It found any resulting embankment deformation from seismic loads would not compromise the performance of the dam.

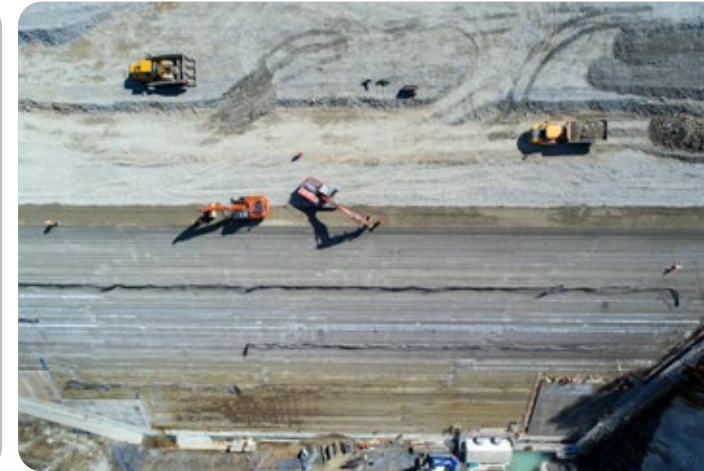
The concrete-face rockfill dam, designed to the highest standards required by NZSOLD guidelines.

A concrete-face rockfill dam design was selected as the most appropriate and efficient design for the geology, topography and seismic and flood loads. This remained as the dam design, with adjustments made due to the rock found onsite.

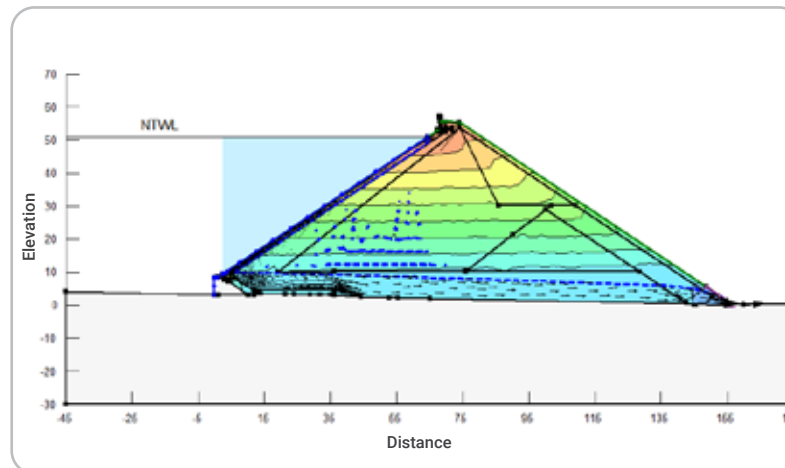
Seepage flow through maximum dam section. (Credit: Damwatch Engineering Ltd.)

- A highly engineered flow-limiting barrier (zone 2B) to firstly reduce flow into the embankment.
- Size and transmissivity of chimney and blanket drains (zone 3P) to allow drainage, under full head and without any concrete face, without saturating the indigenously-mined dirty rockfill. The drainage chimney and blanket were constructed of imported drainage fill from a nearby quarry.
- A lined toe-berm captures any seepage and releases flow through weirs that measure and monitor any flow through the embankment.

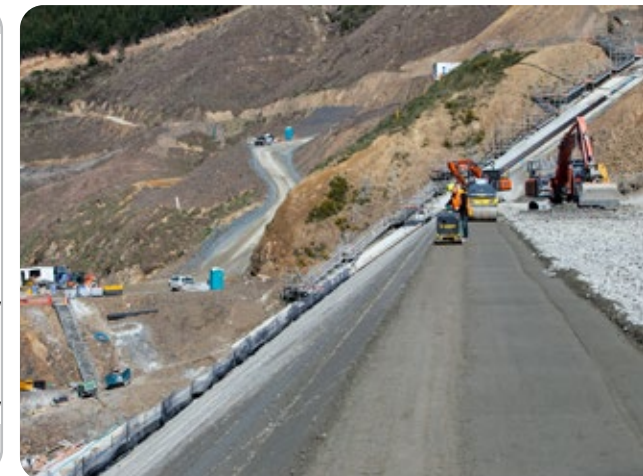
Flow-limiting zone on left and chimney drain on right.

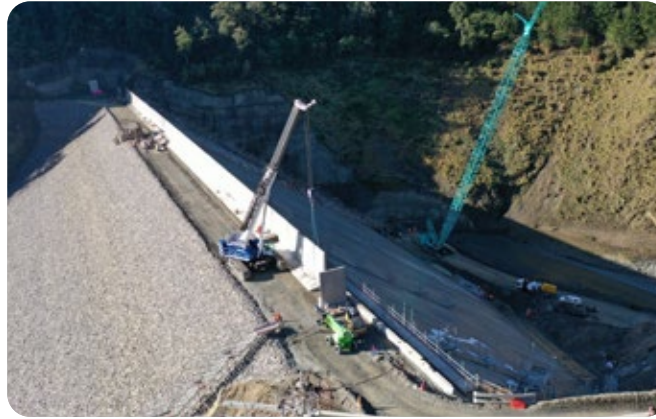
Installation of the parapet wall on the dam's crest, June 2022.

The concrete face is designed to international best practice with flexible waterstop joints to the plinth. The concrete parapet wall on top of the crest was precast, installed in sections, and has an elastic geosynthetic membrane external waterstop to allow flexibility and movement if there is a seismic event.

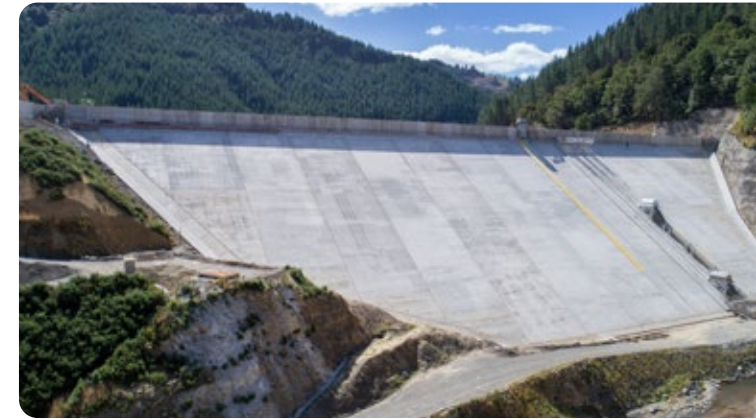
Concrete face completed, September 2022.

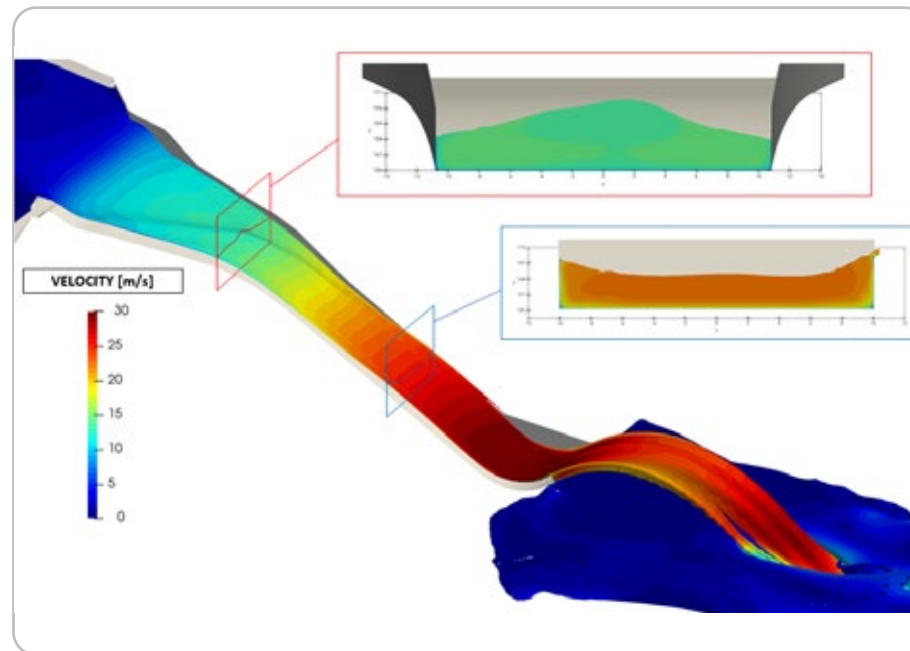
Velocities for the PMF scenario estimated using a 3D CFD model of the Stage 5 design. (Credit: Damwatch Engineering Ltd).

- **Inflow Design Flood (IDF) Capacity:** The dam's adopted IDF is the PMF, which accounts for a peak outflow of 1,059 m<sup>3</sup>/s. 2020 modelling showed that the spillway is actually capable of passing 1,200 m<sup>3</sup>/s, 13 per cent more than PMF requirements, with its design also catering for predicted increases in flood intensity due to climate change.
- **Drainage:** Extensive longitudinal and lateral drains flow into open drainage and then into weirs to both release any subsurface flow and hydrostatic uplift, and to monitor any subsurface flow.
- **Anchoring:** Dam engineering standards changed following the failure of the Oroville Dam spillway in 2017. In line with this contemporary standard, circa 1,500 anchors were installed in the spillway at a typical depth of five metres into the rock at the dam.

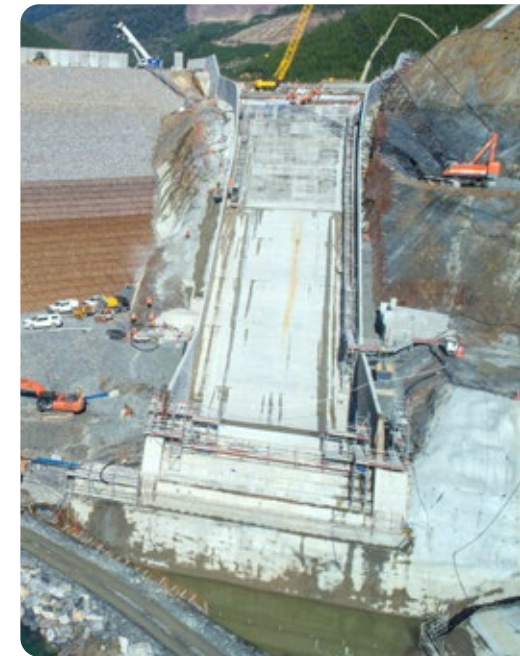
Spillway nears completion, August 2022.

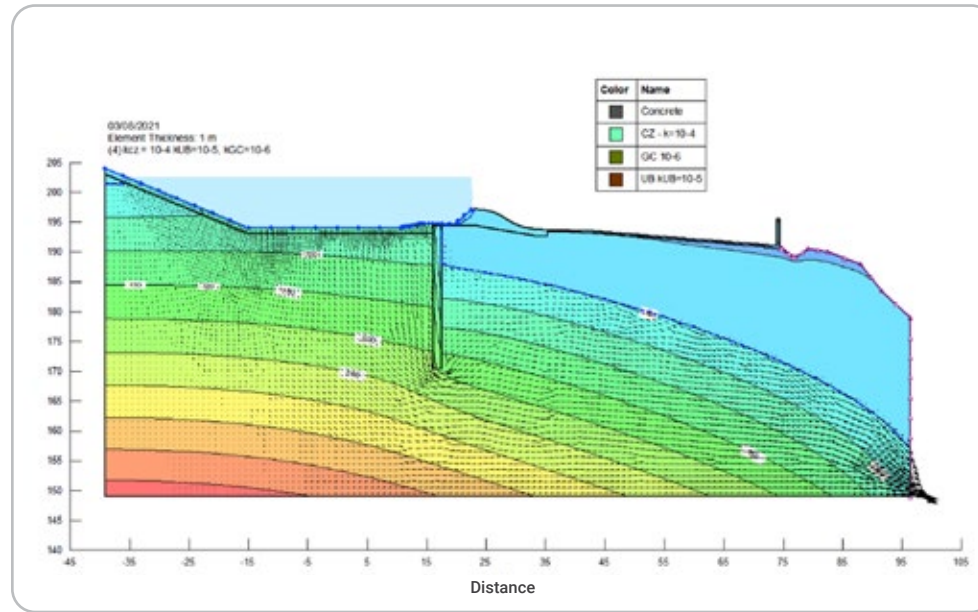
Seepage analysis (Credit: Damwatch Engineering Ltd).

- Geomembrane lining of the approach channel to prevent ingress of seepage into the shear zones and to lengthen the seepage path. The geomembrane was sourced and delivered from Carpi Tech in Europe.
- Drainage zones to remove any seepage that bypasses the liner.
- Increased grouting across the spillway alignment including additional grouting through shear zones.
- An increased network of piezometers to monitor seepage within the approach channel and shear zones.

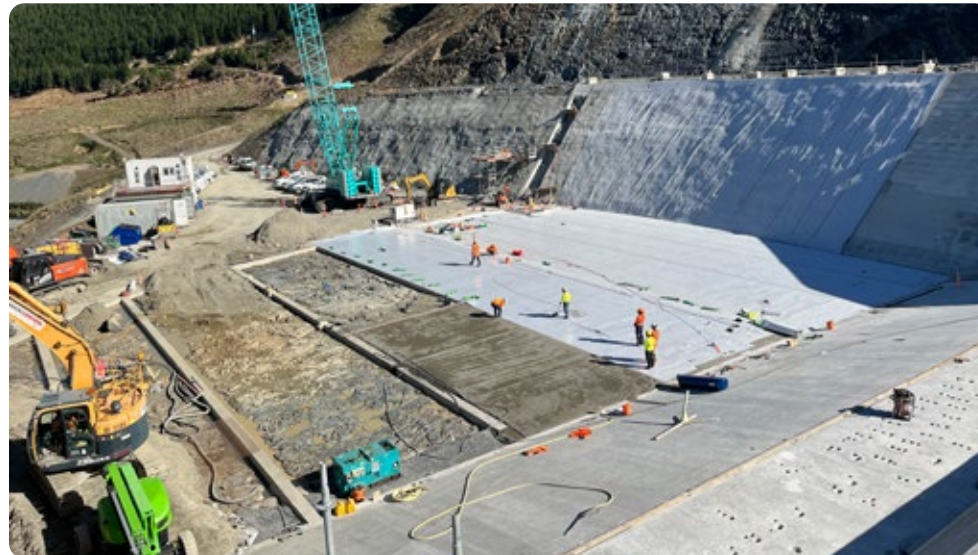
Carpi waterproof liner being placed on the spillway approach, April 2023.

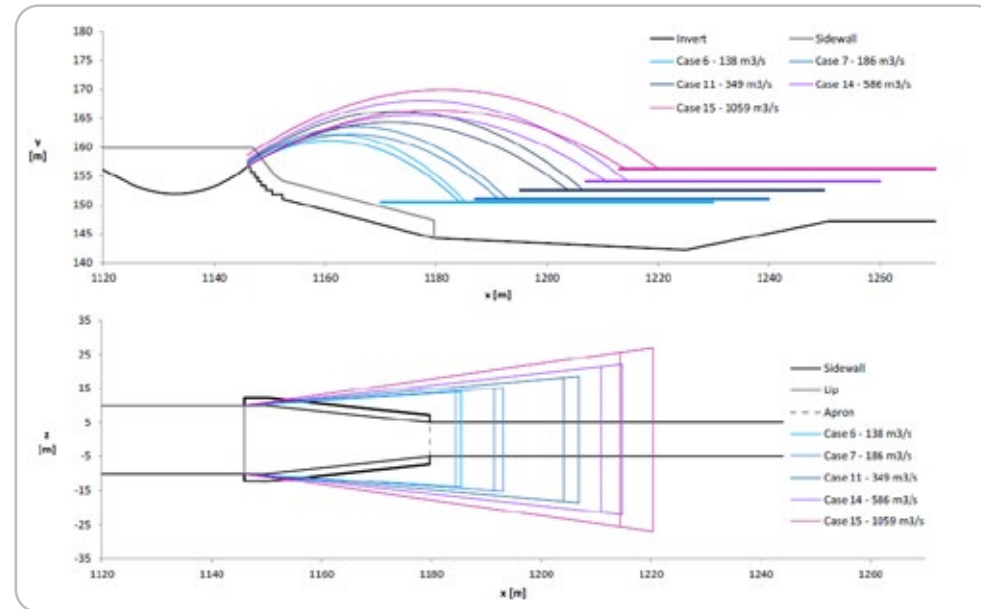
Profile and plan view of estimated jet trajectories for flow cases (Credit: Damwatch Engineering Ltd).

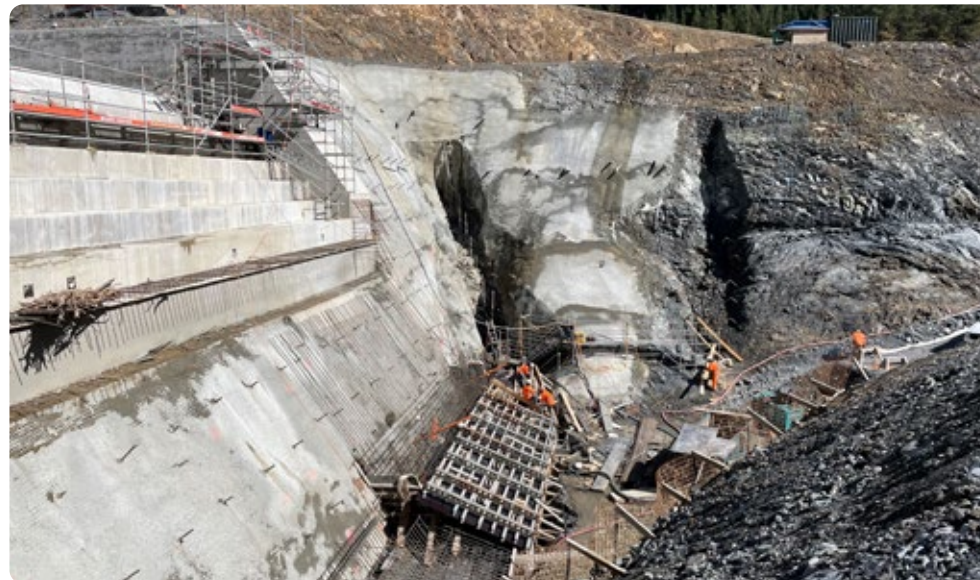
Constructing the cut-off wall at base of flip bucket and plunge pool shotcreting.

- The plunge pool was deepened to be six metres below river level and the cut-off wall was deepened to a further three metres below the plunge pool.
- Treatment of the shear zones immediately in front of the cut-off wall included either shotcrete reinforcement or excavation and concrete backfill.

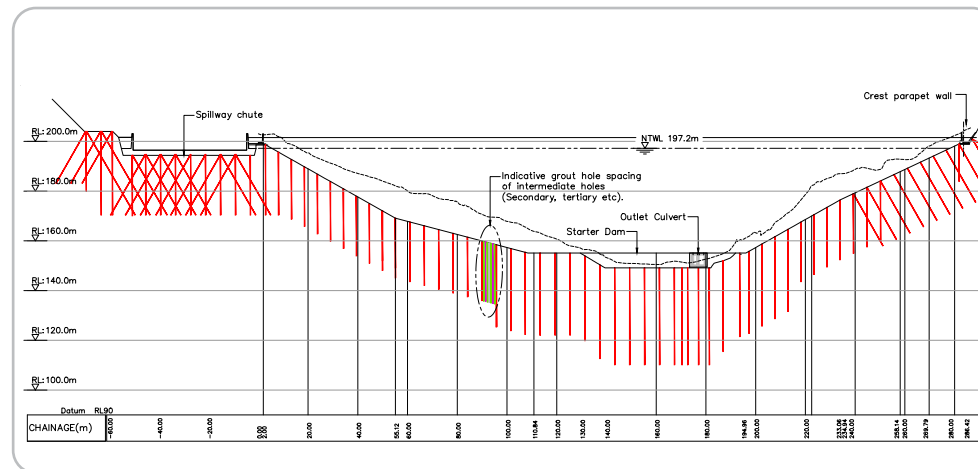
Diagram of the grout curtain showing curtain alignment along the entire length of the dam and spillway. (Credit: Damwatch Engineering Ltd).

Extending up to 40 metres into the subsurface, the grout curtain provides a low-permeability barrier to limit seepage flows beneath the embankment. This required more than 18,000 metres of drilling and pumping grout into the subsurface.

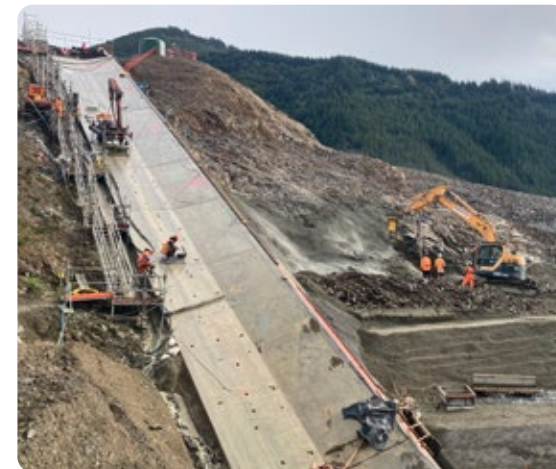
Grout curtain being drilled through true left plinth slabs.

Plinths found and seal the upstream edge of the dam and are tied to the concrete face. A grout curtain through the plinth and up to 40 metres deep was made by pumping grout through more than 880 bores into the substrata.

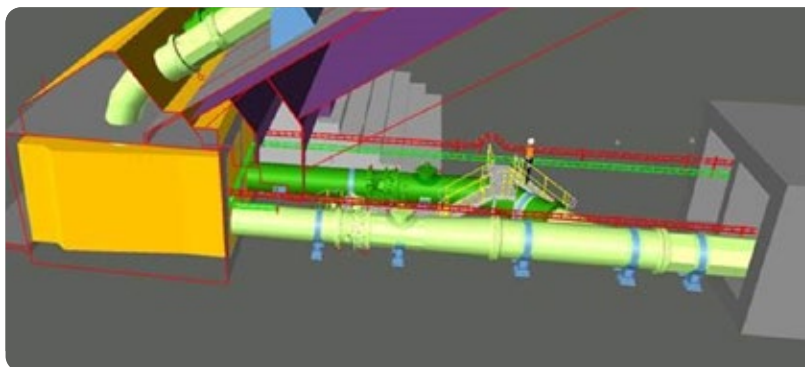
The two intake pipes enter the upstream valve chamber, where water quality is achieved by mixing the flows from the two pipes using primary isolating valves (PIV).

The two stainless steel intake screens allow selective offtake for water quality. The screens can be winched to the dam crest for cleaning and maintenance. These screens are connected to a stainless steel welded pipe in the culvert, with primary isolating valves (PIV) on each intake and energy dispersing cone valves at the discharge point downstream. The outlet works have been designed to remain operational following a 1:10,000 Annual Exceedance Probability (AEP) Safety Evaluation Earthquake (SEE), if one occurs.

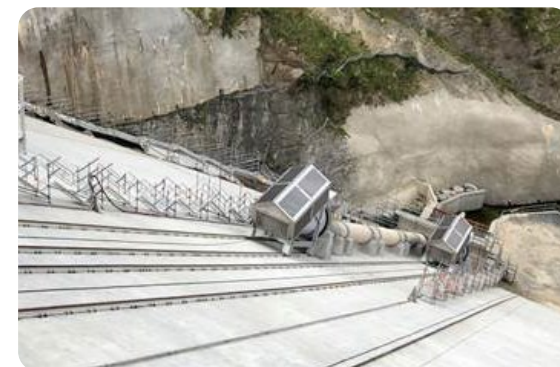
Intake screens and pipes on the dam face.

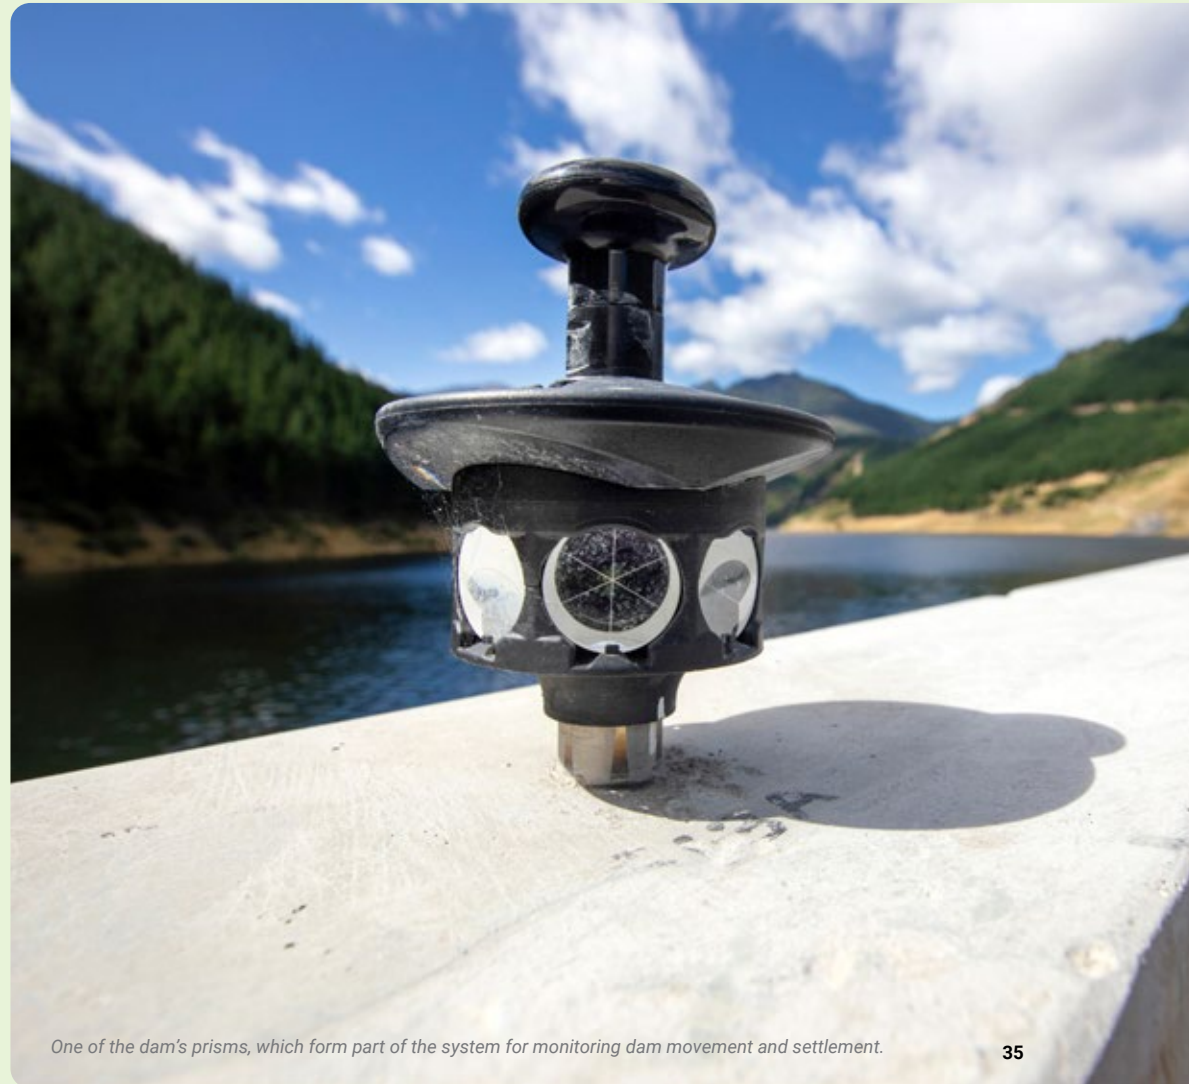
*One of the dam's prisms, which form part of the system for monitoring dam movement and settlement.*

- 1 Real-time monitoring of reservoir and spillway levels and outflows.
- 2 Real-time monitoring of seepage and flows through the drainage layer and from beneath the spillway into the monitoring weirs.
- 3 Real-time monitoring of water levels and flow through the dam and beneath the spillway using 26 telemetry-equipped piezometers.
- 4 Real-time leak detection at the plinth (the leading upstream edge) using thermistors.
- 5 Observation wells from the dam crest through the embankment to measure seepage levels and monitor rockfill performance.
- 6 Seismographs to measure earthquake loads.
- 7 Regular surveying of the dam for deformation, and surveying of the reservoir for slope stability.
- 8 Onsite cameras for remote monitoring.
- 9 Regular comprehensive inspections.

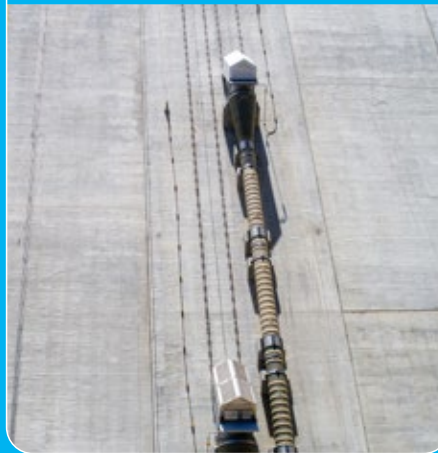
Reservoir water is filtered through the upper and lower INTAKE SCREENS to meet water quality objectives. The 20mm screen openings prevent harm to fish and eels and prevent debris from entering the pipes and valves.

The INTAKE SCREENS can be winched to the dam crest for cleaning and maintenance, with a platform to make it safe for personnel.

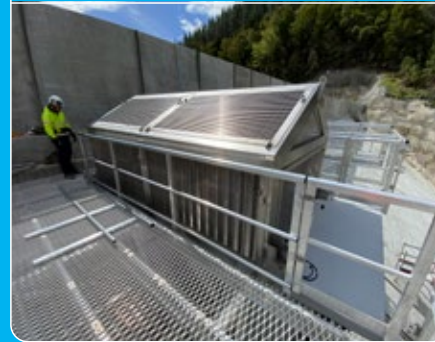
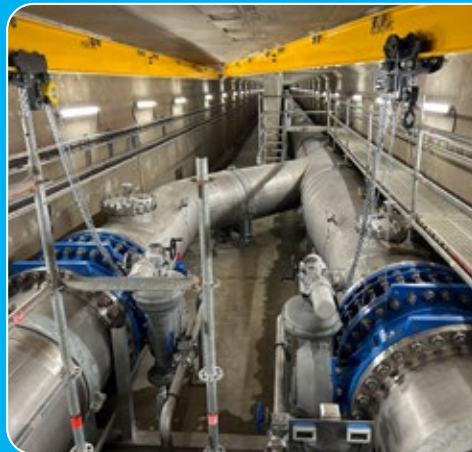
The two intake pipes enter the UPSTREAM VALVE CHAMBER where water quality is achieved by mixing the flows from the two pipes using butterfly valves (PIVs).

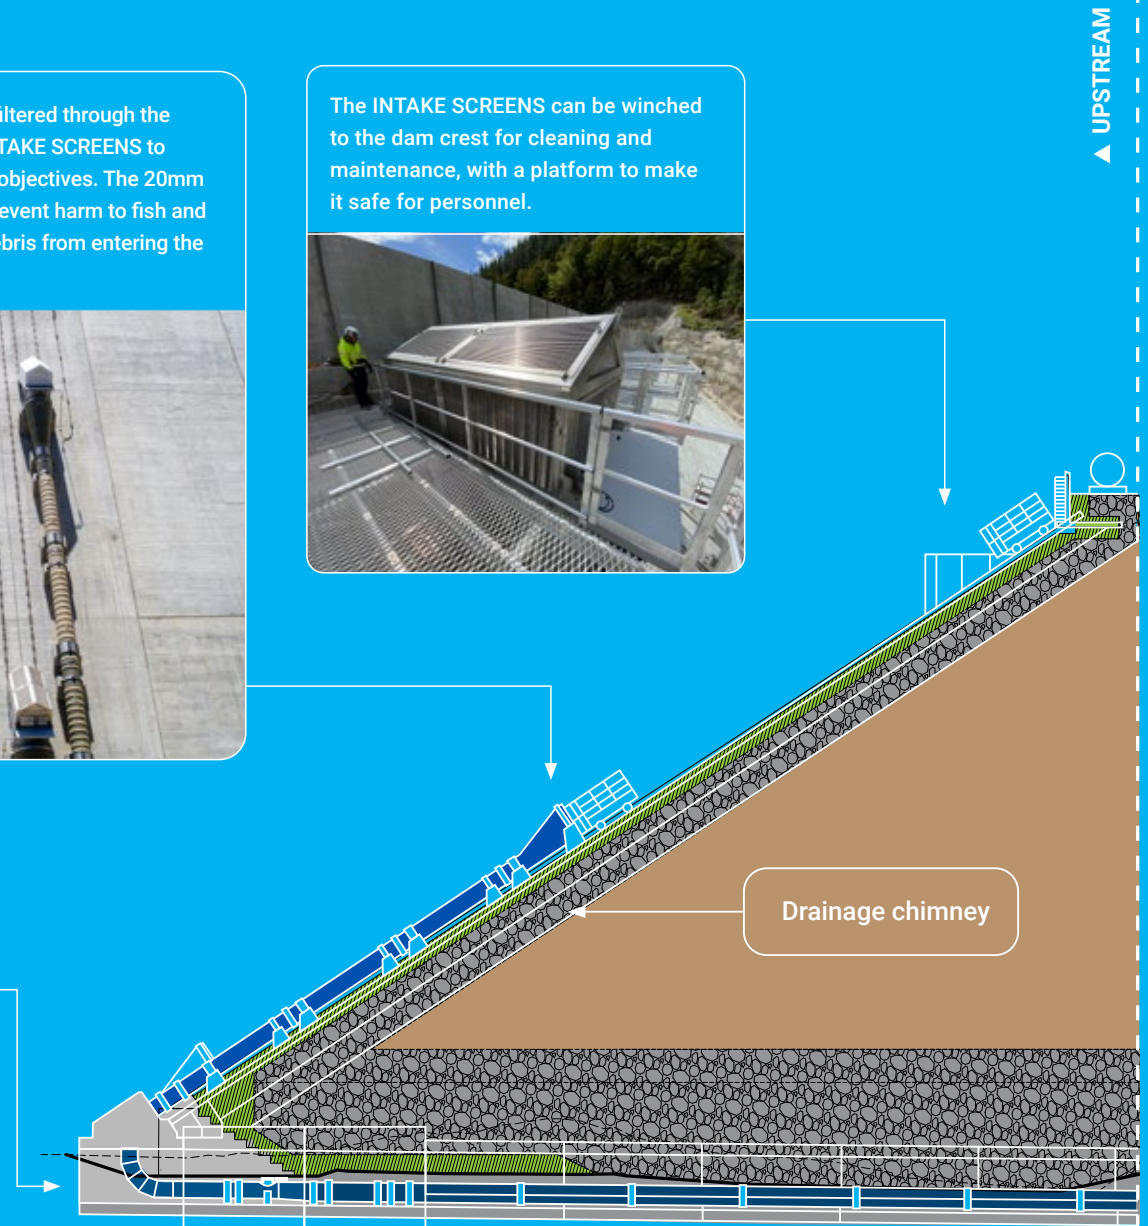
Water from the upstream reservoir flows into either or both of the lower and upper intake screens. The screens work as a filter to exclude fish, eels and debris from the outlet works. The water then flows through the screens into the upstream valve chamber where the water from the two intakes is mixed to maintain water quality targets. After flowing through approximately 160 metres of pipework, the length of the dam, the water reaches the downstream valve chamber where cone valves control the release of the water to the river.

The RIGHT-HAND SIDE CULVERT houses the pipe for upstream reservoir water to flow downstream to the discharge valves.

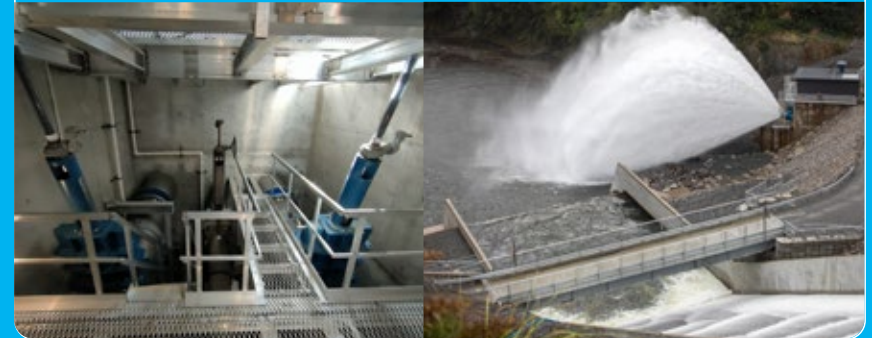
A DOWNSTREAM VALVE CHAMBER houses cone valves to disperse the pressurised flow into the river by dissipating energy. The micro-hydropower turbine inside the downstream valve chamber generates power for the dam. A ventilation system provides safe access for personnel to the culvert.

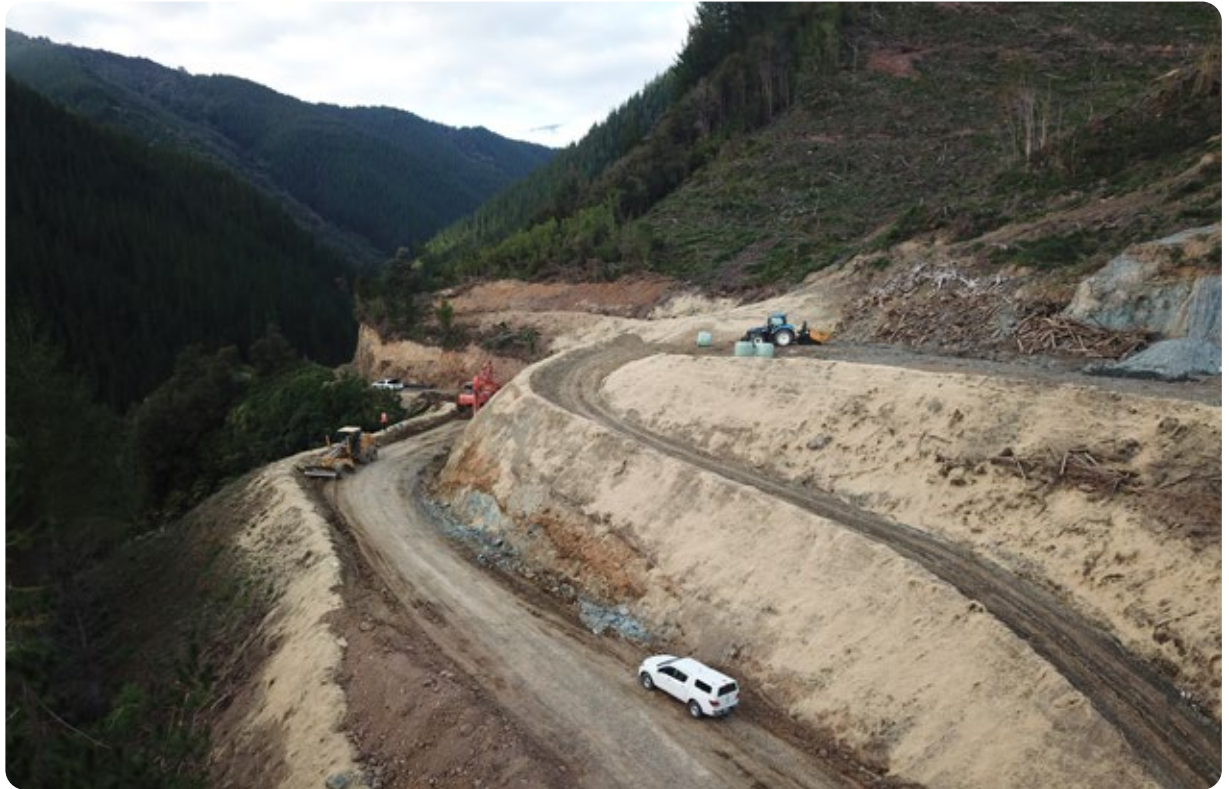
*Building the site access road, 2019.*

Site preparations by the Contractor began with upgrades to the 6.5-kilometre Lee Valley access road, construction of new haulage roads, and alternative access roads to land that would otherwise be landlocked when the reservoir was full. Sediment retention ponds and the 'Pig Flat' construction compound were also built, and vegetation was cleared from the dam site and reservoir, ready for the dam structures to be built.

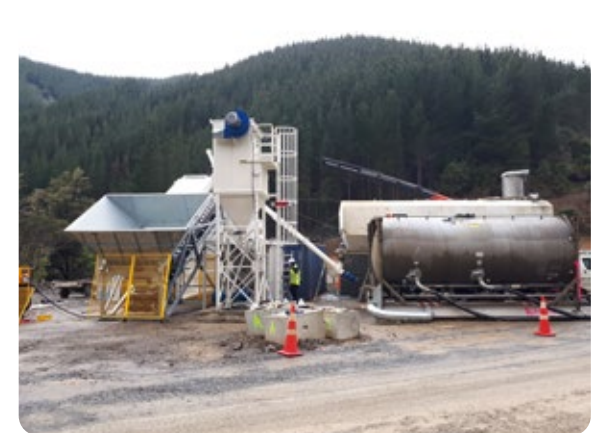
*Onsite concrete batching plant built in 2019.*

In 2019, an onsite concrete batching plant was built to provide the concrete, turning what would have been a one-hour drive to the nearest concrete plant into just five minutes to site.

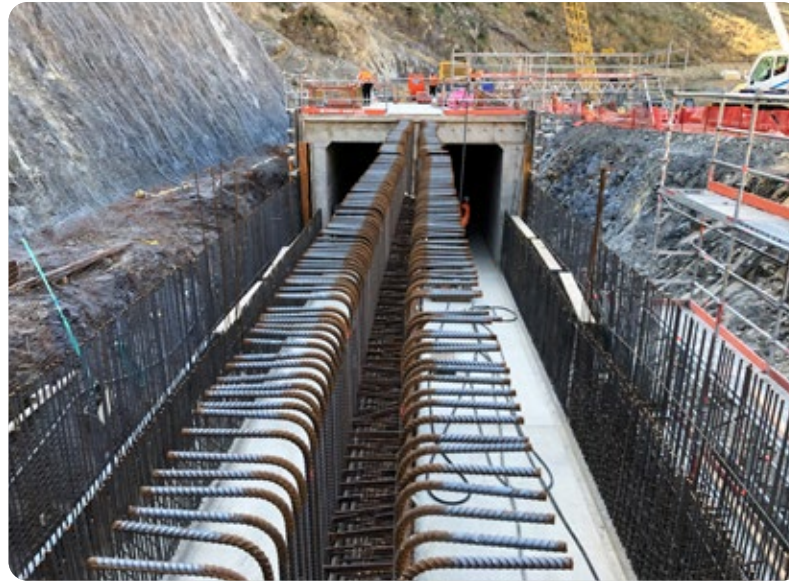
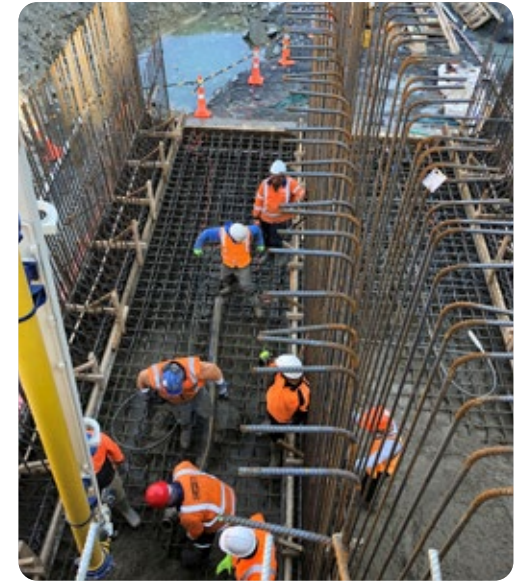
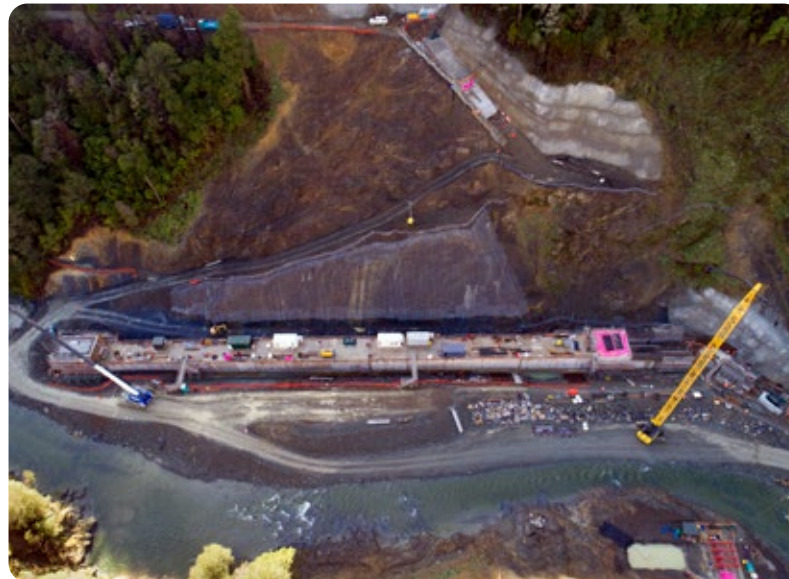
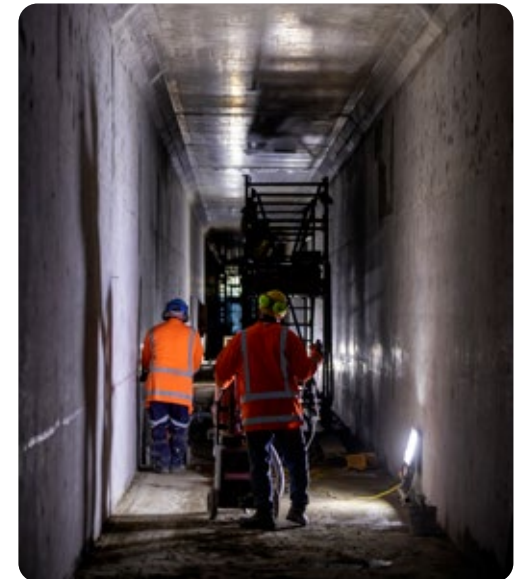
*The culvert was constructed of 4,500m<sup>3</sup> of concrete and 815 tonnes of steel.*

The culvert was constructed between 7 November 2019 and 1 September 2020, interrupted because of a one-month shutdown during April 2020 – the first COVID-19 lockdown. After the foundation was cleaned, mapped, treated and sealed with concrete, the culvert was constructed of 4,500 m<sup>3</sup> of concrete and 815 tonnes of steel, and its upstream section includes 1.6 metre-thick walls, roof and floor.
