# SECURING OUR REGION'S FUTURE

CONSTRUCTING THE WAIMEA COMMUNITY DAM

Constructing New Zealand's  
largest dam in 25 years to  
secure Tasman's water supply.

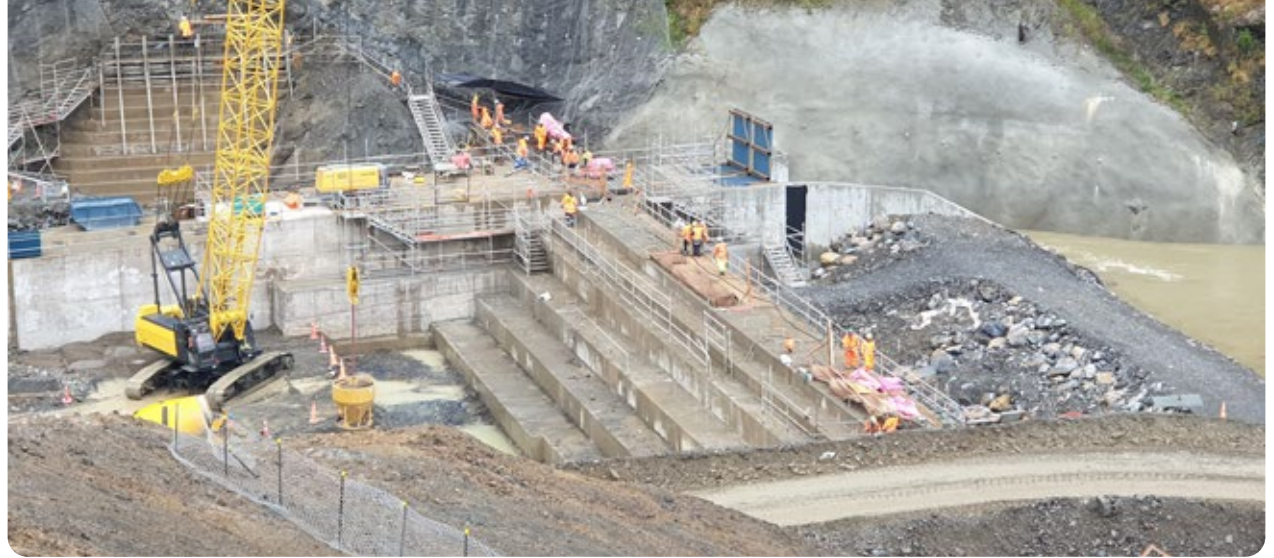
*The starter dam concrete structure and one of the gravel coffer dams, 2020.*

Once the river was diverted into the culvert, two coffer dams were constructed at either end of the culvert in September 2020 to guide the river and protect the works on the riverbed. A gravity concrete starter dam was first constructed on the upstream edge of the embankment in late 2020.

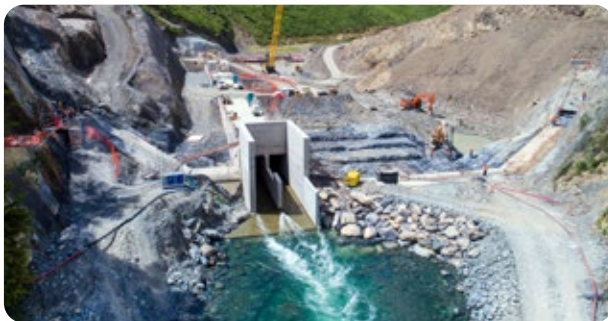
*Construction of the rockfill dam started in November 2020.*

Between November 2020 and June 2021 the reinforced rockfill dam was constructed in the downstream face of the embankment to protect the embankment works from flood events. The reinforcing was laid at one metre lifts to a height of 29 metres above river level and the reinforcing extended up to 23 metres back into the embankment. The reinforced rockfill dam is designed to withstand and protect the works in a flood event with a 1:1,000 AEP.

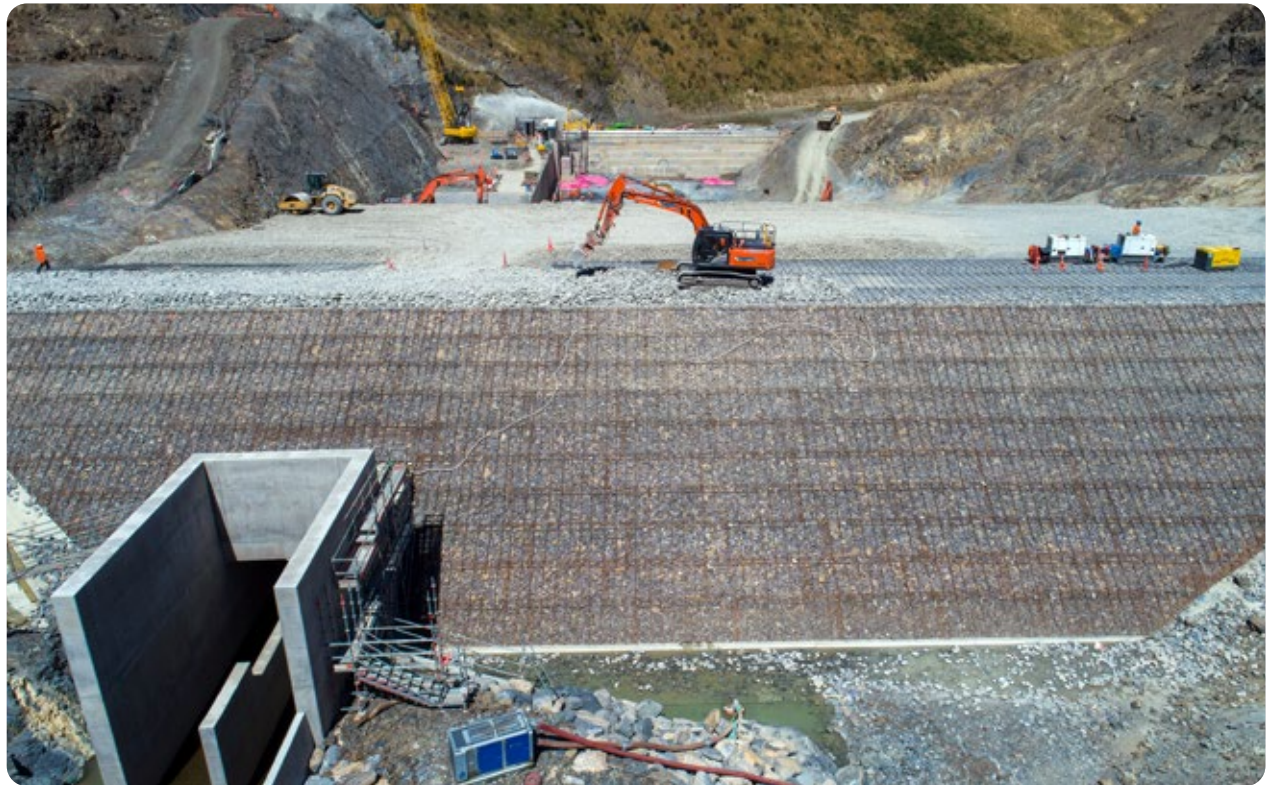
*The completed rockfill face protects the embankment during construction.*

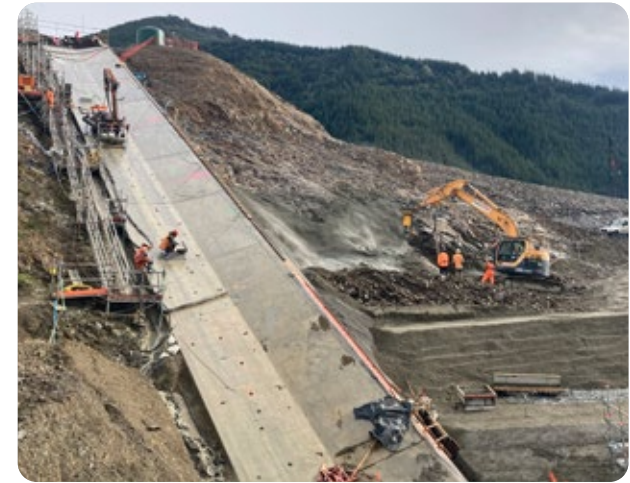
*The plinth being constructed, 2020.*

Ahead of the main embankment, a 4.6 metre-wide concrete plinth was constructed around the upstream perimeter of the embankment, down both abutments, to connect with the starter dam. The plinth was anchored to a depth of more than three metres in the bedrock at two metre centres, with its foundation on the RHS abutment modified to suit the topography and geology.

Then, through the plinth and across the spillway, more than 18,000 metres of drilling was completed to a depth of more than 40 metres to construct the grout curtain that seals the subsurface and reduces subsurface seepage beneath the dam.

The concrete face would later tie into the plinth. The plinth essentially anchors the upstream edge of the embankment to the founding rock, and then seals the subsurface with the dam face.

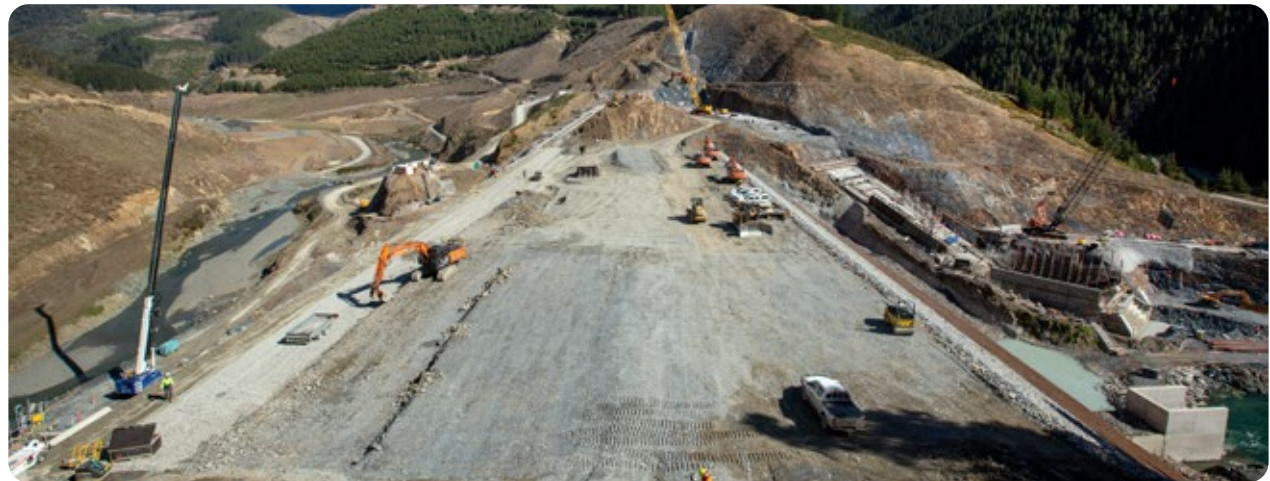
*Embankment during construction, September 2021.*

A total of 108 concrete kerbs were progressively stacked atop each other on the upstream face. The kerbs facilitated construction of the flow limiter and drainage chimney, while providing erosion protection to the flow limiter. The first 10 metres of rockfill at the bottom of the embankment were imported rock, forming the drainage blanket. Subsequent layers were predominantly indigenously mined rock downstream of the flow-limiting layer and drainage chimney. In total, 110,000 m<sup>3</sup> of rock were imported from nearby quarries and 25,000 tonnes of sand were imported from Tasman, Marlborough and the West Coast to construct the new embankment drainage and flow-limiting zones.

The bulk of the 490,000 m<sup>3</sup> embankment is around 370,000 m<sup>3</sup> of indigenously mined rock and river gravels. With the precast parapet wall units installed along the top of its crest, the embankment stands at 53 metres high above river level, is 220 metres long and is six metres wide at the crest.

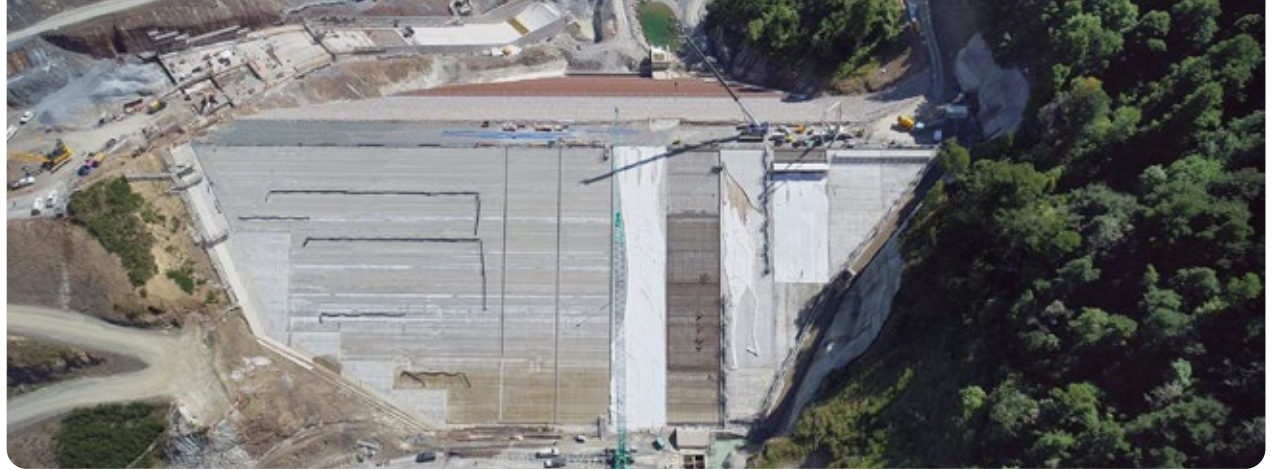
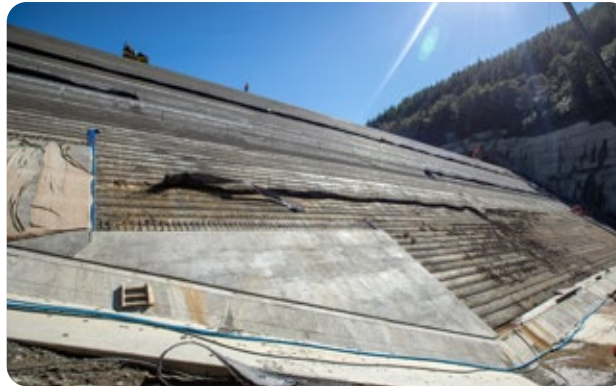
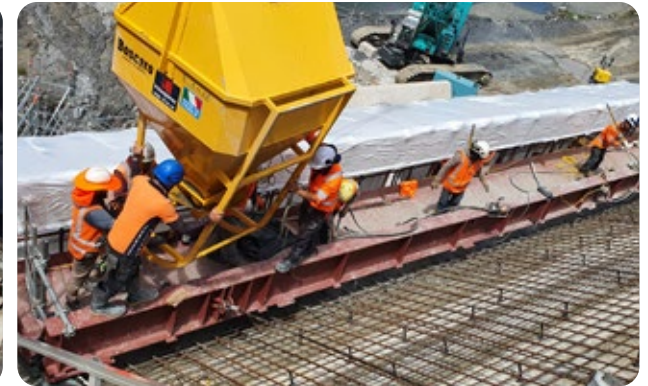
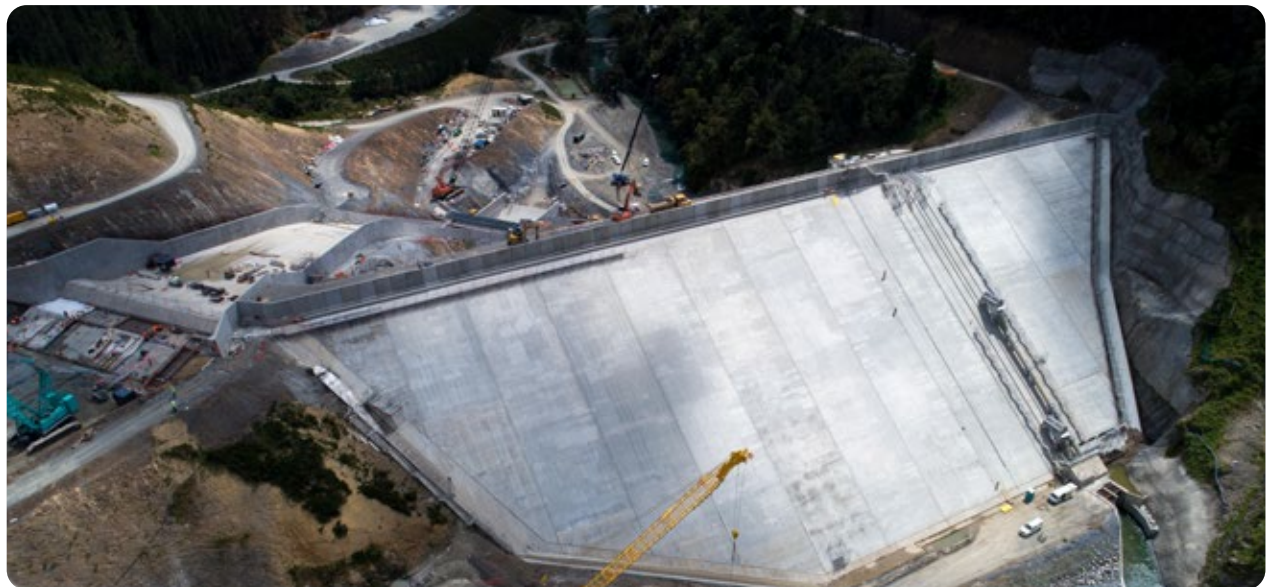
*Top: Early in the concrete face's construction.*

*Middle left: Preparing the concrete face in September 2021.*

The parapet wall panels were precast earlier offsite and then laid out in a row of bollards on top of the embankment once the face was completed. An elastic geosynthetic external wall-stop seals the joints while providing for movement between the parapet modules.

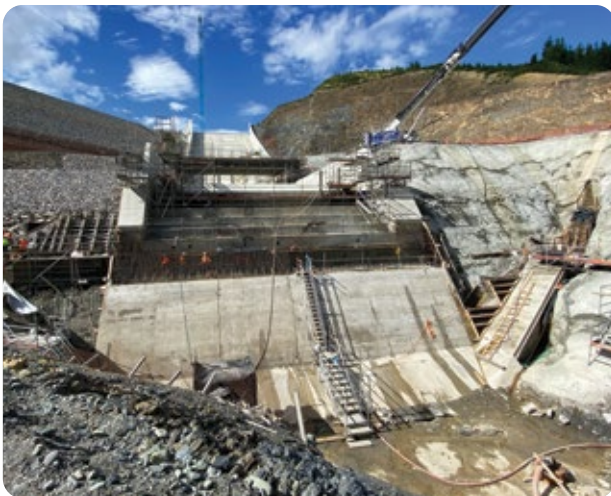
A nine metre cut-off wall below the flip bucket.

At the bottom of the spillway, more shear zones hampered the construction of the plunge pool. Extensive concrete reinforcement was needed to handle the pressure of the water coming out of the flip bucket. A nine metre-high concrete cut-off wall between the spillway flip bucket, and extending to three metres below the plunge pool, was constructed to protect the spillway from erosion.

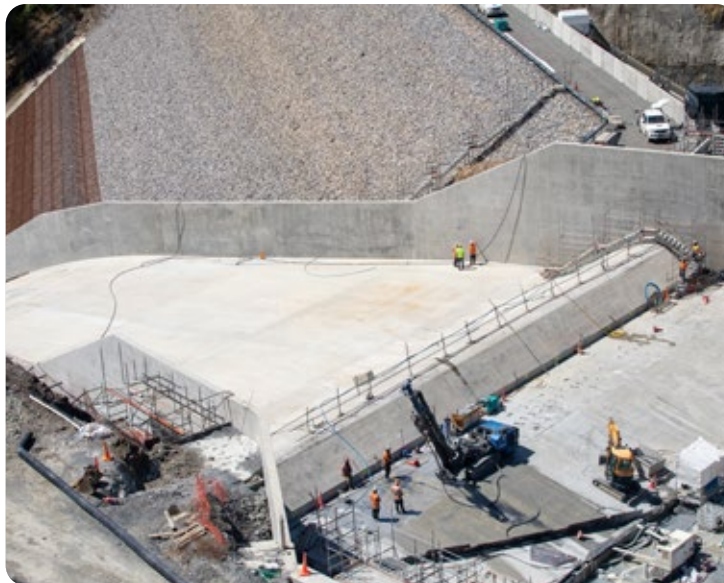
Upper spillway and ogee weir.

Upstream and bisecting the top of the spillway, more shear zones were encountered in the rock foundation. To ensure water couldn't seep and erode through the shear zone, which would otherwise compromise the integrity of the spillway, a 4,500 m<sup>2</sup> flexible geosynthetic liner was installed by Carpi Tech in the approach to the spillway. Subsurfacing grouting and instrumentation were also both extended in the spillway approach apron to mitigate the impact of these shear zones.

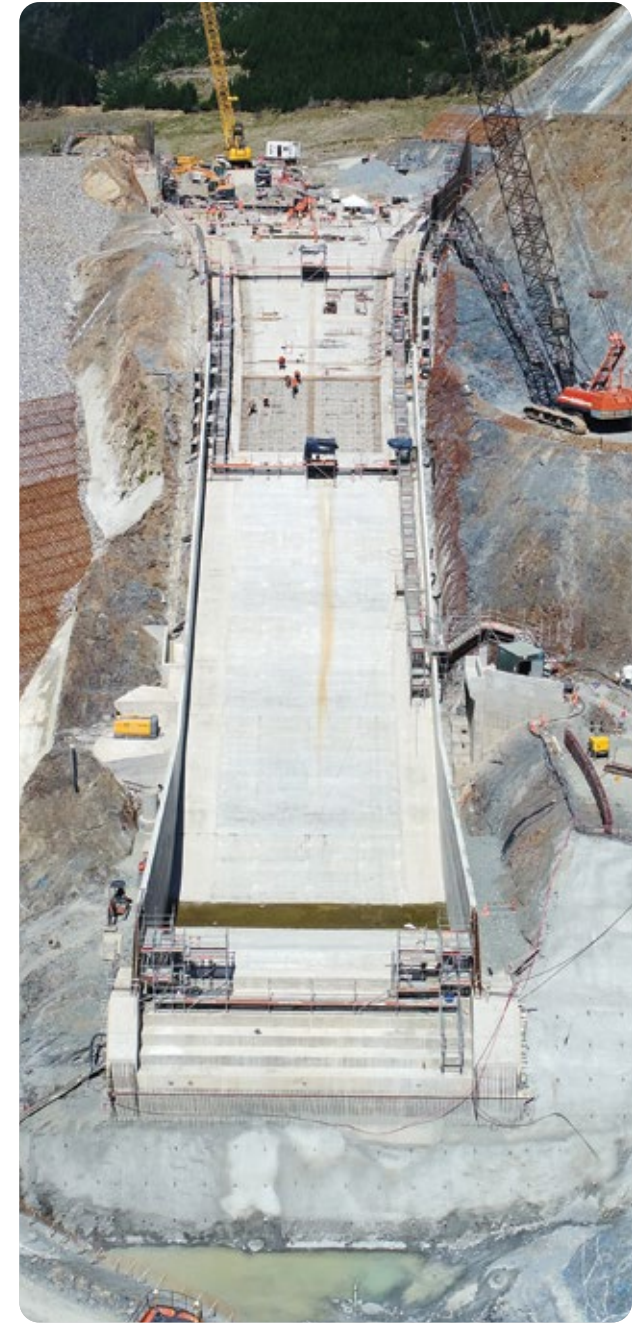
The spillway during construction.

Construction of the rectangular-walled spillway progressed through 2021 and 2022, with final completion in September 2022. The concrete slip-forming of the spillway's wall bases was unique for New Zealand and required specialist personnel and equipment from Brazil.

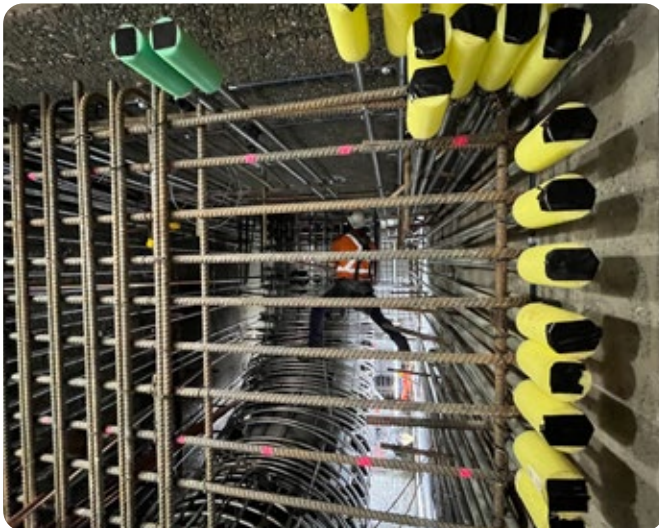
Reinforced pipework, July 2023.

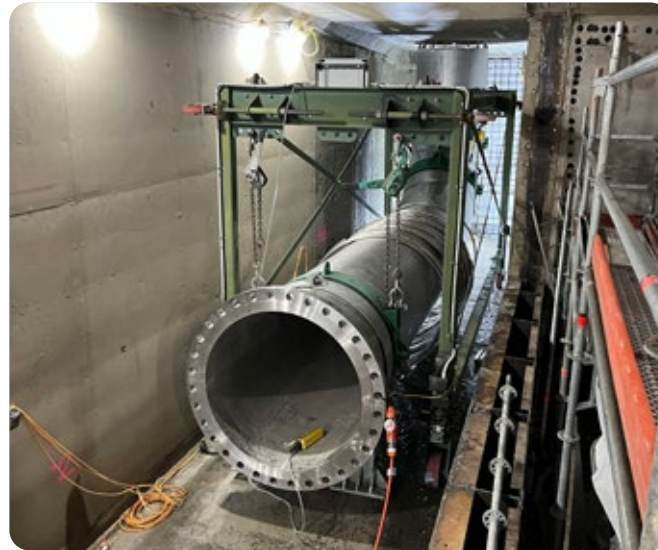
Installing lobster back bend pipe.

On 18 October 2022, with the embankment and spillway sufficiently complete, the LHS of the diversion culvert was closed with the first stoplog. With the river flowing down the RHS, the permanent intake lobster back bend pipe, entombing concrete plug and the PIV were all installed in the left side. A temporary 1.2 metre diameter HDPE pipe was then installed for the subsequent river diversion.

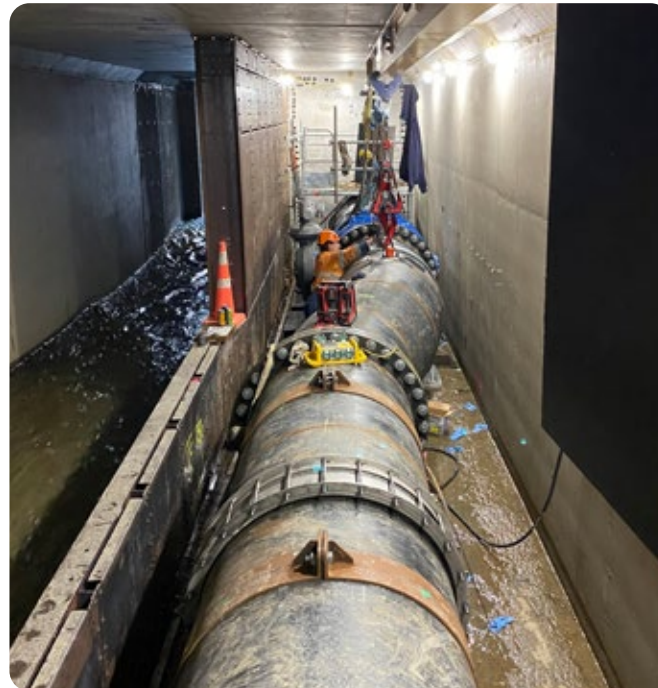
Installing temporary diversion pipe in left culvert.

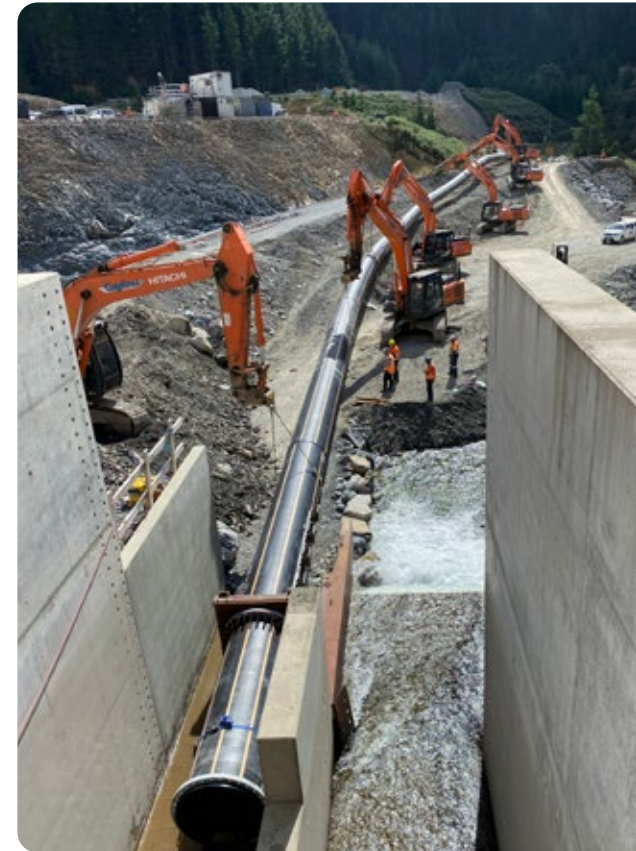
Installing temporary river diversion HDPE pipe in left culvert.

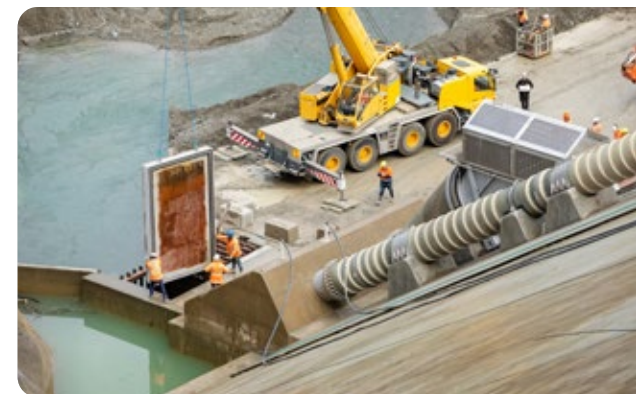
The second stoplog installed to permanently close the river diversion, 26 May 2023.

There were minor delays to the temporary works in April and May 2023 due to flood events. But then in late May, once engineering certification and subsequent regulatory approval was completed, the temporary river diversion pipe and facilities were commissioned. The second stoplog was installed on 26 May 2023 to the RHS of the culvert to close the reservoir so it could start filling with rainfall.

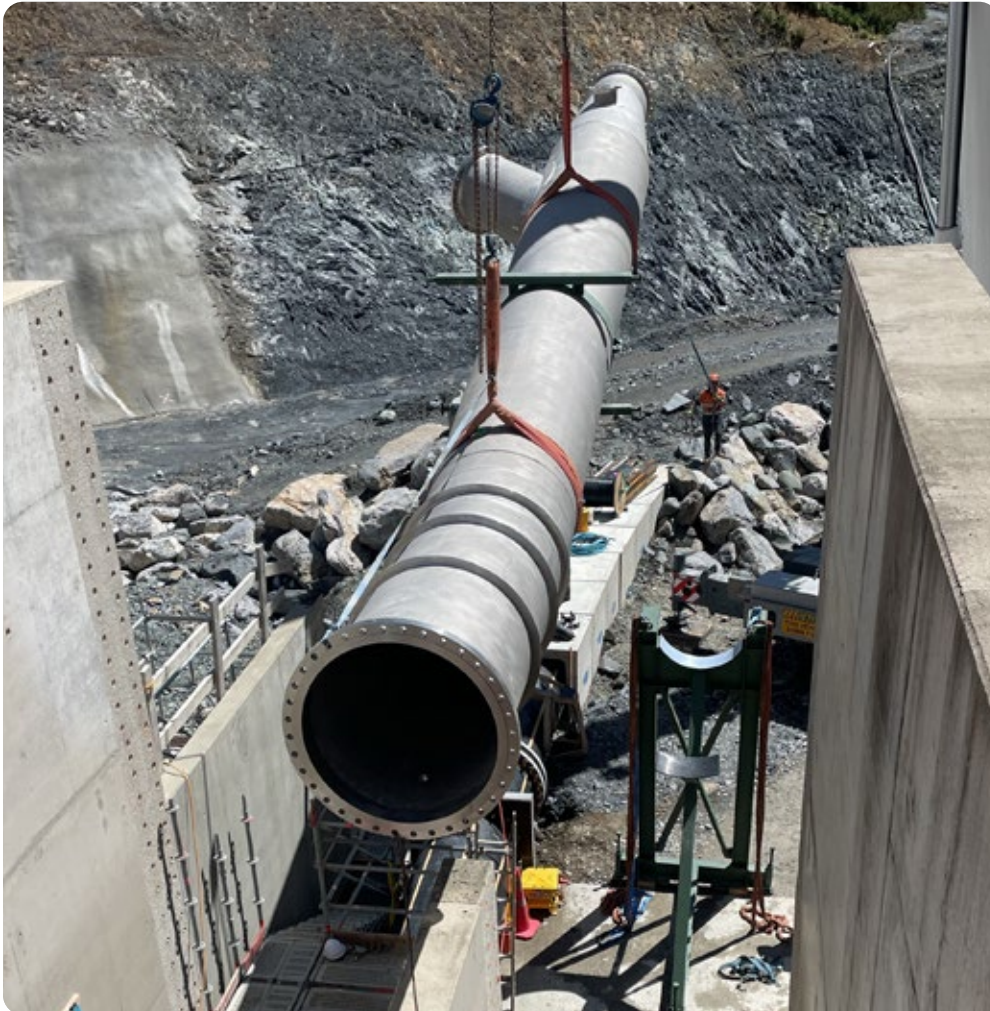
*Fifteen-degree bend pipe being lifted into position at the culvert outlet chamber.*

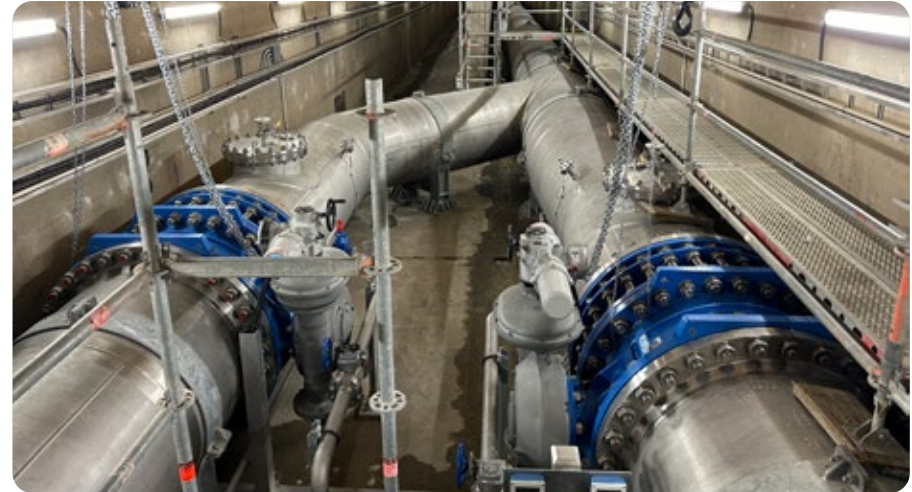
*Intake pipes and PIVs.*

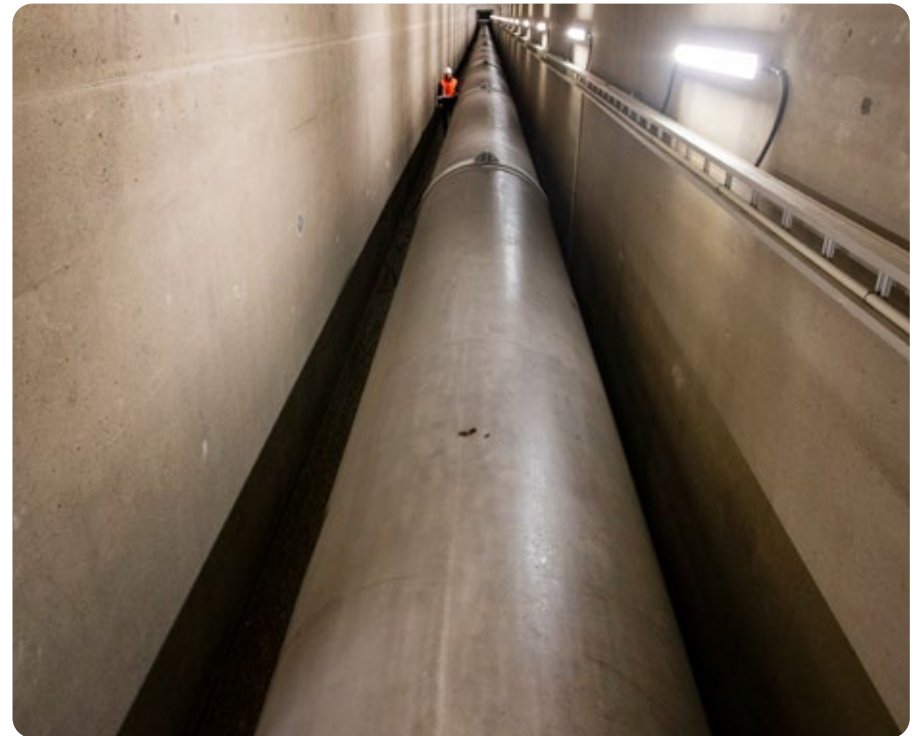
*1.4 metre diameter stainless steel pipe in the right culvert.*

With the river flowing through the temporary pipe and facilities in the LHS culvert, the permanent 1.4 metre diameter stainless steel pipe, valves, electrical and control systems were installed between June and December 2023 in the RHS culvert.

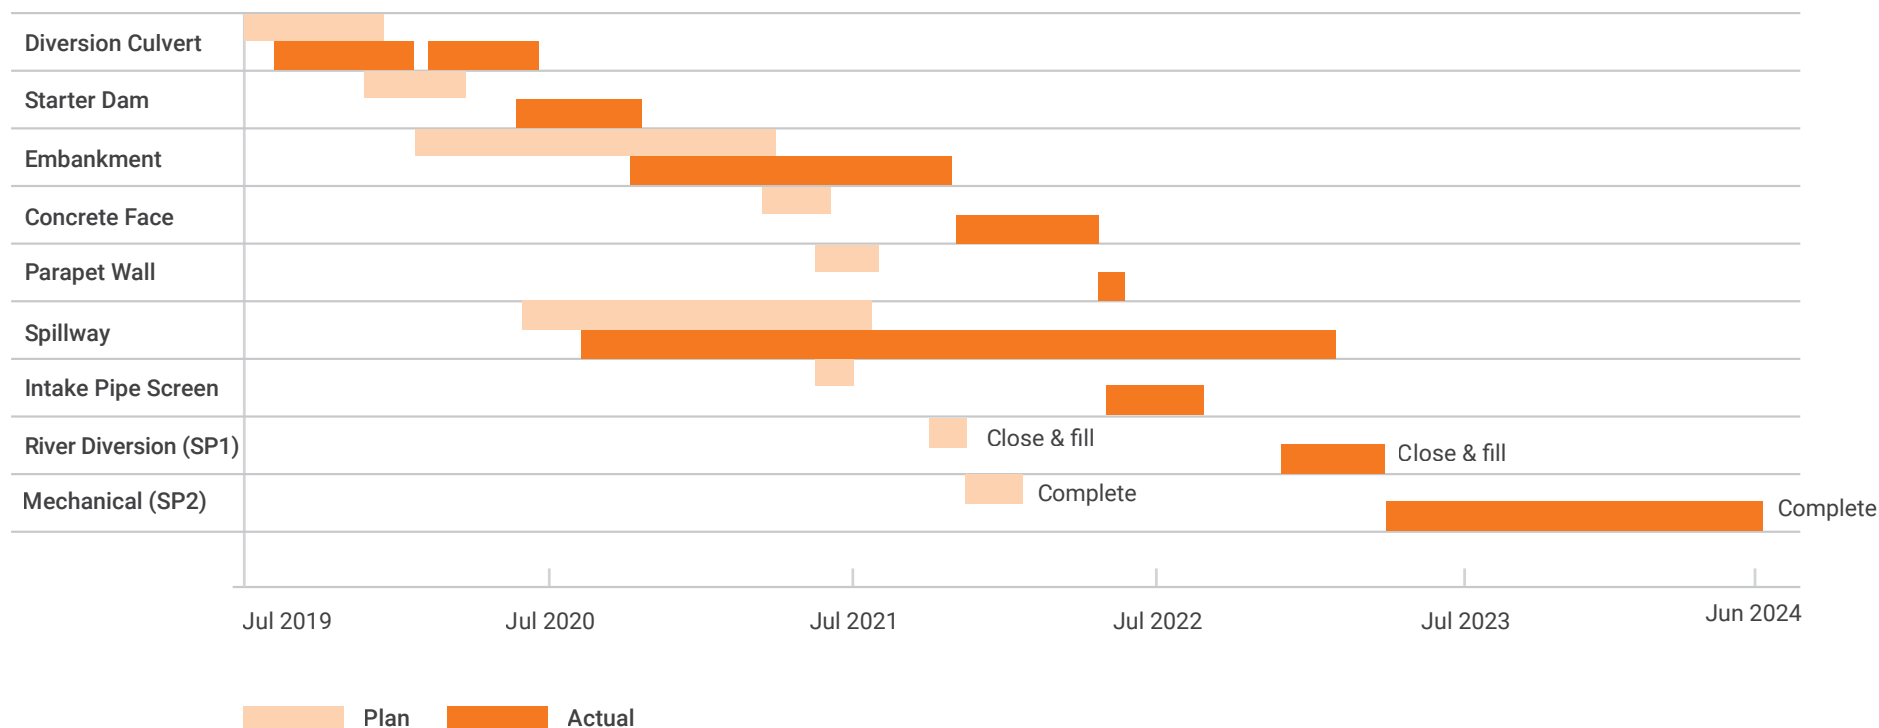
## MILESTONE COMPARISON

Milestone comparisons from the start of construction.

**Delays throughout construction added more than two years to the project programme. These delays were caused by COVID-19, wet weather and floods during construction, a dry period during reservoir filling and other construction delays.**

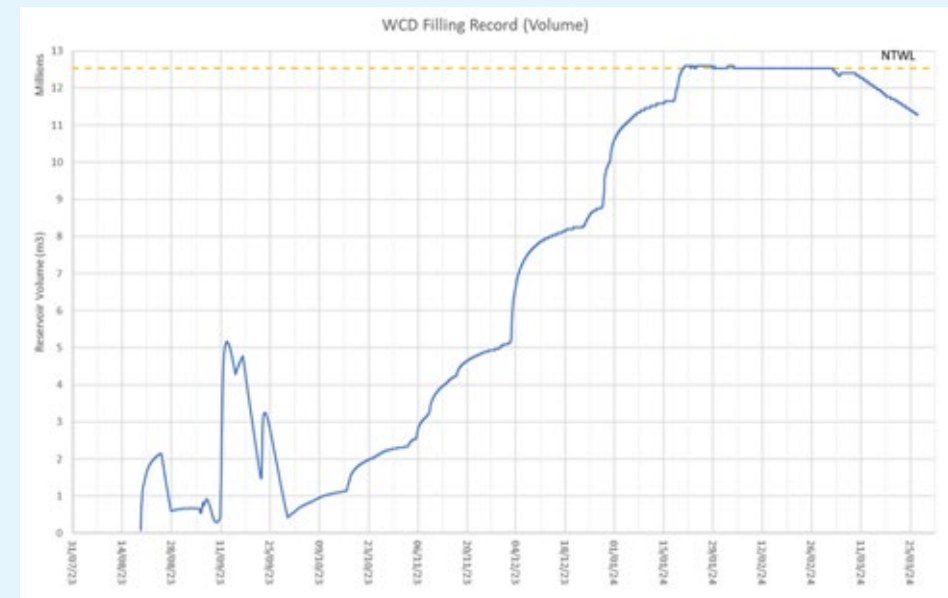
Left: The reservoir being filled in stages, October 2023.

In August 2023 the dam was ready for the reservoir to be filled. It was filled in stages, with the dam's performance assessed at four hold points in accordance with the reservoir filling, surveillance and instrumentation plans.

Filling of the reservoir was paused in September 2023 to fix seepage at a shear zone on the left plinth. Filling then continued, but it was slow because the region experienced an abnormally dry spring.

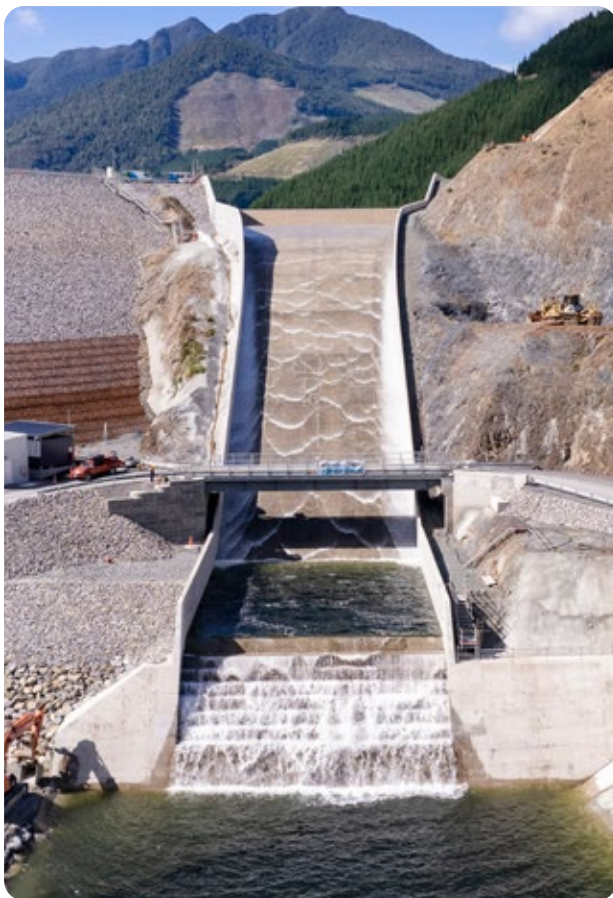
Water from the reservoir flowing down the spillway, January 2024.

The reservoir reached water capacity on 21 January 2024, with water flowing down the spillway naturally for the first time. Following surveillance and testing procedures, the temporary pipework in the culvert was removed in early February 2024. The permanent intake pipes were connected together and commissioned in late February.

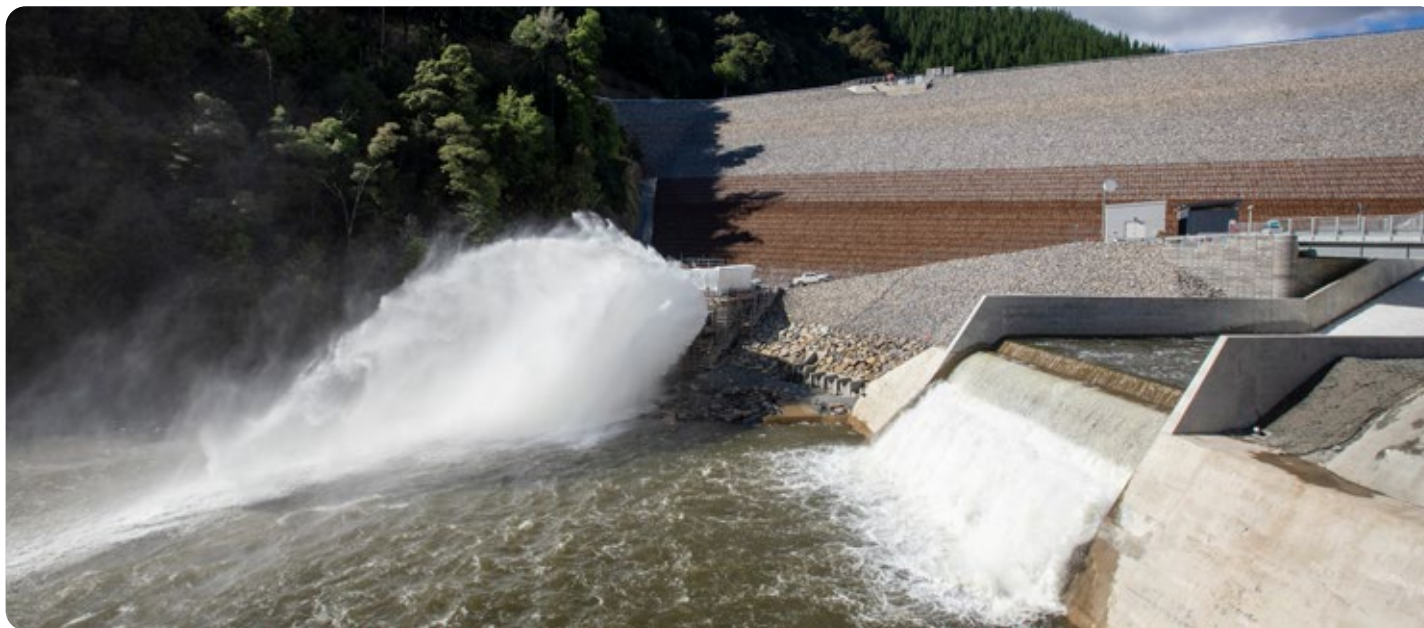
The two large fixed cone valves tested, commissioned and ready for operations, April 2024.

Successful testing of the two larger cone valves in early April 2024 marked the dam's completion and it being ready for operations.

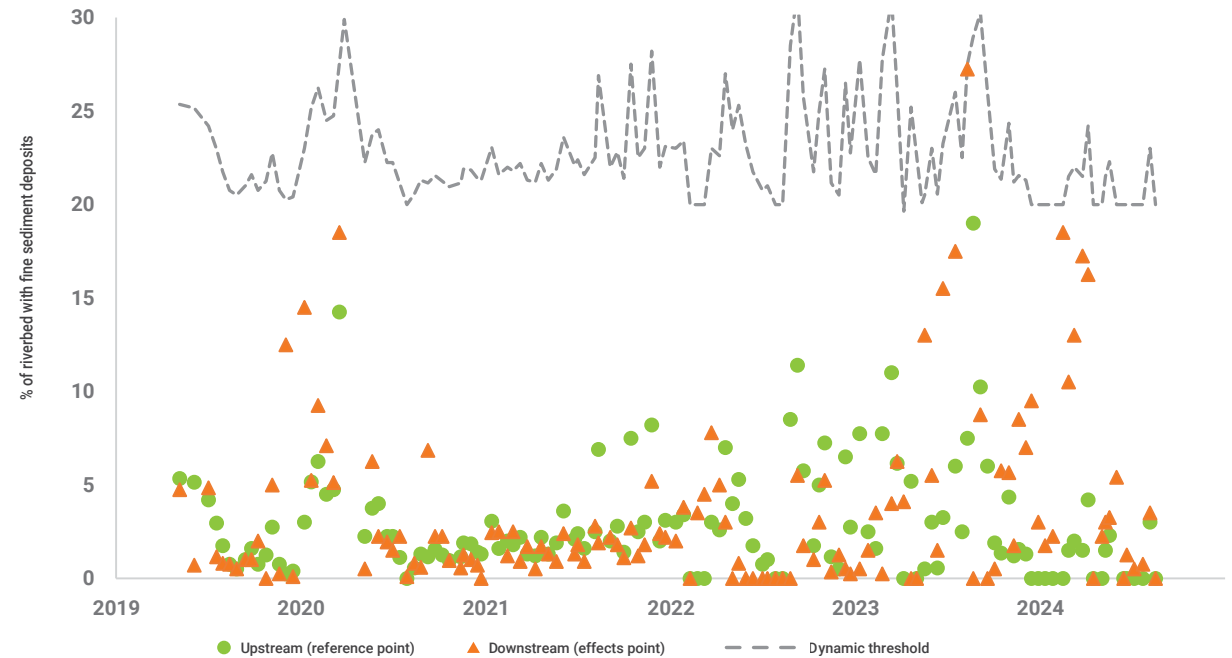
## LEE RIVER DEPOSITED FINE SEDIMENT

Sediment in the Lee River was monitored and recorded during construction.

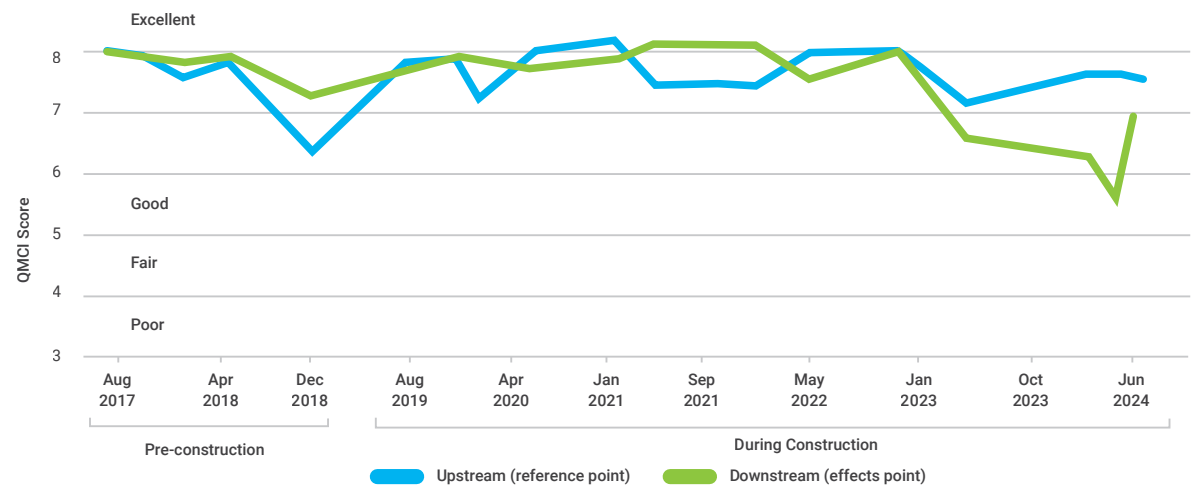
## LEE RIVER QMCI SCORE

QMCI scores since the project started.

One measure of river health is the Quantitative Macroinvertebrate Community Index (QMCI). Macroinvertebrates are the wide range of small insect species that live in waterways and are an essential part of the food chain. The QMCI measures how many of these small water insects are living in the river. Before construction began, the QMCI for the Lee River was classed as 'excellent'. Regular tests during the project saw the Lee River's QMCI remain 'excellent' during construction. With the dam now operational, water quality monitoring continues.
